FLIGHT SAFETY FOUNDATION
Aviation Mechanics Bulletin

July–August 2002

Vol. 50 No. 4

Improved Understanding Of Human Factors Could Reduce Foreign Object Damage

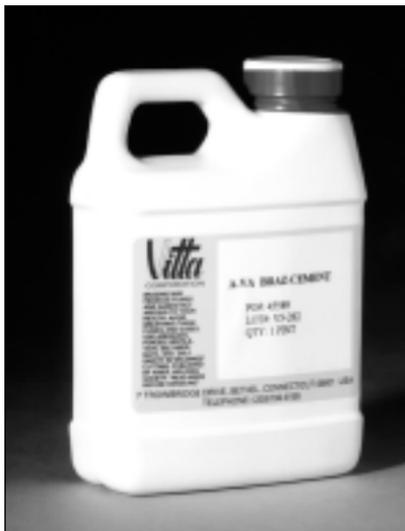
Low-viscosity Cement

A-VA Braz-Cement is a low-viscosity, water-based cement designed to be used as a liquid binder to hold a variety of powdered filler metals in place before brazing, said the manufacturer, Vitta Corp.

A-VA Braz-Cement is nontoxic, non-flammable and odorless. It rapidly wets brazing powders and, when dry, produces a clear, tough, flexible film. A-VA Braz-Cement may be used for

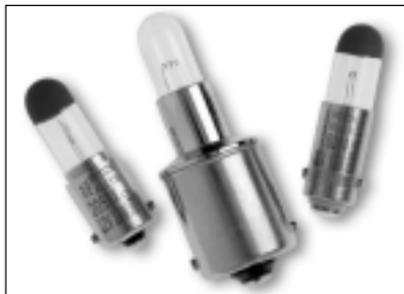
Halogen Lamps

The lifetimes of Welch Allyn HPX halogen aircraft/transportation lamps have been increased by as much as 150 percent to up to 10,000 hours, the manufacturer said.

The increases resulted from improvements in components, the manufacturing process, product testing and the

gas chemistry used in the lamps, the manufacturer said. The lamps are available in six-volt, 12-volt and 28-volt versions at wattages from 10 watts to 15.4 watts and are designed to withstand electrical power spikes. HPX aircraft lamps are used as reading lamps, cockpit lamps and galley lamps.

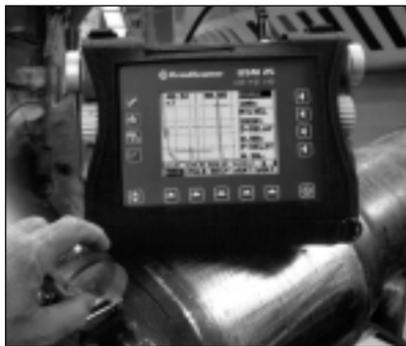
Portable Flaw Detector

Krautkramer USM 25 series portable flaw detectors have a minimum range of 0.02 inch (0.51 millimeter) for optimum thin-range use and

evaluation of echo dynamics, said the manufacturer, Agfa NDT.

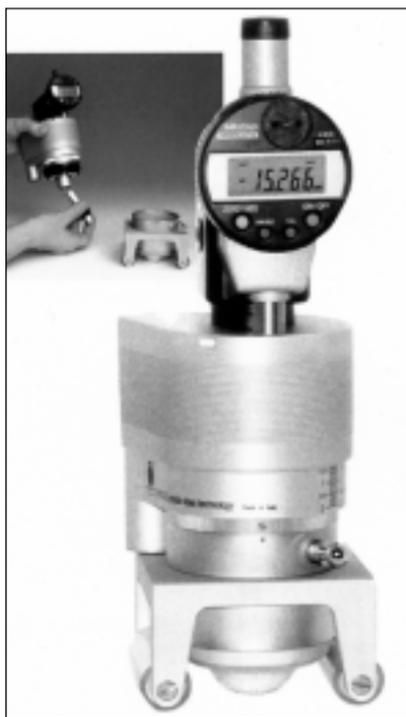
Portable Microscope

A compact, portable microscope from AEI Optics Unlimited provides real-time, flat-field images for a variety of applications, including observing and measuring surface finishes and aircraft skin cracks, the manufacturer said.

The Video-Check Roll and the Video-Check Roll-Z produce images at

magnifications from 25 times actual size to 2,350 times actual size for observation and long-term storage, the manufacturer said. The focusing barrels of both microscopes contain programmable rings to vary illumination effects, and the housing allows operators to easily change fixed-magnification objectives. Plastic-covered, non-conductive, silicone-free rollers protect targets against damage and unwanted deposits.

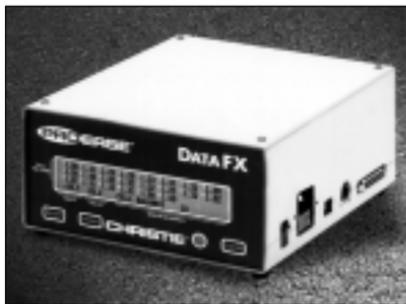
Battery Monitor

The DataFX monitors aircraft batteries and battery cells with a large-screen display for viewing as many as 22 cell voltages simultaneously, said the manufacturer, the Christie division of Marathon Power Technologies.

The DataFX works with any aircraft battery charger/analyzer used in servicing large, vented NiCad batteries and lead acid batteries. After the DataFX is connected to the aircraft battery charger/analyzer, it scans a battery's cells during charge and

discharge to measure cell voltages at various intervals and displays the result on a panel screen. The information can be transferred to paper with an optional serial printer.
