FLIGHT SAFETY FOUNDATION
Aviation Mechanics Bulletin

**Fall-protection
Equipment Safeguards
Maintenance Personnel
Working at Height**

Vol. 52 No. 4

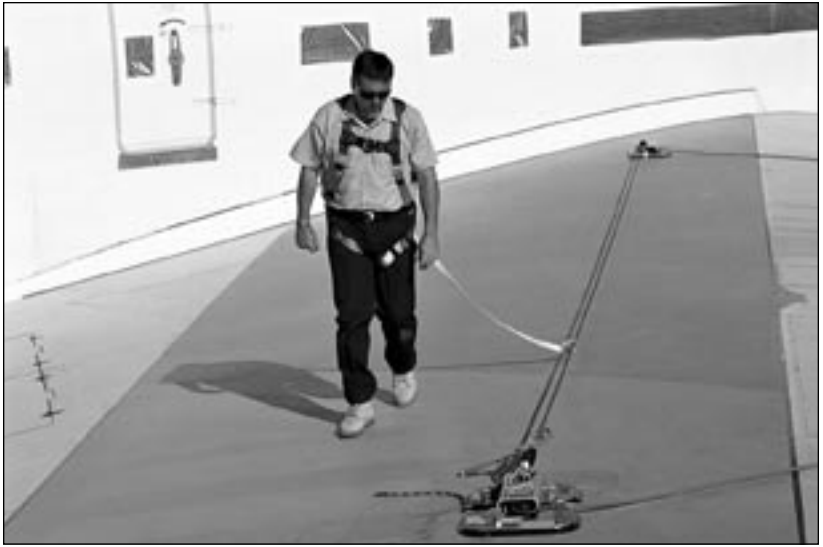
A horizontal lifeline secured to two anchorage connectors helps protect against a fall from an airplane's wing. (Photo: DBI/SALA)

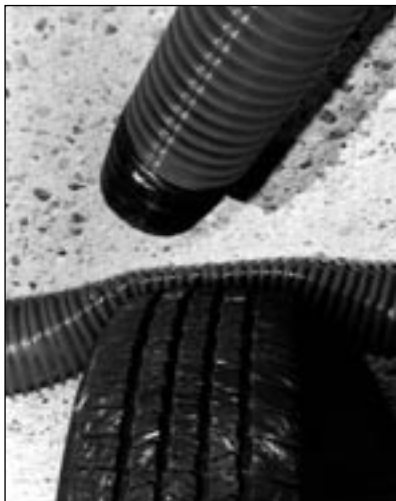
Crush-proof Urethane Hose

Standard lengths are 12 feet, 15 feet and 25 feet (3.0 meters, 3.7 meters and 4.6 meters), and other lengths can be specially ordered.

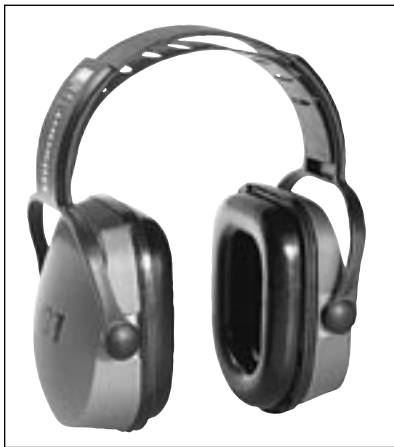
Earmuffs

The Clarity line of earmuffs from Bilsom features technology that filters out harmful or distracting noise while allowing users to hear warnings, alarms and coworkers' voices in environments such as noisy shop floors. Sound is blocked uniformly across a series of octave bands, but human-voice frequencies pass through more easily.

The three models in the Clarity line, C1, C2 and C3, provide noise reduction ratings (NRRs) of 20, 23 and 27, respectively. The range of available noise reduction allows users to choose the right level for their environment, avoiding overprotection where it might be dangerous, the manufacturer says.

Clarity earmuffs' sound management capability is based on design and material technology, rather than sophisticated but expensive electronic noise canceling, the manufacturer says. The product uses a dielectric design that is said to protect against shock in environments where electrical equipment is used.

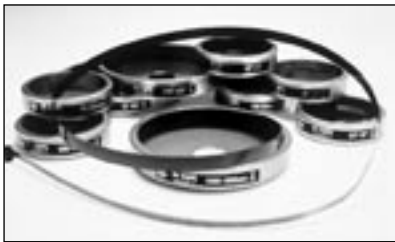
Diameter-measurement Tape

Measuring accurately the inside diameter or outside diameter of a rounded form such as a duct is simple with Pi Tape measurement tape, the manufacturer says. The product is said to be less expensive and faster to use than micrometers, calipers or laser-type distance-measuring devices.

The tape's graduated markings are engraved and acid-etched on a ground surface and are fixed, so that periodic calibration is not necessary. The tape gauges are available in inches or millimeters. Tapes marked in inches read to a diameter of 0.001 inch with an accuracy of plus or minus 0.001 inch up to 144 inches. Tapes marked in millimeters read to a diameter of

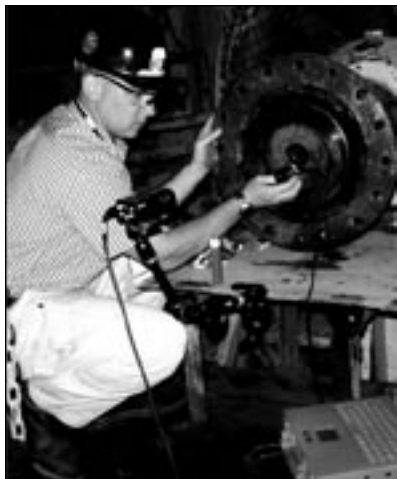
Portable Flaw-detection System

A portable ultrasonic flaw-detection system for large shafts such as those in aircraft-engine turbines, the ShafTest requires access only to the shaft end. Test results can be analyzed off-line

to minimize equipment out-of-service time, and stored shaft signatures allow monitoring of crack growth.
