FLIGHT SAFETY FOUNDATION
Aviation Mechanics Bulletin

JULY–AUGUST 1999

Omission of Oil-plug Seals Leads to In-flight Engine Shutdowns

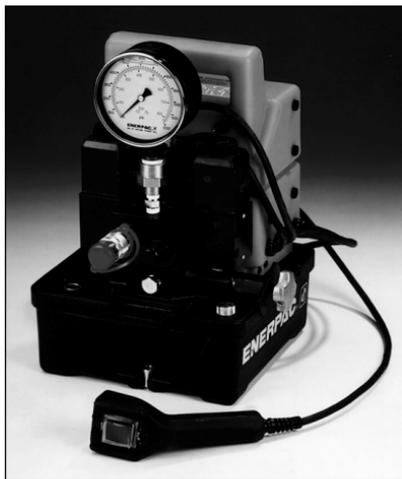
The air-driven model features a high-output, air-driven, two-stage pump and an air-operated valve with remote control. The model is suitable for use under circumstances that require explosion-proof equipment, said the manufacturer.

*Enerpac
Portable Pump*
