Aviation Mechanics Bulletin

MARCH–APRIL 2005

Overheated Heater Ribbon, Contaminated Insulation Cited in B-767 Cargo Fire

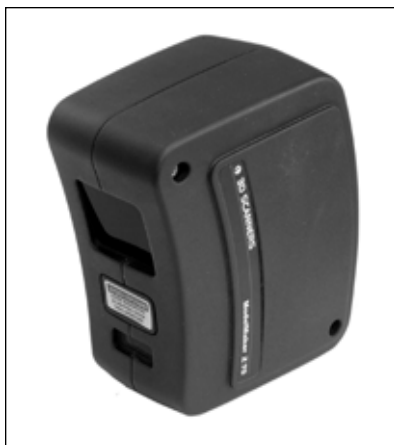
Portable Laser Scanner

The ModelMaker system comprises a portable coordinate-measuring machine, to which a three-dimensional (3D) laser-stripe sensor is attached. A laser-stripe sensor performs significantly faster than a simple laser-point sensor, the manufacturer says. A personal computer and dedicated software extract, display, manipulate and export the data.

To record the shape of a component, a technician moves the sensor over the surface, and a dedicated interface card translates the video image of the line into 3D coordinates. The data can be exported to standard 3D computer-aided design (CAD) packages to fabricate the replacement object.

The ModelMaker Z series portable laser scanner from NVision can be used to reverse-engineer aerospace components. The unit creates a solid model for quickly and economically producing replacement parts that are no longer in production by the original equipment manufacturer, the manufacturer says.

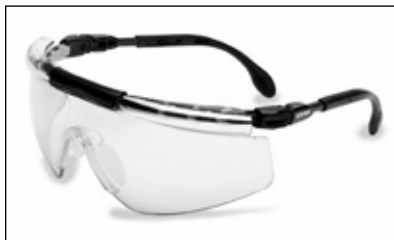
Safety Eyewear

Wearers can adjust the eyewear at four different locations. The nosepiece design, for example, rotates, pivots and slants to provide a precise fit for the user's nose bridge. The temple arms ratchet up and down, then snap securely into place to accommodate cheekbone contours. Cushioning at all contact points and soft materials provide comfort for all-day wear, the manufacturer says.

The extended wraparound lens of polycarbonate blocks 99.9 percent of ultraviolet (UV) rays, the manufacturer says, and is available with anti-fog coatings and a variety of tints.
