# What Happens When The Alarm Bell Sounds?

*Robert A. Feeler*  
*Editorial Coordinator*

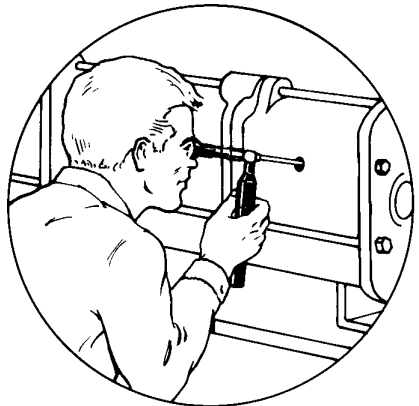
The unit is self-contained with illumination provided by a Krypton bulb powered by two AA batteries in the handle. The tube is .21 inches (.55

centimeters) in diameter and slightly over six inches (15.2 centimeters) in length. An optionally available fiber bundle and halogen light source is also offered by the manufacturer. For more complete information on this inspection device, contact: Titan Tool Supply Co., Inc., P.O. Box 569, Buffalo, NY 14207, U.S. Telephone (716) 873-9907.

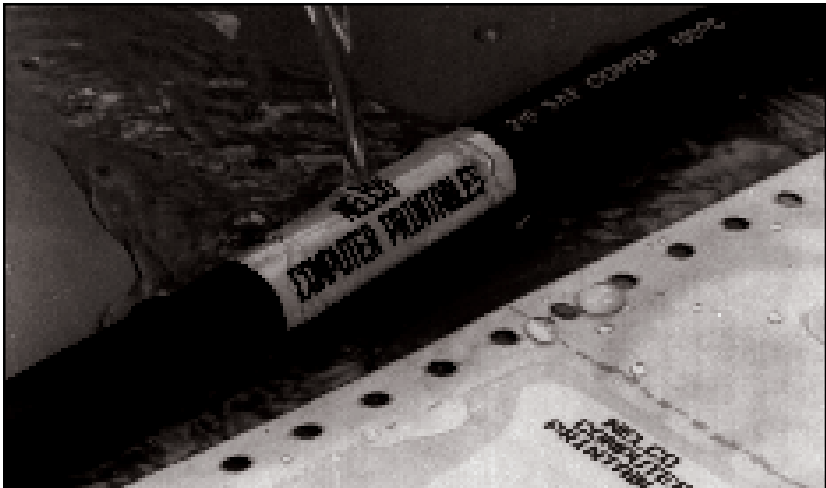
The manufacturer states that the labels are made of a self-laminating vinyl film that wraps around a round or flat surface to create a permanent label which is smearproof and waterproof. The labels are said to be resistant to oils, water and solvents commonly used in aircraft operations.
