FLIGHT SAFETY FOUNDATION  
**Aviation Mechanics Bulletin**

MAY–JUNE 2002

**MELs for Corporate and  
Business Aircraft Guide  
Deferred-maintenance  
Decisions**

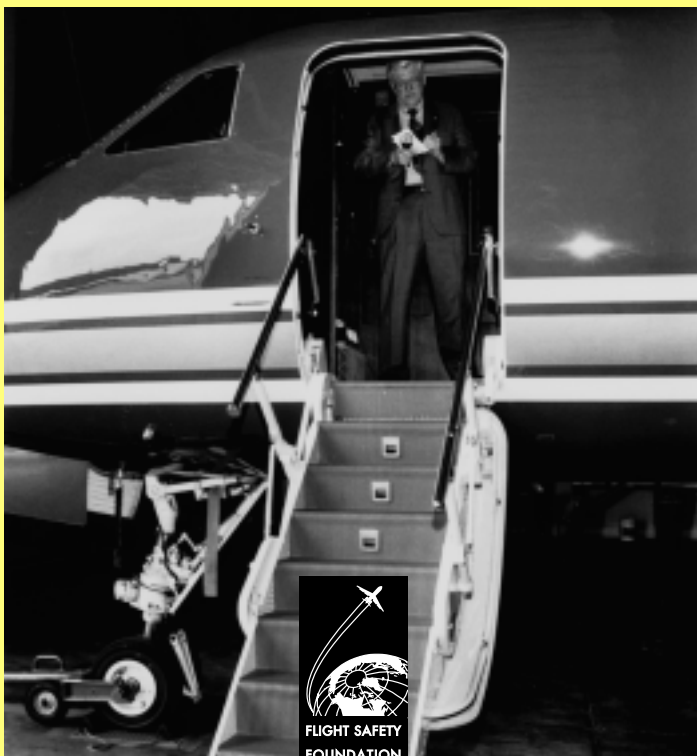
Cover: Darol V. Holsman, FSF manager of aviation safety audits, examines minimum equipment list documents for a Gulfstream IV. (FSF photo)

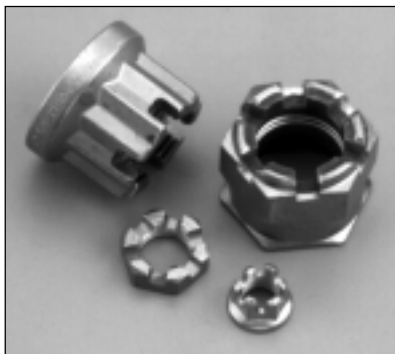
SPS Technologies castellated locknuts are available in hex configuration and 12-point configuration, in a variety of materials and finishes for use in commercial aircraft and military aircraft and other applications, the manufacturer said.

*Castellated Locknuts*

The locknuts are available in sizes from 0.190 inch (4.826 millimeters) in diameter to two inches (51 millimeters) in diameter and often are used with cotter pins for additional locking assurance, the manufacturer said.

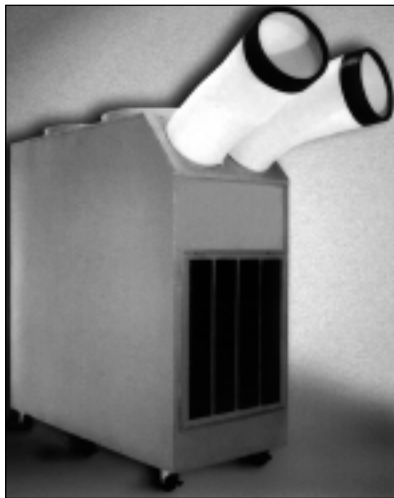
The Moving Cooler isolates the condenser and evaporative air streams to improve operating efficiency in producing cooler air, which is directed toward specific areas by two flexible cold-air outlets up to 10 inches (25 centimeters) in diameter and up to two feet (0.6 meter) long. The unit, which operates on casters, can be moved easily and fits through standard doorways. The Moving

*Portable Air-conditioning Unit*

Cooler is available in five cooling capacities between one ton (0.9 metric ton) and five tons (4.5 metric tons).

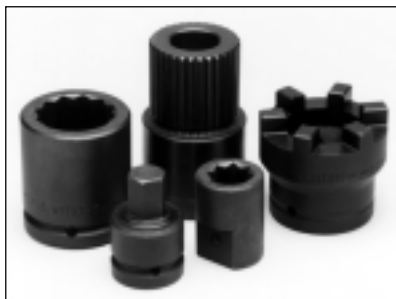
Wright Tools has begun producing custom-built hand tools developed according to customer specifications, the manufacturer said.

*Custom-built Hand Tools*
