How to Practice Good Tire Sense

*Catastrophic tire failures can be minimized
by proper attention to storage, maintenance
and operational practices.*

*Hennie Venter
Supervisor for Mechanical Systems
South African Airways (SAA)*

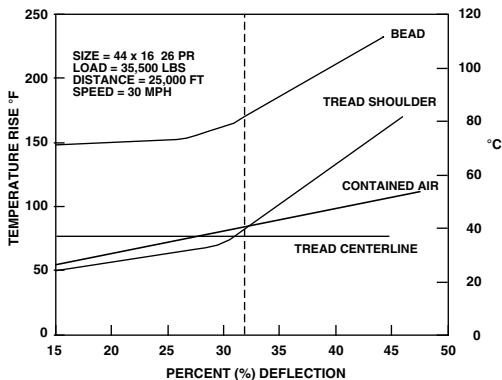
Figure 1

TEMPERATURE RISE VS PERCENT DEFLECTION

als. It is also stenciled on the landing gear or landing gear doors. The maintenance staff will check the tire pressures on every preflight. Under-inflation creates an excessive deflection in the tire called a traction wave. This is a very high flex point that causes heat buildup, especially in the shoulder and bead areas (Figure 1). It can result in tread separation or a complete breakup of the carcass.

After six miles of taxiing, the temperature almost doubles on a tire that has eight percent more deflec-

tion than specified. This excessive heat buildup can be the cause of separation in the shoulder or in the bead. If not discovered in time, it may end in a failure. Very close inspection will be required to see a bubble that might form in the area of separation. If a tire becomes a “leaker” in service — that is a tire that has a pressure drop of 10 percent or greater over a 24-hour period — it may also suffer a separation. The manual’s procedure for such a leaker is that it must be removed and returned to the shop for inspection.

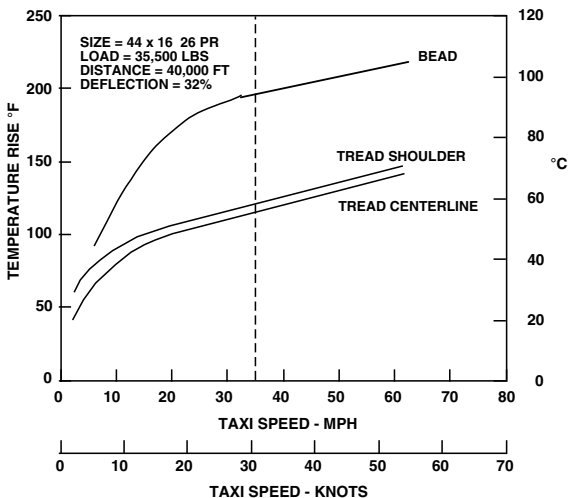
TEMPERATURE RISE VS TAXI SPEED

We already recognized that aircraft tires cannot handle high side loads because of their design. However, aircraft must be maneuvered on the ground which does result in side loads. It is for this reason that the speed at which these maneuvers are done should never exceed the limits specified. Taxi speed should never exceed 15 knots through a 45-degree turn and 10 knots through a 90-degree turn. Figure 2 clearly displays the heat build up as the speed increases.
