FLIGHT SAFETY FOUNDATION
Aviation Mechanics Bulletin

MAY–JUNE 2004

‘Rigorous’ Maintenance Programs Recommended for Fire Fighting Aircraft

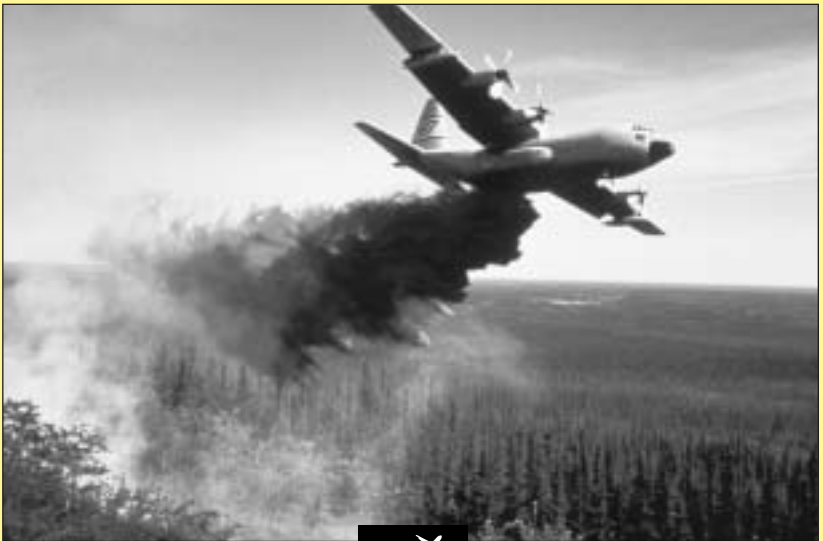
On the cover: Fire retardant is dropped from a Lockheed C-130 Hercules onto a forest fire in the United States. (Photo: U.S. Bureau of Land Management, Office of Fire and Aviation).

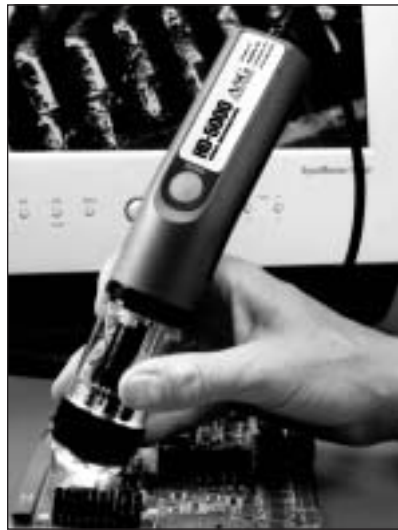
Hand-held Video Microscope

A hand-held video microscope, the ASG HD-5000 functions as a portable, high-resolution inspection system for observation and recording. The unit has switchable 20x or 50x magnification that can be output to a video monitor. Integral white light-emitting diodes (LEDs) provide illumination for the 0.25-inch

(0.64-centimeter) charge-coupled device (CCD) camera.

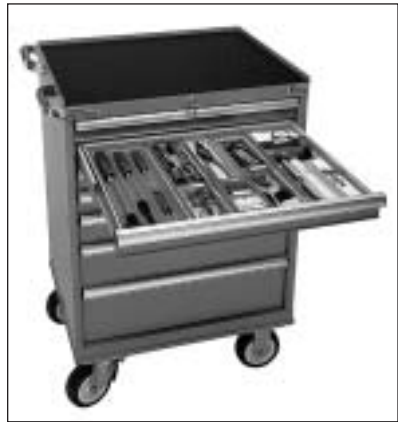
Mobile Cabinet

Lista International Corp. describes its mobile storage cabinets as versatile workstations on wheels with built-in safety features.

The cabinets feature a range of optional top surfaces selectable according to the application. Drawers are individually locked for added safety when moving the unit. Each mobile storage cabinet has two swivel casters and two fixed casters, with a foot-pedal lock for secure parking. Drawers are interlocked so that when one drawer is extended, the others are locked in place to ensure the unit's overall stability.
