FLIGHT SAFETY FOUNDATION
Aviation Mechanics Bulletin

**Managing Aircraft-tire
Wear and Damage
Requires Adherence to
Removal Limits**

May-June 1999

Vol. 47 No. 3

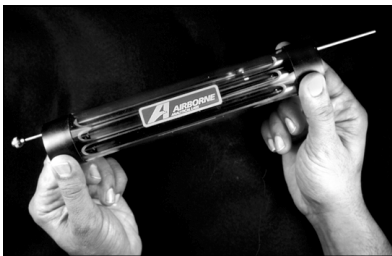
VIS-PROBE is an on-site test device designed to test oil viscosity and provide pass/fail results within 10 minutes. The device can be used to test lubricants for aircraft turbine engines, ground-based turbine engines and helicopter gearboxes, said the manufacturer.

*Airborne Analytical Labs
Vis-Probe*

VIS-PROBE is supplied with a certificate of calibration and the manufacturer states that the product accommodates all turbine-engine oils, including PRF-23699 and DOD-L-85734 types. Use of the device requires minimal training.

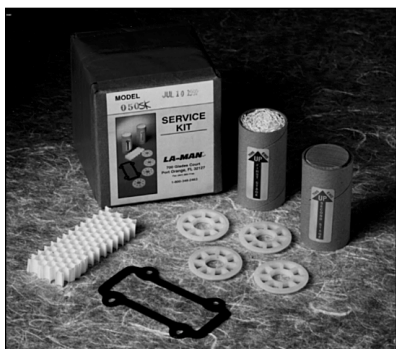
LA-MAN Corp. supplies filter-replacement kits for its Extractor/Dryer® two-stage compressed-air-line filtration systems. Routine filter replacement helps maintain compressed-air systems and air-operated tools and ensures that they can operate more efficiently, said the manufacturer. The kits include first-stage and second-stage filter

*LA-MAN
Filter Replacement Kits*

elements to remove moisture and contaminants, a honeycomb base core, gaskets and seals.

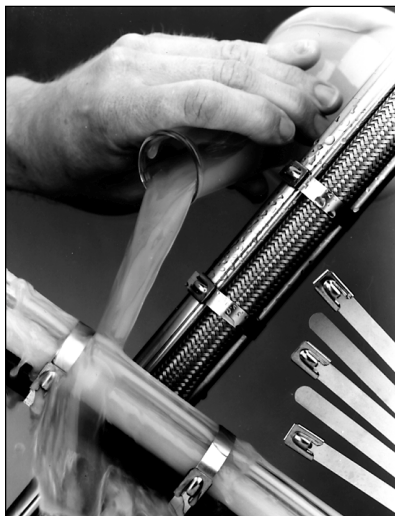
Nelco Self-Lock Stainless Steel Cable Ties are designed for use where rough weather, salt spray, extreme vibration, radiation, chemical exposure and other hostile environments require a strong, durable cable tie, said the manufacturer.

The permanent ties feature 150-pound (68-kilogram) minimum loop tensile strength; are 3/16 inch (in.; 0.48 centimeter [cm]) wide by 0.01 in. (0.03 cm) thick; and are available in sizes

*Nelco Self-Lock Stainless
Steel Cable Tie*

ranging from five in. (12.7 cm) long to 47 in. (119 cm) long.
