FLIGHT SAFETY FOUNDATION  
**Aviation Mechanics Bulletin**

**November–December 2000**

# Survey Assesses Safety Attitudes of Aviation Maintenance Personnel In Australia

*An analysis of responses reveals that the most frequent unsafe acts are procedural shortcuts, misunderstandings and memory lapses.*

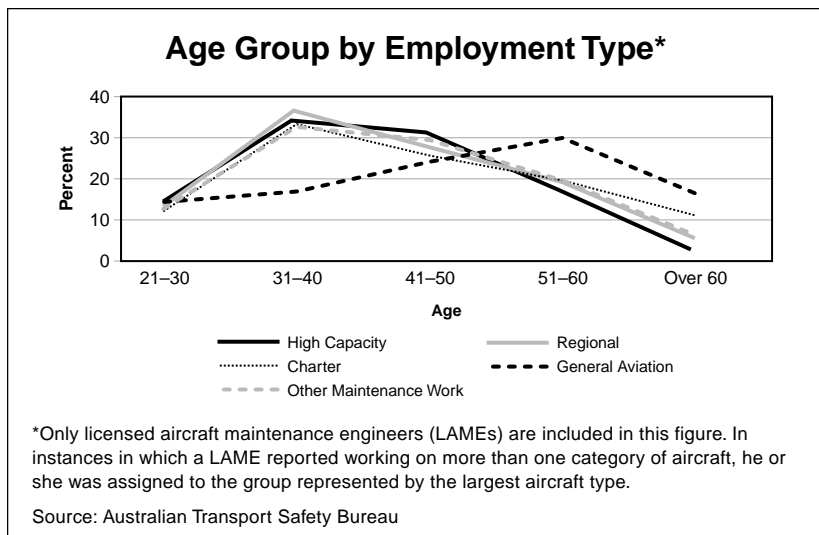
**Figure 1**

commonly in the 31-year–40-year age group (Figure 1). The age distribution for LAMEs working on general aviation aircraft was significantly different. Approximately 30 percent of those LAMEs were in the 51-year–60-year age group, and approximately 70 percent were more than 40 years of age.

- Respondents who work in the general aviation industry tended to be older than other survey respondents;
- More than 10 percent of respondents indicated that they had worked for a period of more than 20 hours at least once in the previous 12 months;
- For airline maintenance, the most common forms of occurrences involved systems operated unsafely during maintenance and aircraft-towing events;
- For non-airline maintenance, the most common forms of occurrences were incorrect assembly or orientation of components, incomplete installation, and the contact of workers with hazards;

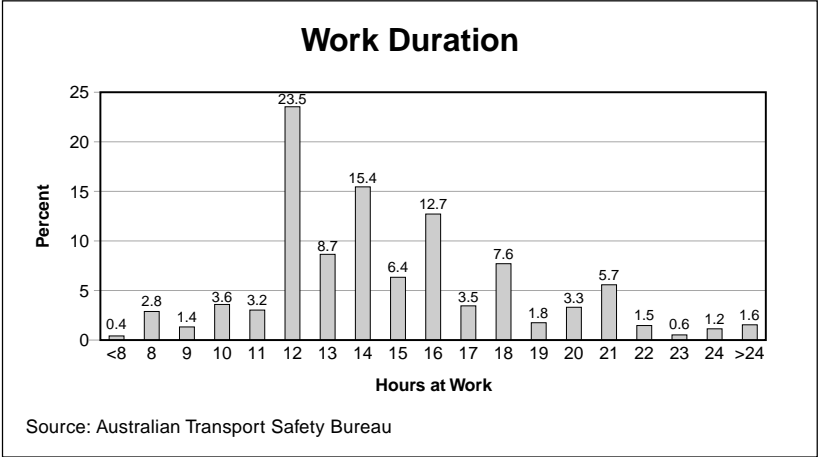
**Figure 2**

Respondents were asked to report the longest period they had been at work in the previous 12 months. The most commonly reported duration was 12 hours, reported by more than 23 percent of respondents (Figure 2, page 3). More than 10 percent of respondents indicated that they had worked for more than a 20-hour period at least once in the previous year.

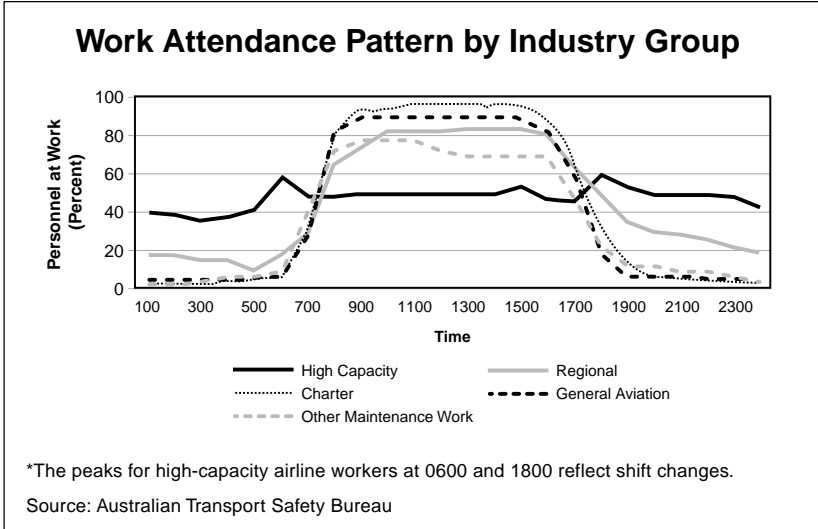
**Figure 3**

Respondents were asked to report the hours they had worked during their most recent work period (Figure 3). The work attendance pattern

reported by those working on high-capacity aircraft was significantly different from that reported by workers in other sectors of the

industry. High-capacity maintenance work was being performed continuously throughout the 24-hour day. Those who worked on general aviation and/or charter aircraft, or who performed “other maintenance work,” were at work mostly during daylight hours. Workers in the regional airline industry also worked mostly during the day, but reported more night work than those in general aviation.

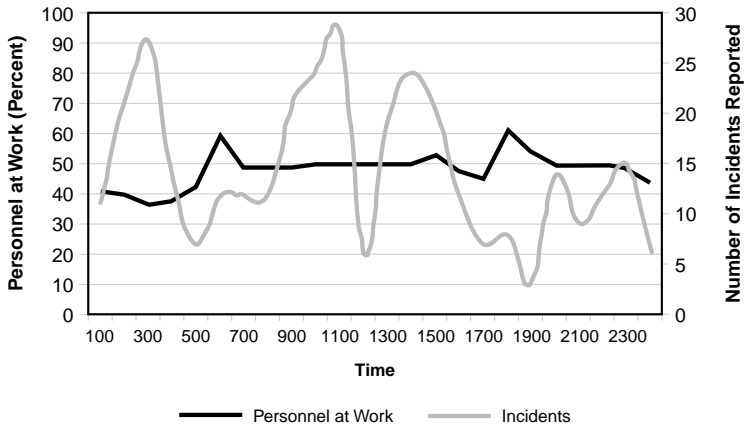
**Figure 4**

**Personnel at Work and Occurrences  
Throughout the Day for High-capacity  
Airline Maintenance**

The number of occurrences involving the maintenance of high-capacity aircraft varied throughout the day, even though the number of workers present at work did not vary significantly (Figure 4, page 6).
