FLIGHT SAFETY FOUNDATION
Aviation Mechanics Bulletin

**Fatigue Evaluation
Indicates Most Aviation
Maintenance Personnel Obtain
Insufficient Sleep**

November–December 2001

Vol. 49 No. 6

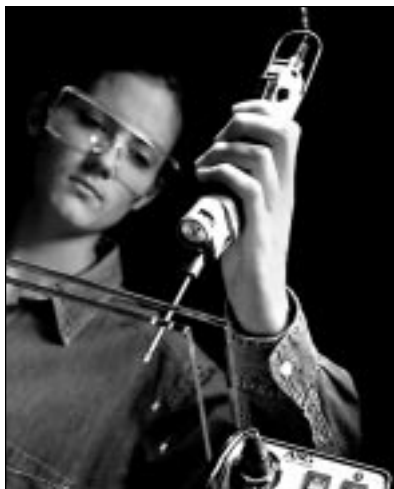
Torque-controlled Screwdriver

A torque-controlled screwdriver with a brushless motor has been designed to eliminate carbon dust and to last longer, said the manufacturer, ASG.

The screwdriver is rated for continuous use with minimal heat buildup, the manufacturer said. The screwdriver is designed for medium-torque assembly applications to light-torque assembly applications and stops

automatically when a preset torque is achieved. The 7.95-inch (20-centimeter), 12.7-ounce (360-gram) screwdriver can be converted from a lever-start screwdriver to a push-to-start screwdriver.

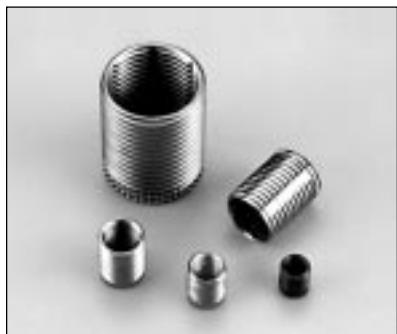
Solid-wall Swaged Inserts

A variety of lightweight solid-wall swaged inserts have been designed for use in aircraft engines and other aerospace applications, said the manufacturer, SPS Technologies.

The inserts are available in various alloy-steel materials with various

finishes, are intended to improve thread life and thread performance, and include a locking knurl design to aid in installation.

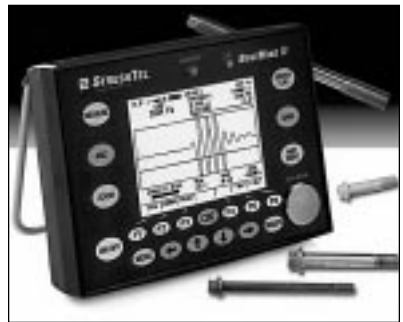
Ultrasonic Tension Meter

The StressTel BoltMike III ultrasonically measures the tension and clamp load of threaded fasteners in the tightening of critical bolted joints in aircraft engines and the verification of tension on bolts on clamping wheel assemblies, said the manufacturer.

The instrument weighs 2.5 pounds (1.14 kilograms), operates for as long as 40 hours on standard double-A

batteries and has rapid calibration and setup, the manufacturer said.

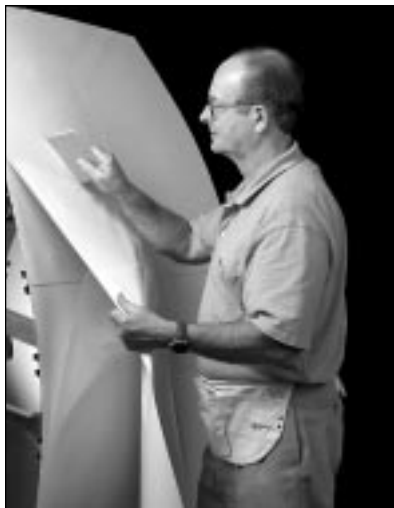
Paint Replacement Tape

paints on aircraft surfaces, said the manufacturer, 3M Engineered Adhesives Division.

The tapes are easy to apply, provide protection for interior surfaces and exterior surfaces, and resist accumulation of surface contaminants. The tapes require little maintenance and resist degradation or discoloration caused by exposure to ultraviolet light.
