FLIGHT SAFETY FOUNDATION  
**Aviation Mechanics Bulletin**

NOVEMBER–DECEMBER 2005

# **Loose Cylinder Nuts Cited in Fatal Ditching**

*The U.S. National Transportation Safety Board said that the engine failure preceding the ditching of the Cessna 402C resulted when the nuts backed off the studs after ‘the application of insufficient torque ... during undocumented maintenance.’*

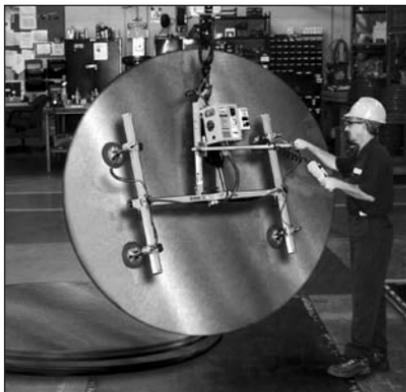
The Anver ETC Series Powered Vacuum Lifter/Tilter is designed to let one person easily handle, maneuver and position awkward loads. Equipped with an ergonomic gripping area, the lifter grasps objects with adjustable cross-arms and vacuum-suction pads that have spring-loaded suspensions.

A variety of suction pads in different shapes, sizes and materials are available to accommodate the user's requirements. Applications include lifting and positioning steel, plastic, fiberglass and composite materials

*Vacuum Lifter/Tilter*

weighing as much as 500 pounds (227 kilograms).

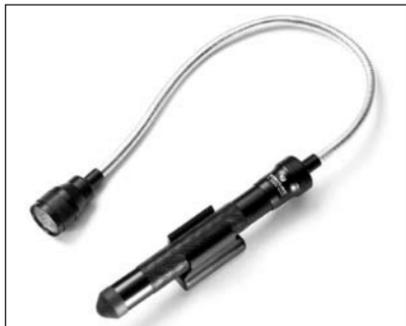
A light-emitting diode (LED) flashlight with a flexible, durable 14-inch (36-centimeter) cable, the JR Luxeon Reach is designed to be bent around mechanical parts to illuminate inaccessible or concealed areas.

*Flexible LED Flashlight*

The flashlight operates as long as three hours at maximum intensity (24 lumens), powered by two AA-size alkaline batteries. A magnetic clip holder allows the unit to be attached to any metal surface. The lamp housing, with an unbreakable polycarbonate lens, is connected to the cable by a water-resistant O-ring.
