FLIGHT SAFETY FOUNDATION
Aviation Mechanics Bulletin

NOVEMBER-DECEMBER 1996

**Team of Maintenance
Inspectors and Human
Factors Researchers
Improves Shift-turnover Log**

Vol. 44 No. 6

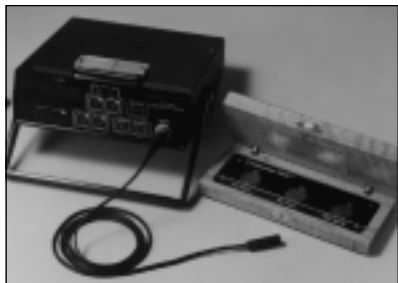
typically accurate within plus or minus 2 percent, the FM-140XL is accurate to within 0.5 percent, according to the company. A multiadjustable handle enables the operator to lock the unit into position to achieve the easiest viewing angle.

For quick sorting applications, the tester allows the operator to pre-set a range of acceptable readings. A green light flashes when a reading is within the acceptable range; a red light signals a reading that is outside the selected range. The FM-140XL is also useful for measuring small changes in conductivity that can take place during engineering processes such as hardening, annealing and heat treating, or that can occur naturally with age or from corrosion.

FM-140XL Digital Conductivity Tester from Centurion NDT

Measuring seven centimeters high by 22 centimeters wide by 23 centimeters deep (2.75 inches by 8.5 inches by nine inches), and weighing only two kilograms (five pounds), the FM-140XL is portable, yet its rugged build enables it to withstand a rough shop environment, the manufacturer claims. The unit is powered by a rechargeable nickel-cadmium battery pack that provides up to 10 hours of continuous operation on a single charge. Custom probes and a carrying case are also available. For more information, contact: Centurion NDT Inc., 707 Remington Road, Suite 9, Schaumburg, IL 60173 U.S. Telephone: (847) 884-4949; Fax: (847) 884-8772.

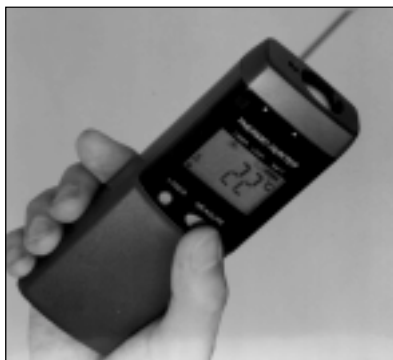
The new PT-3 Series pocket-size non-contact IR thermometer from CAPINTEC Inc. is intended for use in maintenance and troubleshooting. This ultracompact portable instrument features a built-in laser to pinpoint targets of interest.

PT-3 Series IR thermometer from CAPINTEC Inc.

The PT-3 operates in the eight-micrometer (μm) to 14- μm spectral band and covers a temperature range from -20 degrees C to 400 degrees C (-4 degrees F to 752 degrees F). The liquid crystal display (LCD) offers one-degree resolution and includes automatic backlighting for taking measurements in dark areas. Re-

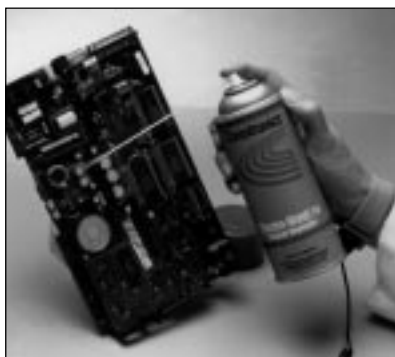
The product has a low-odor formula that is nonflammable, contains no CFCs, does contain hydrochlorofluorocarbons (HCFCs) and is specifically

engineered to clean and degrease energized equipment and electronics without damaging surrounding plastics, the manufacturer says.

*Electro-Wash® PSN Cleaner
Degreaser from Chemtronics®*

Electro-Wash PSN Cleaner Degreaser is said to dry quickly and have excellent wetting and penetrating action that flushes even tight-tolerance areas clean. The product is available in a 340-gram (12-ounce) aerosol container that sprays at any angle, even upside down. For more information, contact: Chemtronics, 8125 Cobb Center Drive, Kennesaw, GA 30152-3486 U.S. Telephone: (770) 423-0748; Fax: (770) 423-0748.

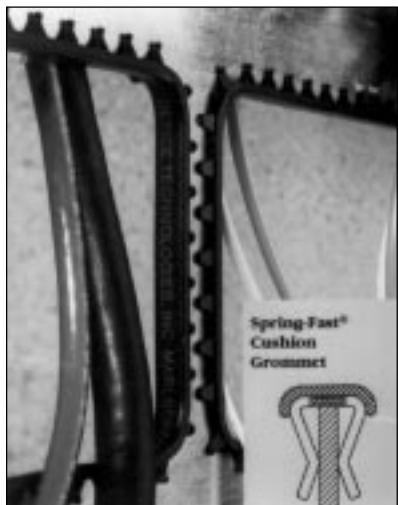
hoses from abrasion caused by rough edges in sheet metal or other installations. Originally developed for sensitive fiber-optic cable telecommunications applications, the Spring-Fast® Cushion Grommets are said to be ideal for airframe installations as well.

*Spring-Fast® Cushion Grommets
from Device Technologies Inc.*

The cushion grommets are made of nylon-coated stainless steel, with a soft polymer cushion to provide maximum protection from abrasion or cutting. The manufacturer says that the material is durable, strong and flexible and has the ability to conform to any two-axis contour. The grommet edging snaps on, and the unique spring gripping fingers hold it in place. No tooling is required for the installation, and no adhesive is needed to hold it securely.

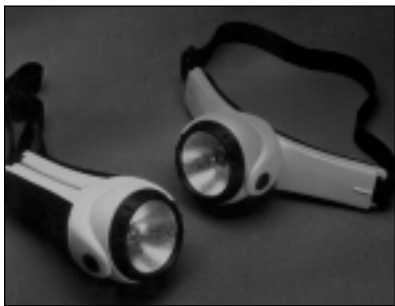
Streamlight Inc. has developed a convertible flashlight that can be held in the hands or worn, as the occasion demands. Called WOW™, the light is said to offer the advantages of a rugged hand-held light combined with those of a hands-free lamp that can be worn around the head, hung around the neck or suspended above a work area.

As a hand-held flashlight, WOW is a compact unit weighing 159 grams (5.6 ounces). When hands-free operation is required, the unit's handles rotate open and the adjustable elastic strap can be used to fasten the light around a maintenance technician's head or suspend it around the neck or from a nearby fixture.

WOW™ from Streamlight Inc.

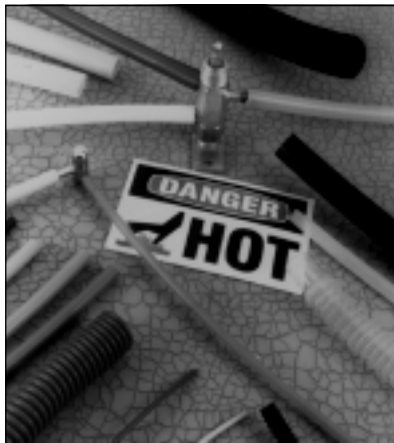
M.M. Newman Corp. has introduced a full line of Teflon® tubing for handling very hot liquids and gases. The tubing, which is nonflammable and chemically inert, is said to be capable of operating at continuous temperatures of up to 232 degrees C (450 degrees F). In addition, the tubing is unaffected by acids, alkalis and other corrosive media, making it suitable for a wide range of fluid-transfer applications, according to the manufacturer.

*Teflon® tubing from
M.M. Newman Corp.*

Plain styles are available in sizes ranging from 0.25 millimeter to 32 millimeters (0.01 inch to 1.25 inches) internal diameter, with varying wall thicknesses. Corrugated and convoluted (screw-thread) styles come in sizes from six millimeters to 25 millimeters (0.25 inch to one inch) internal diameter.
