FLIGHT SAFETY FOUNDATION
Aviation Mechanics Bulletin

NOVEMBER–DECEMBER 1998

Preventing Fretting Damage Becomes Increasingly Critical as Aircraft Age

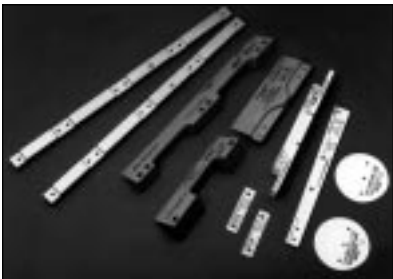
Starmet Corp. provides repair and refurbishment capabilities for depleted uranium (DU) and tungsten aircraft counterweights. The company says its Aircraft Counterweight Repair Facility is the only U.S. Federal Aviation Administration–approved facility for repairing such weights. The facility restores DU and tungsten weights to “as-new” condition using specifications of customers or manufacturers and provides stripping and removal of paint, replating and repainting services.

Starmet-refurbished Aircraft Counterweights

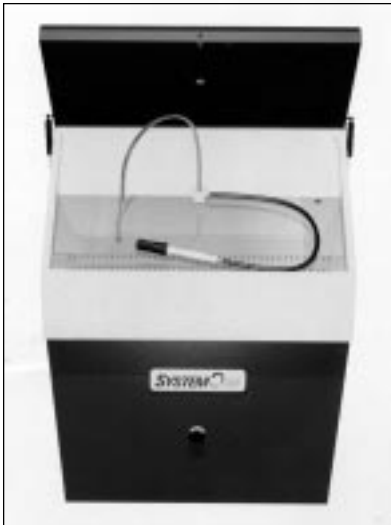
The SystemOne® Model 500 recycling general-parts washer uses a low-temperature vacuum-distillation and recovery process that recycles solvent without off-site processing, according to the manufacturer. The self-contained washer removes all contaminants from dirty solvent, minimizes waste by-product volume, and eliminates the need for transportation of large quantities of hazardous, dirty solvent, said the company. The Model 500 has a 36-inch by 27-inch by 9.5-inch (91 centimeter [cm] by 69 cm by 24 cm) sink work area.

*SystemOne® Model 500
Parts Washer*
