FLIGHT SAFETY FOUNDATION
Aviation Mechanics Bulletin

NOVEMBER–DECEMBER 1999

**Safety Specialists
Recommend
Precautions for Work in
Aircraft Fuel Tanks**

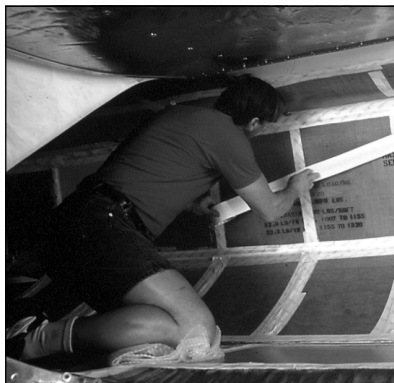
Scapa Tapes North America described the T3601 and T3605 tapes as fire-retardant tapes that are designed for joining and sealing the liners of aircraft cargo compartments and for making general repairs in the cargo area. The company said that T3601 is a self-wound, polyethylene-coated, white cloth tape with a natural-rubber-based, pressure-sensitive adhesive and that the tape meets fire-retardancy requirements of U.S. Federal Aviation Regulations (FARs) Part 25.853(a).

The company said that T3605 is a white, polyethylene-coated, high-

*Pressure-sensitive Tape
Scapa Tapes North America*

count, glass cloth tape with a rubber adhesive designed to limit flame penetration. The tape meets fire-retardancy requirements of FARs Part 25.855(d).
