Human Factors Study Suggests CRM Training Shows Promise in Aviation Maintenance

Robert A. Feeler
Editorial Coordinator

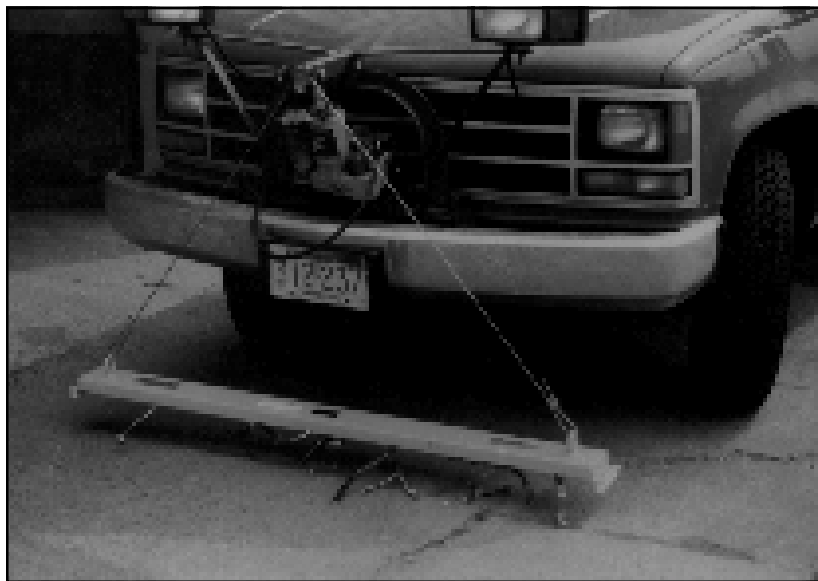
Permanent magnetic sweepers require no electrical connections.

sweepers that can be suspended from vehicles operating on aircraft ramps and taxiways. The manufacturer says that the PSS series of suspended permanent magnets comes in a full range of lengths, one of which can be suspended under the front of virtually any vehicle.
