FLIGHT SAFETY FOUNDATION
Aviation Mechanics Bulletin

SEPTEMBER–OCTOBER 2002

**Report on A320
Decompression Faults
Maintenance Personnel's
Work on Air Packs**

Vol. 50 No. 5

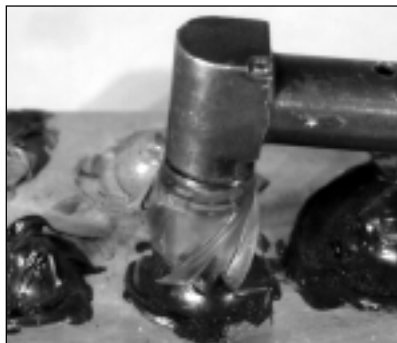
The SR Cutter and the SR Radial Bristle Disc remove seam sealants quickly and safely during aircraft maintenance without damaging underlying materials, said the manufacturer, 3M Aerospace.

The SR Cutter is a plastic rotary cutting tool that removes thick layers of sealants. It is available in diameters of 0.40 inch (10 millimeters) and 0.83 inch (21 millimeters) and has an

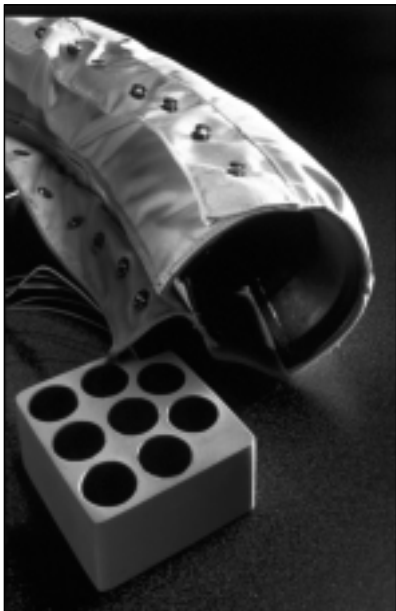
Fyrejacket Protective Oversleeve

(SAE) Aerospace Standard AS 1072 Type 2, the manufacturer said.

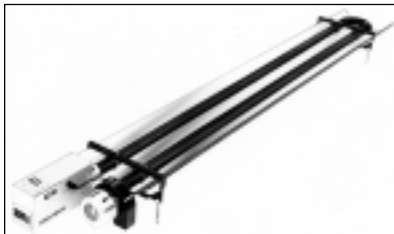
Radiant Tube Heaters

Ambi-Rad gas-fired, vacuum-operated ER-series radiant tube heaters provide an even heat distribution for buildings with large open spaces and doors that often are open, said the manufacturer, Advanced Radiant Systems.

The heaters are designed to warm people and objects near the floor rather than the air in the entire space. The heaters have burner ratings that range from 40,000 British thermal units per hour (Btu/h) to 150,000 Btu/h, and are available in U-shaped tubes or straight tubes from 20 feet (six meters) to 60 feet (18 meters) long.

As many as 10 burners can be connected to a single exhaust fan, the manufacturer said.

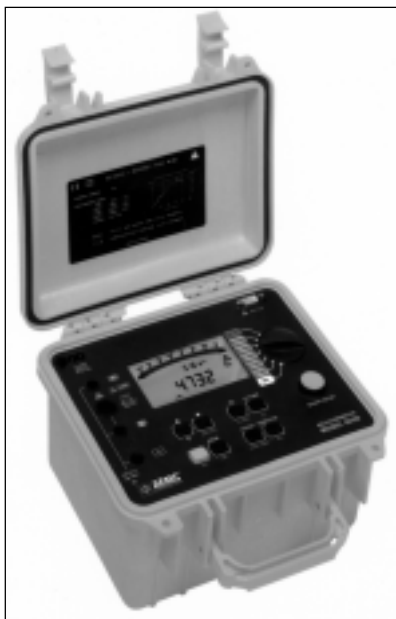
5,000-volt Insulation Tester

The Model 5060 digital/analog megohmmeter is a fully automated 5,000-volt insulation tester that provides measurements to 10,000 gigohms, said the manufacturer, AEMC Instruments.

The megohmmeter has a software package for display of test results and graphs and a memory function for storage of test results. The megohmmeter can be programmed and controlled by a personal computer, the manufacturer said.
