FLIGHT SAFETY FOUNDATION  
**Aviation Mechanics Bulletin**

SEPTEMBER–OCTOBER 2003

**Continued Limits  
Recommended on Use of  
Cellular Telephones  
In Aircraft**

**Vol. 51 No. 5**

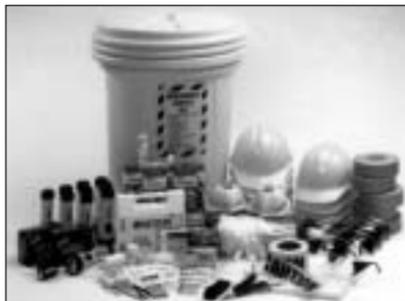
*Industrial Emergency Kit*

The Seton 10-Person Industrial Kit is designed to enhance emergency preparedness in the workplace. Each kit contains equipment selected from the U.S. Department of Homeland Security's list of recommended emergency supplies.

The kit includes one first-aid kit (containing supplies for 10 people), 10 hard hats, five rolls of duct tape, one roll of barricade tape, 10 flashlights, 24 industrial "D" batteries, five heavy-duty 32-inch by 40-inch (81-centimeter by 102-centimeter) plastic bags, 10 pairs of safety glasses, 10 personal eye-wash systems, 100 disposable gloves, 10 respirators and one "super pliers." The items are packed in a highly visible 30-U.S.-gallon (114-liter) container.

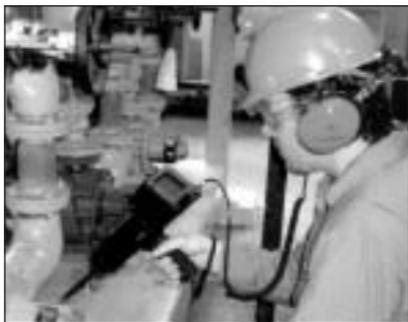
*Ultrasonic Inspection System*

Test data can be uploaded to the sensor unit as well as downloaded

to a computer. Uploaded data enable inspectors to compare current test results with baseline data on the same screen, the manufacturer said. Spectral analysis software included with the system gives inspectors the ability to view recorded sounds both as spectral images and as time-series images for sound-wave analysis.

Test data can be entered in English units or metric units. According to the company, 23 modes of operation can be selected to customize the instrument functions and screens to meet specific inspection needs.

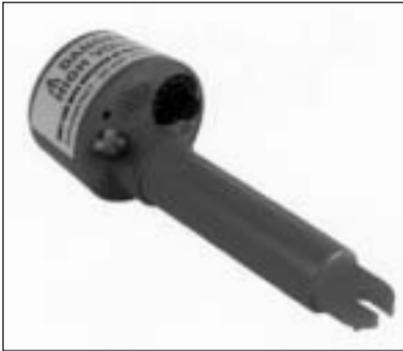
*High-voltage Detector*

Voltages from 80 volts to 275 kilovolts can be detected without physical contact by the AEMC Instruments Model 275HVD. An eight-position switch is used to select a detection range, and as the lightweight sensor is moved closer to the voltage conductor, the sensor measures the electrical field around the conductor. When the range threshold is reached, a buzzer sounds and a bright red light illuminates to warn the operator of the "live" high-voltage conductor.

The Model 275HVD is powered by three standard alkaline “C” batteries and can be used either indoors or outdoors. A self-test position can be used to ensure that all system functions and that annunciators are working correctly.

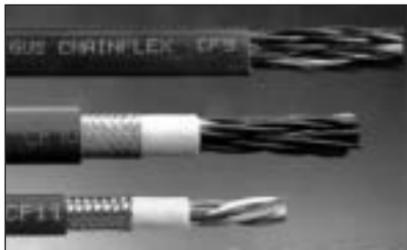
*Control Cables and Power Cables*

Chainflex cables, which are encased in thermoplastic elastomer (TPE)

jackets, were immersed for seven days in Skydrol at a controlled temperature of 158 degrees Fahrenheit (70 degrees Celsius). At the end of the test period, the cables had resisted damage from the hydraulic fluid, the manufacturer said.

Chainflex TPE cables are designed for continuous flexing and tight bending, the manufacturer said. They are designed to be abrasion-resistant, oil-resistant, flame-retardant, ultraviolet wave-resistant and halogen-free.

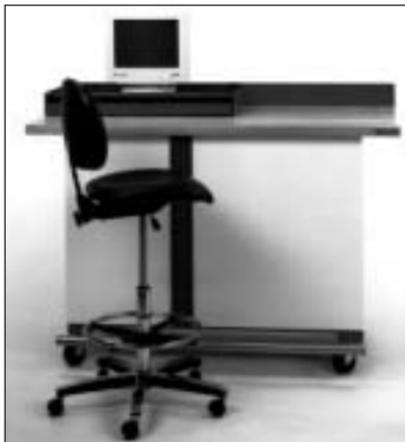
*Mobile Work Station*

The MTC features a processor compartment with a built-in fan and filter; a monitor stand with a pull-out keyboard shelf that hides the keyboard when not in use; a door in the back panel for fast access to computer connections; and a solid hardwood maple top that provides a work space.

Models are available in a 36-inch (0.91-meter) width and a 60-inch (1.52-meter) width. The customer may specify a primary color and an accent color.
