FLIGHT SAFETY FOUNDATION
Aviation Mechanics Bulletin

Aircraft Wiring Incidents Persist in Aging Systems

Vol. 52 No. 5

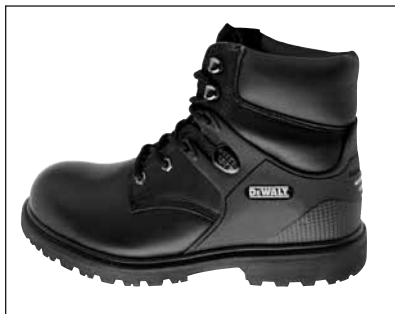
Industrial Footwear

The line features full-grain leather uppers, corrosion-resistant eyelets on lace-up models, and acid-resistant, oil-resistant and slip-resistant outer soles. Comfort is enhanced by padded collar and ankle areas to prevent chafing, and removable cushioned inner soles with gel heel pads (except in air-circulation models) that reduce shock, knee strain and back strain, according to the manufacturer.

The line includes three specialty styles: a lightweight series that uses athletic shoe-like construction for reduced weight and greater flexibility; a series featuring a heel-protection system that is said to provide extra support and stability for reduced foot fatigue and increased safety; and an air-circulation series that incorporates air-cushioning chambers for additional shock absorption.

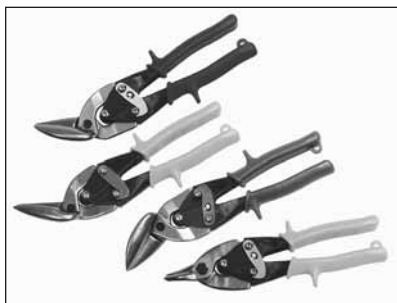
Aviation Snips

Klein Tools offers aviation snips for cutting and trimming sheet metal used in the aviation industry. Offset snips — designed to enable easy cutting of tight curves — are available in right, left and straight cutting patterns, with the capacity for cutting 18-gauge cold-rolled sheet metal and 22-gauge stainless-steel sheet metal. Snips with a notch cutting pattern are suitable for use on 16-gauge cold-rolled sheet metal and 18-gauge stainless-steel sheet metal.

Forged and heat-treated, the snips' steel blades offer strength and durability for cutting or notching sheet metal, the manufacturer says. The contoured plastic handles are color-coded according to the cutting pattern.

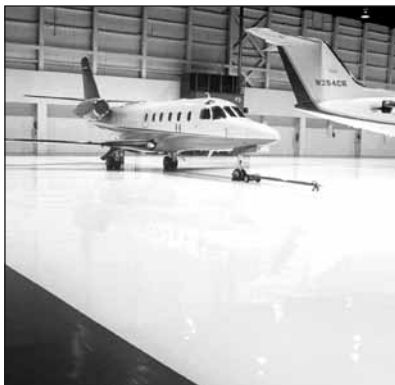
Floor Coating

Garland Floor Company's Chemi-Cote UR 5000, designed to protect concrete and metal, provides a low-maintenance surface on the hangar floor. The polyurethane coating resists abrasion, impacts, chemicals and stains, including stains caused by tires, jet fuel and hydraulic fluid, the manufacturer says.

Chemi-Cote UR 5000 provides a smooth, nonporous surface that is easy to clean and does not abrade under repeated washings, the manufacturer says. The glossy coating is said to be stable against ultraviolet light and to retain color and gloss

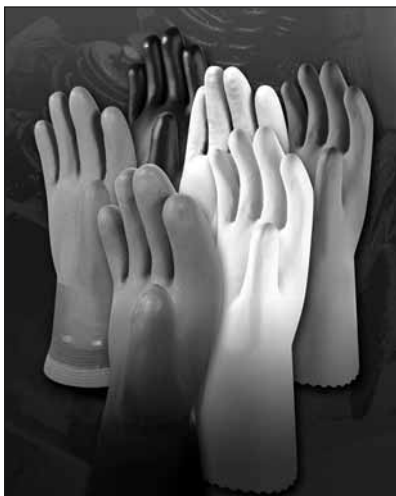
PowerCoat Gloves

PowerCoat gloves, a line of work gloves from Perfect Fit Glove Co., are designed for protection against chemicals and liquids such as acids, solvents, petrochemicals, caustics, grease and oils. The gloves also resist punctures, cuts and abrasions, the manufacturer says.

Materials, depending on the model, include polyvinyl chloride, nitrile, neoprene or natural latex. Described as ergonomically correct and extremely flexible, the gloves are said to improve productivity and lessen the likelihood of fatigue-associated injuries. A seamless liner in all models is designed for greater comfort and strength.

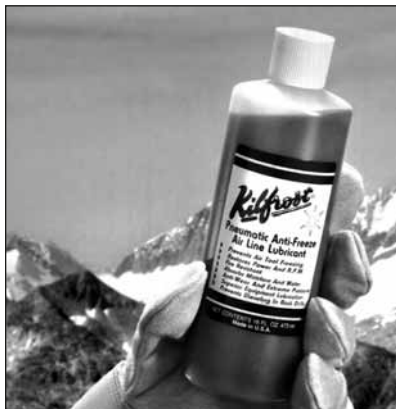
Moisture-absorbent Lubricant

Kilfrost by Keystone Lubricants is a fluid that lubricates the tool, absorbs moisture and lowers the freezing point of water. The result is that tool freezing is prevented, the manufacturer says.

The product's formula is semi-synthetic and will not affect polycarbonate, polyurethane or buna seals, the manufacturer says. Kilfrost is nontoxic, nonflammable and noncorrosive.
