FLIGHT SAFETY FOUNDATION
Aviation Mechanics Bulletin

SEPTEMBER–OCTOBER 1995

One Cure for Workplace Safety Complacency: Safety Checklists

One Cure For Workplace Safety Complacency: Safety Checklists	1
News & Tips	8
Maintenance Alerts	10
New Products	16

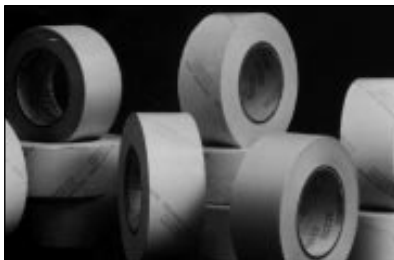
#297 and #290 Fiberglass Cloth Tapes from Polyken Technologies

A new line of #297 fiberglass cloth tapes produced by Polyken Technologies to meet U.S. Federal Aviation Regulations (FARs) Part 25.855 is claimed to offer additional convenience compared with previously used materials. The manufacturer says that this tape meets specifications for heat, flame and smoke resistance, with these additional qualities:

- Flexibility that makes form-fitting seals over irregular surfaces;
- Adhesion that prevents curling and lifting;
- Application ease, because a blue polyethylene liner facilitates efficient application; and,
- High tensile strength so that the tape does not rip easily under stress.

The tape is available as #290 with preprinted backing indicating FARs approval. Tapes come in two- or three-inch (five- to 7.6-centimeter) widths in 36-yard (33-meter) rolls.
