# Airport Operations

## Ramp Incidents Take Toll in Equipment Losses and Personnel Injuries

*Flight and ground crew awareness of hazards during ramp operations is critical in further reducing injuries and equipment damage in gate and taxiway areas, a U.S. study says.*

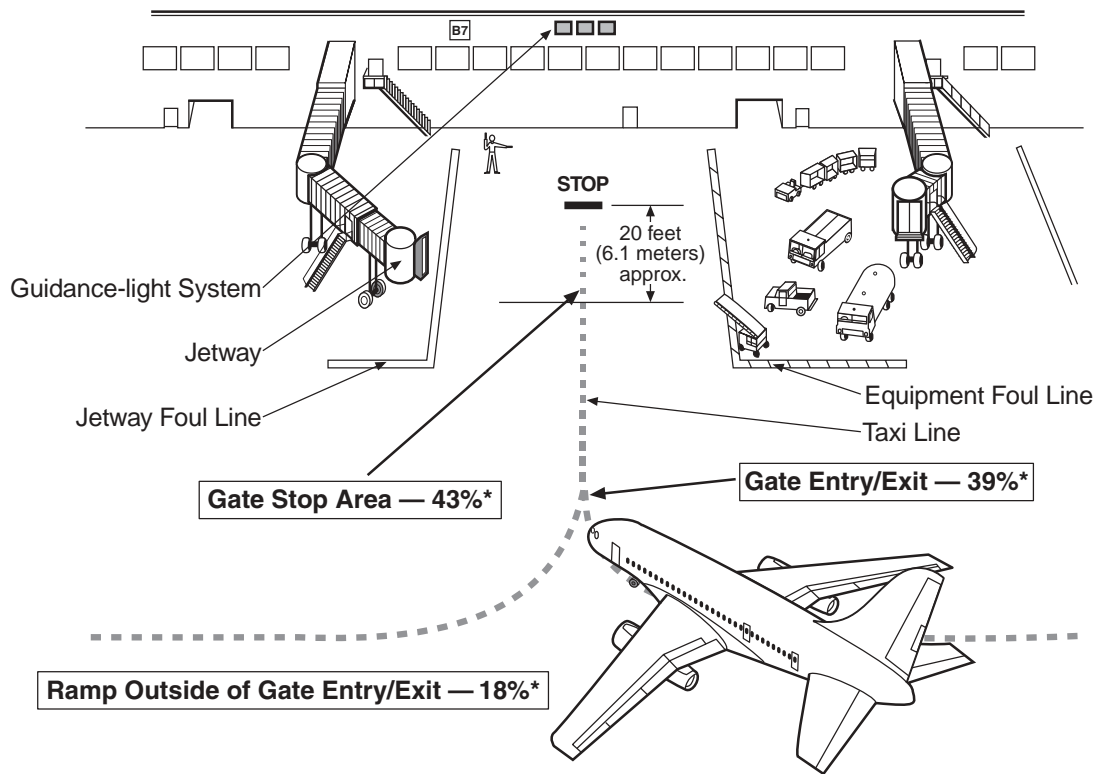
## Ramp Operations Areas and Incident Locations, Study of 182 ASRS Incident\* Reports

\* Although the events in the study set involved damage to equipment or injury to persons, they were classified by ASRS as "incidents" rather than "accidents" as defined by U.S. Federal Aviation Regulations Part 830.2.

\*\* Percentage of total number of incidents in study data set.

The study found that ramp incidents were not evenly distributed between arriving and departing aircraft. The study found that the aircraft was arriving at the gate in 58 percent of the reports and departing the gate in 35 percent of the reports (another 7 percent involved miscellaneous events such as gate changes or power-outs). Different procedures — or lack of procedures — during arrival and departure may account for this disparity.

aircraft to avoid as they enter the congested areas next to gates and terminal buildings. Ground crews are sometimes not in position during arrival, increasing the possibility that ground equipment might remain outside the foul line. But there were fewer incidents on the ramp outside of the gate entry/exit during arrivals (13 percent of the outside-gate-entry/exit incidents) than during departures (30 percent). [In both sets of percentages, the remaining percentage was not categorized in the ASRS study because of unclear or missing information in the incident reports.] This may be related to the large number of pushback, power-out and power-turn procedures that occur during departure operations.

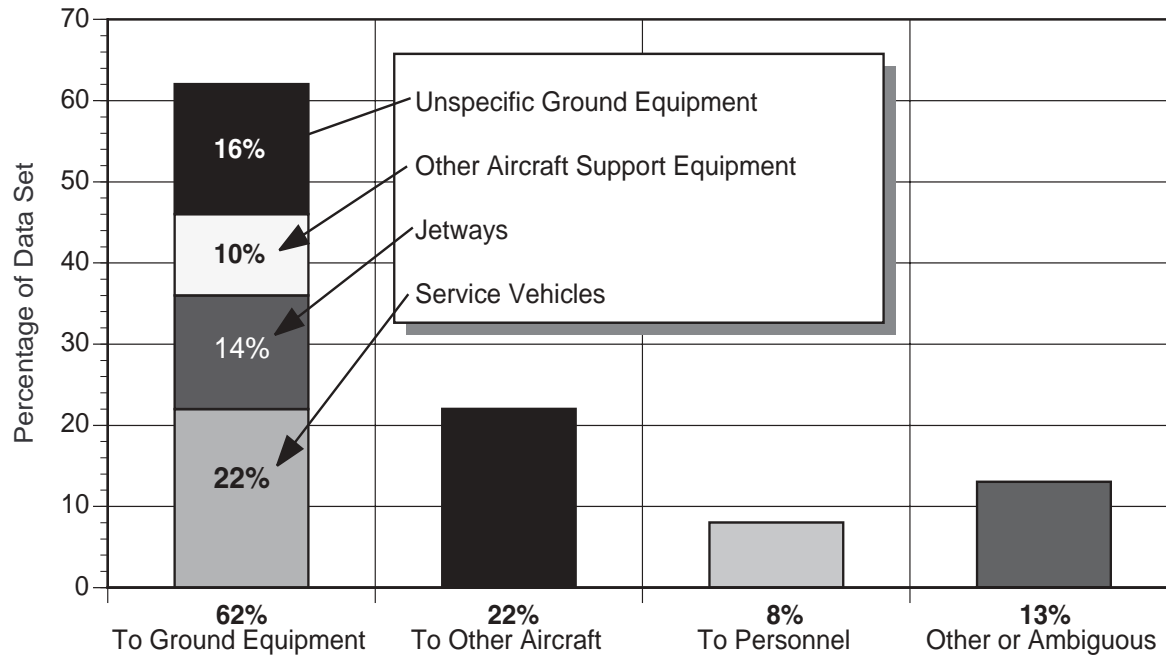
## Damage and Injuries on the Ramp, Study of 182 ASRS Incident\* Reports

\* Although the events in the study set involved damage to equipment or injury to persons, they were classified by ASRS as "incidents" rather than "accidents" as defined by U.S. Federal Aviation Regulations Part 830.2.

Note: Multiple citations are possible in this category; thus, the combined percentage of types of damage is more than 100 percent.

Ground equipment and other aircraft appear to be most vulnerable to damage or injury in ramp incidents (Figure 2, page 4). Damage to ground equipment occurred most often in the gate stop area, less often in the gate entry/exit area and rarely on the ramp outside of the gate entry/exit.

Aircraft-to-aircraft damage usually occurred on the ramp outside of the gate entry/exit and in the gate entry/exit area, where taxiing aircraft were sharing a common maneuvering area and were likely to be in radio contact with a controlling

agency. Damage to aircraft at the gate stop area was less common in Part 121 operations than in Part 135 operations.

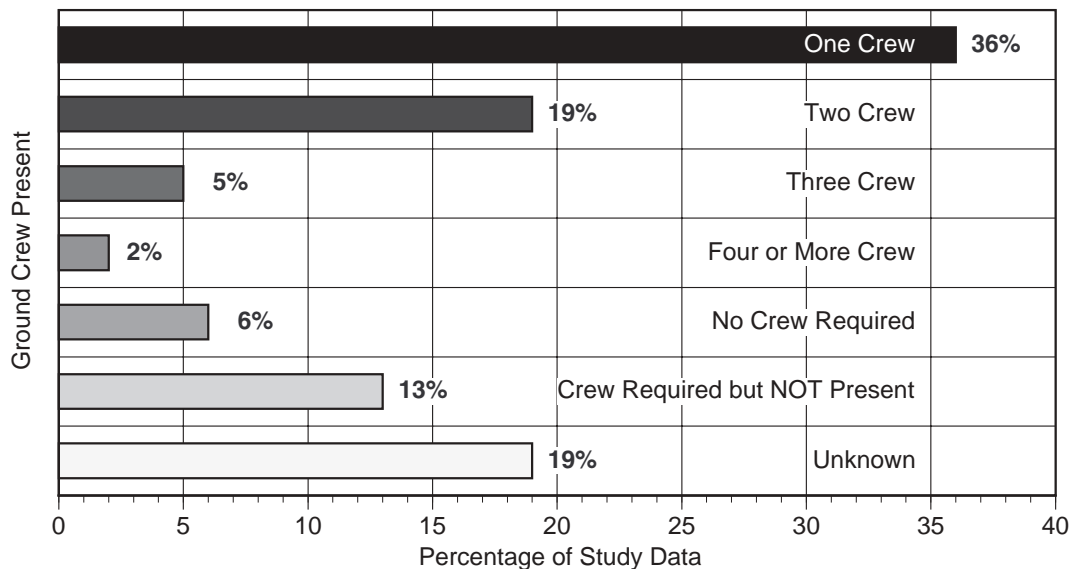
## Ground Crew Present at Time of Ramp Incidents, Study of 182 ASRS Incident\* Reports

\* Although the events in the study set involved damage to equipment or injury to persons, they were classified by ASRS as "incidents" rather than "accidents" as defined by U.S. Federal Aviation Regulations Part 830.2.

Flight crews reported that the presence of a marshaler might have had a positive effect in some of the incidents in which no ground crew member was present, 13 percent of the total. Incident reporters also concluded that wingwalkers should have been present in 26 percent of the incidents. In hindsight, many incident reporters, like the following captain, clearly recognized the value of having a wingwalker:

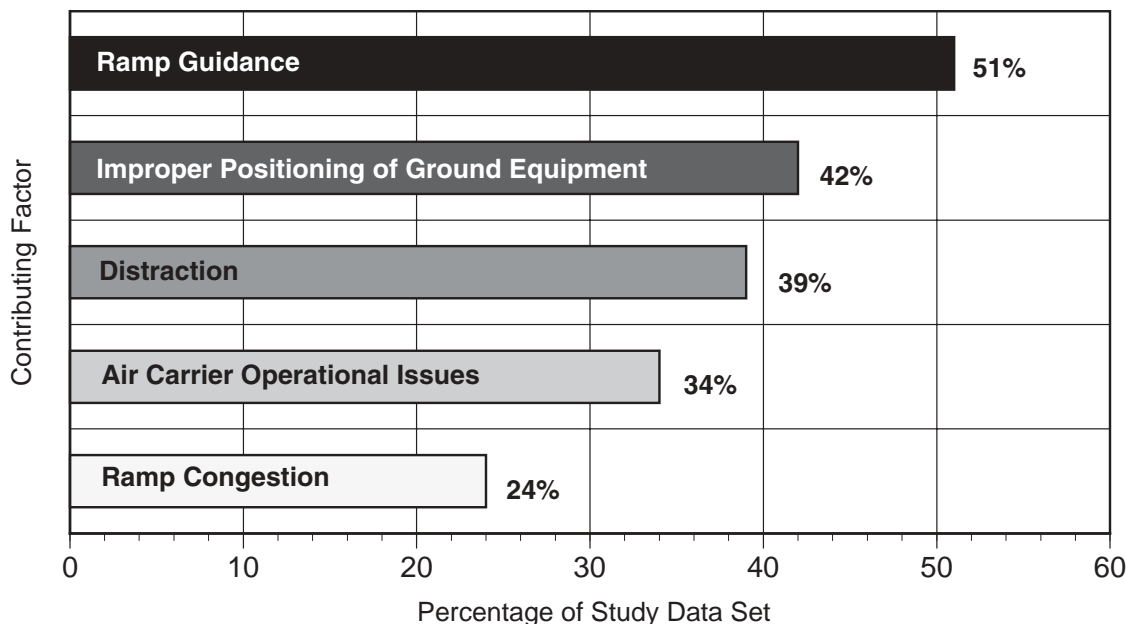
## Factors Contributing to Ramp Incidents, Study of 182 ASRS Incident\* Reports

\* Although the events in the study set involved damage to equipment or injury to persons, they were classified by ASRS as “incidents” rather than “accidents” as defined by U.S. Federal Aviation Regulations Part 830.2.

Incident reporters attributed errors to ground crew members in more than one-half of the reports, and they acknowledged errors of their own almost as frequently. The flight crews defined their own errors in two ways: specific tasks or actions that they failed to perform or performed incorrectly (usually a failure to follow procedures); and incorrect or inappropriate responses to ground crew actions or instructions (usually faulty decision making about the hazards involved in following those instructions) (Figure 4, page 6).
