FLIGHT SAFETY FOUNDATION

# Accident Prevention

## Crew Loses Control of Boeing 737 While Maneuvering to Land

*The airplane was high on approach to Patna, India, and the crew received clearance from air traffic control to conduct a 360-degree turn to reposition for landing. The airplane stalled and descended into a residential area. Fifty-five occupants of the airplane and five people on the ground were killed in the approach-and-landing accident.*

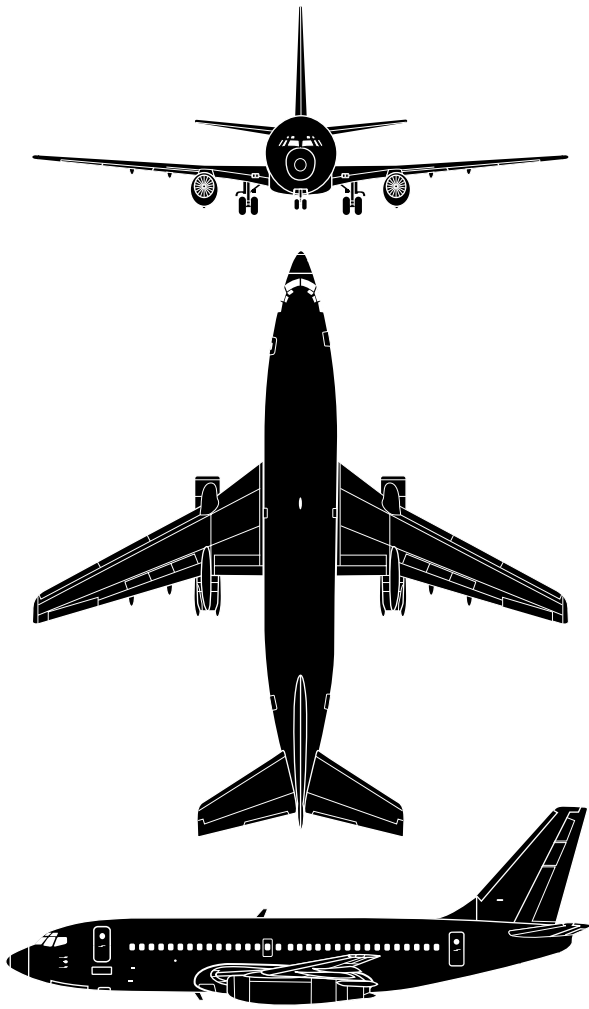
### Boeing 737-200 Advanced

The Boeing 737 originally was designed as a short-range jet transport that would use many components already in production for the B-727. Deliveries of the B-737-100 began in 1967. Fewer than 30 of the 100-series airplanes were built before the model was replaced with the B-737-200, which had a 76-inch (193-centimeter) longer fuselage and accommodated 12 more passengers. The B-737-200 Advanced, introduced in 1971, has aerodynamic improvements, including modified wing-leading-edge slats, Krueger flaps and engine-nacelle fairings.
