## DC-10 Overruns Runway in Tahiti While Being Landed in a Storm

*The flight crew encountered showers, turbulence and a strong, gusting crosswind on final approach. The airplane touched down about midpoint on the wet runway, overran the runway, struck localizer antennas and came to a stop with the forward section of the fuselage in a lagoon.*

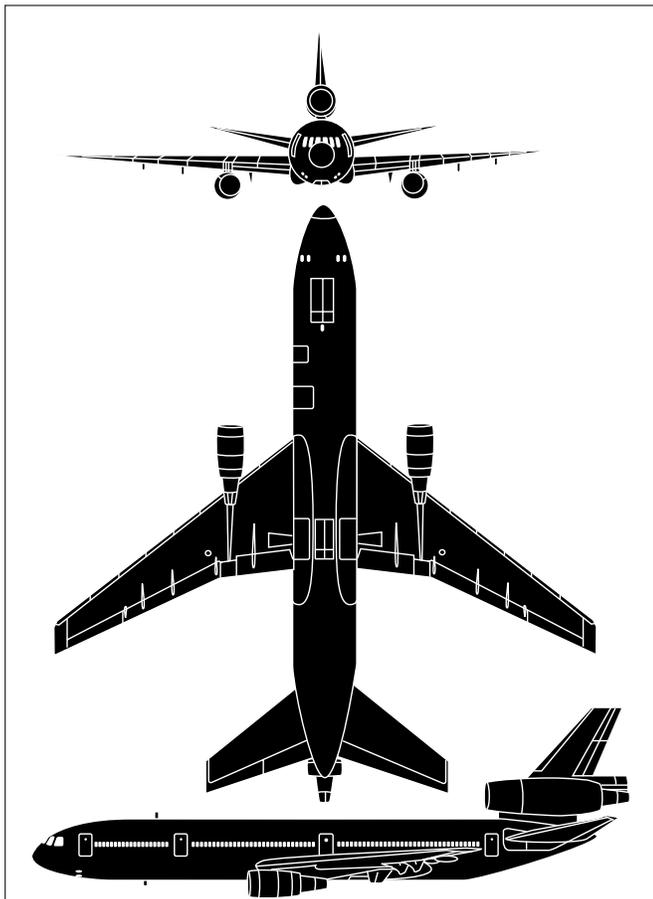
### McDonnell Douglas DC-10-10

The McDonnell Douglas DC-10-10 was the first model in the DC-10 series, a long-range, high-capacity transport airplane. It first flew in August 1970.
