Fuel Imbalance Cited in Learjet 35A Control Loss

The U.S. Air Force said that the flight crew of a C-21A (military version of the Learjet 35A) did not have a checklist to help them correct a fuel imbalance that was caused by a fuel-pump malfunction. During approach for an emergency landing, the crew allowed airspeed to become too slow and made control inputs that caused the aircraft to depart from controlled flight.

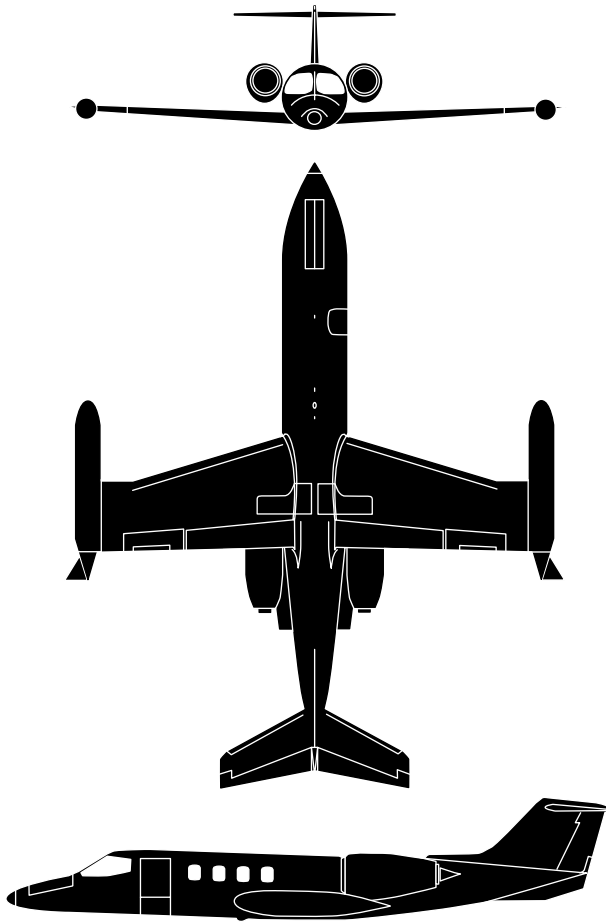
U.S. Air Force C-21A

C-21A is the U.S. Air Force designation for the Gates Learjet 35A, a light twin-turboprop business aircraft that first flew in 1973. The Air Force in 1983 contracted with Gates Learjet for the lease and logistical support of 80 C-21As, which replaced North American/Rockwell CT-39 Sabreliner aircraft for personnel transport, cargo transport and medical-evacuation missions.
