Missing Screws Send Commuter Plummeting

U.S. National Transportation Safety Board officials say failure to follow required maintenance procedures and poor management supervision led to the violent inflight breakup of Continental Express Flight 2574.

by
John A. Pope
Aviation Consultant

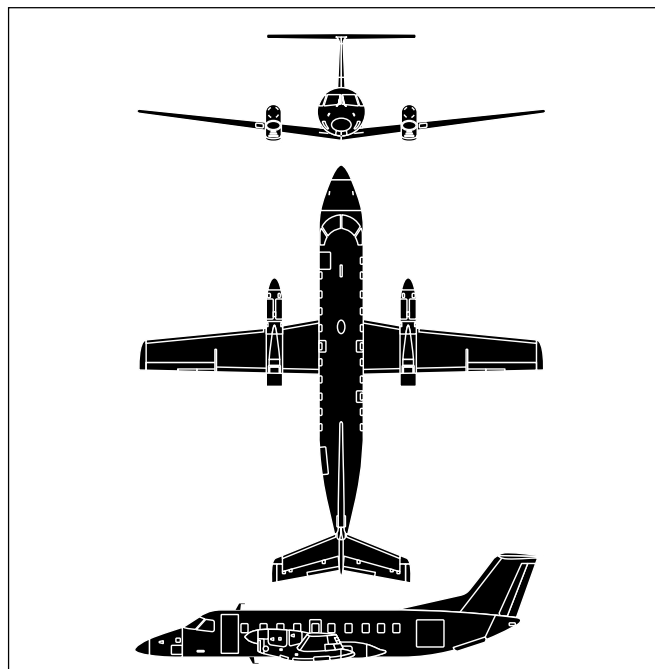
The Embraer EMB-120 Brasilia was first flown in 1983. The twin turboprop passenger aircraft can seat up to 30 passengers. It has a long-range cruising speed at 25,000 feet of 260 knots (482 kilometers) an hour. It has a range of 945 nautical miles (1,750 kilometers) at 25,000 feet with a maximum 30-passenger payload. The aircraft has a service ceiling of 29,800 feet.
