FLIGHT SAFETY FOUNDATION

Accident Prevention

Lightning Strike, Loose Electrical Connector Disable Fokker 100 Hydraulic Systems

An in-flight lightning strike caused depletion of fluid from the main hydraulic systems, and the alternate anti-skid braking system failed, but none of the occupants was injured when the airplane veered off a wet runway during landing.

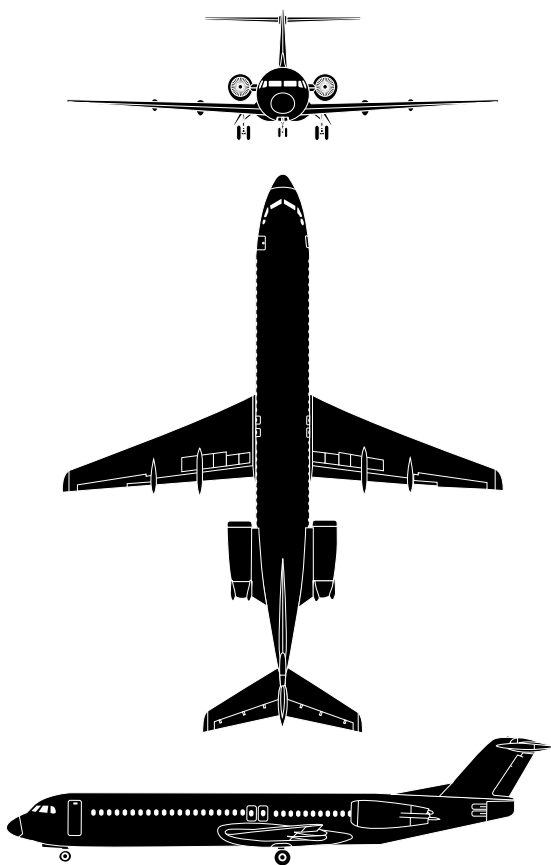
The Fokker 100, a short/medium-range jet transport, replaced the F28-4000 in 1987. Compared with its predecessor, the Fokker 100 has longer wings, a longer fuselage, Rolls-Royce Tay turbofan engines, an improved cabin and an improved flight deck with electronic flight instrument systems.

The airplane accommodates two pilots, three cabin attendants and up to 122 passengers. The standard cabin accommodates 107 passengers in five-abreast seating.

Maximum takeoff weight is 44,450 kilograms (97,995 pounds). Maximum landing weight is 39,915 kilograms (87,997 pounds). Maximum operating Mach number is 0.77. Maximum operating speed at 24,200 feet is 452 knots.
