Improper Response to Stall Warning Cited in A310 CFIT off Ivory Coast

—
FSF Editorial Staff

At 2109 local time Jan. 30, 2000, an Airbus A310-300 operated by Kenya Airways struck the Atlantic Ocean soon after takeoff in nighttime visual meteorological conditions from Félix Houphouët-Boigny International Airport in Abidjan, Ivory Coast. The airplane was destroyed. The 10 crewmembers and 159 passengers were killed; 10 passengers were injured.

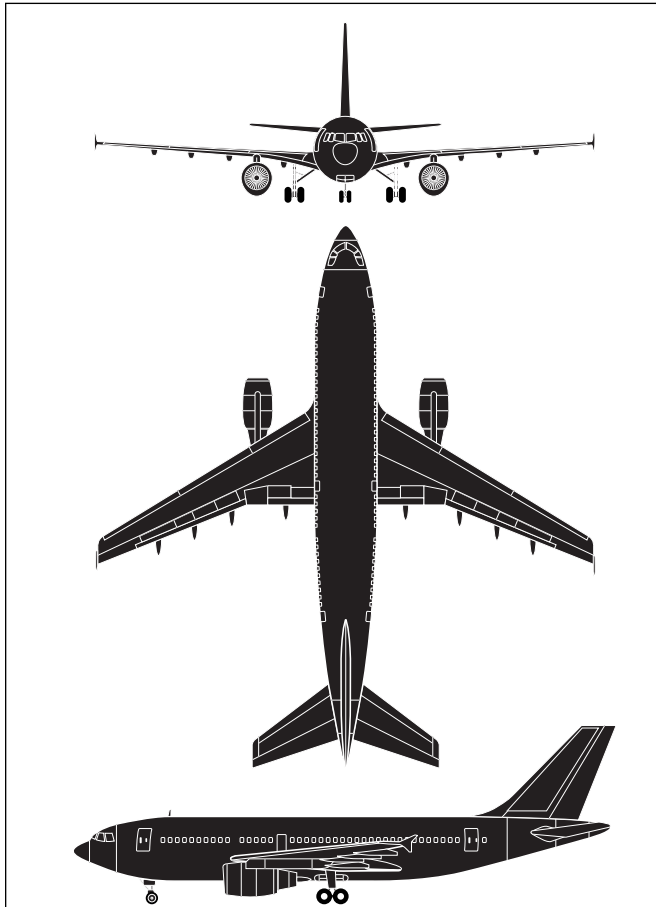
Airbus A310-300

Introduced into service in 1983, the Airbus A310 has a shorter fuselage and smaller wings and horizontal tail surfaces than the A300. The A310-300 is an extended-range version that was first flown in 1985 and is the first Airbus airplane to have triangle-shaped wing tip fences, which were developed to reduce drag.
