Poor Management Decisions, Inadequate Flight Crew Training and Inexperience Cited in Fatal Commuter Crash

When an inadequately prepared captain, flying his first unsupervised revenue flight for a commuter airline, was paired with a low-time first officer, a fatal error chain was established. A U.S. National Transportation Safety Board report said the tragedy underscored several critical safety issues.

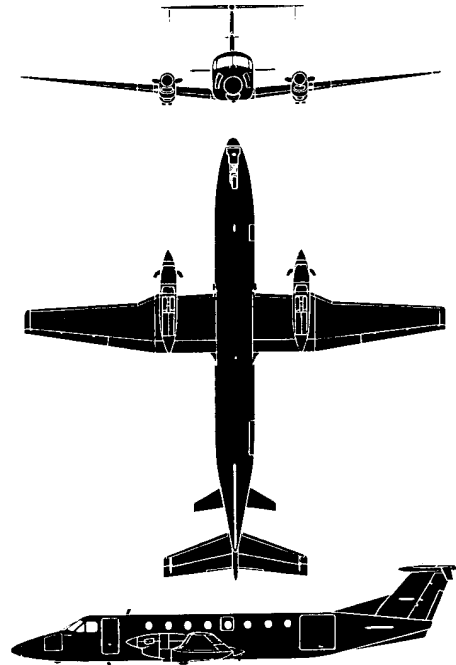
Beechcraft C99 Airliner

The 1399, the predecessor of the C99, first flew in 1966 and deliveries began in 1968. A large main cargo door allowed the aircraft to be used for either all-cargo or cargo/passenger operations. The C99, with increased power and systems refinements, was first delivered in 1981. It has a service ceiling of 28,080 feet (8,560 meters) and a range of 910 nautical miles (1,686 kilometers).
