Aerobatic Maneuver Blamed In Fatal Commuter Crash

A routine proficiency check turned to tragedy when the pilot flying initiated a barrel roll at low altitude during the night flight. The official U.S. accident investigation report said the accident highlighted serious management and training deficiencies.

*John A. Pope
Aviation Consultant*

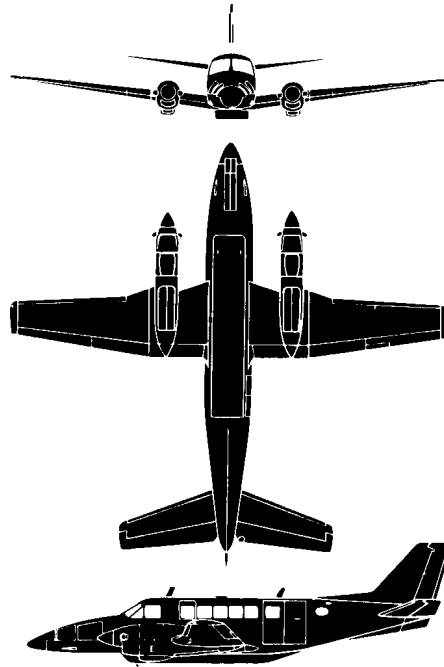
Beechcraft C-99 Airliner

The B-99, the predecessor of the C-99, first flew in 1966 and deliveries began in 1968. A large main cargo door allowed the aircraft to be used for either all-cargo or cargo/passenger operations. The C-99, with increased power and systems refinements, was first delivered in 1981. It has a service ceiling of 28,080 feet (8,560 meters) and a range of 910 nautical miles (1,686 kilometers). The C-99 has a cruising speed of 245 knots at 16,000 feet (4,875 meters). It has a maximum takeoff and landing weight of 11,300 pounds (5,125 kilograms).
