Turboprop Freighter Crashes After Severe Icing Causes Multiple Engine Failures

The official U.K. accident report identified flight crew training, Emergency Checklist use and crew resource management as factors in the accident. The role of air traffic control during emergencies was also examined.

Editorial Staff Report

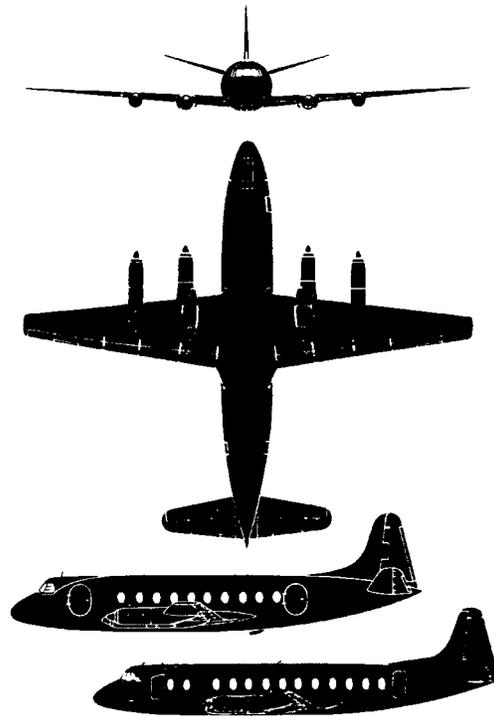
Vickers Viscount

The Vickers Viscount, which first flew in 1948, was the world's first turboprop transport to go into service.
