Controller's Misperception of Aircraft Positions Sets Stage for Collision on Runway in Paris

The investigation generated recommendations about the practice of clearing more than one aircraft onto a runway, the terminology used in takeoff clearances, coordination among controllers and the use of different languages in controller-pilot communication.

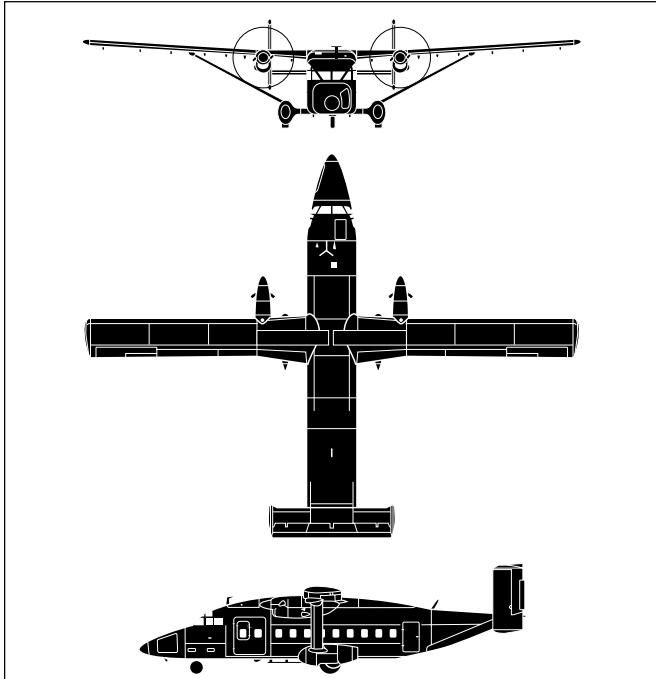
The Short Brothers SD3-30 (Shorts 330) is a twin-turboprop, short-range commuter/regional transport derived from the SC.7 Skyvan, a short-takeoff-and-landing (STOL) utility transport that first flew in 1963 with reciprocating engines and later was equipped with turboprop engines. The 330, which has a larger cabin than the Skyvan and retractable landing gear, first flew in 1974.

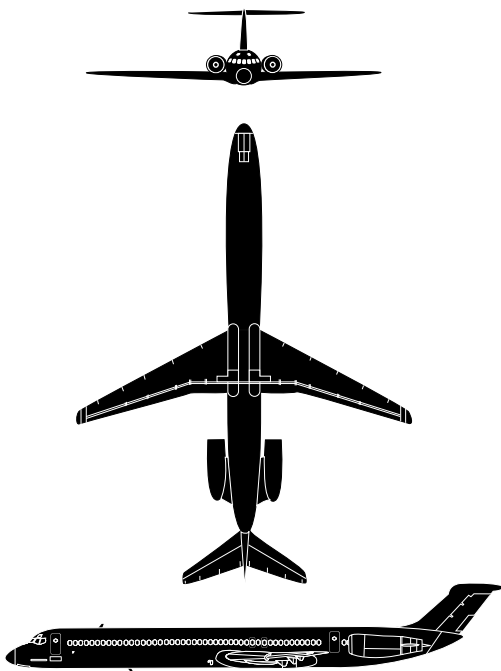
McDonnell Douglas MD-83

The MD-80 series jet transports are derivatives of the Douglas DC-9, which first flew in 1965. Douglas Aircraft Co. and McDonnell Co. merged in 1967 to form McDonnell Douglas Corp. The MD-80, originally called the Super 80, has longer wings, a longer fuselage and more fuel capacity than the DC-9, and an integrated digital flight control system.
