## Embraer Bandeirante Strikes Mountain Ridge During Trans-island Flight in Fiji

*Investigators could not determine the circumstances of the collision, but their accident report included findings of inadequate surveillance by the regulator and inadequate check-and-training procedures, standard operating procedures and record keeping by the operator. The report also said that the captain had insufficient rest before the flight and had consumed an 'above-therapeutic level' of antihistamine.*

Shortly after 0530 local time on July 24, 1999, an Air Fiji Embraer Bandeirante 110P1 (EMB-110) struck a mountain ridge during a planned 25-minute domestic flight in Fiji. The airplane was destroyed, and the two-member flight crew and 15 passengers were killed.

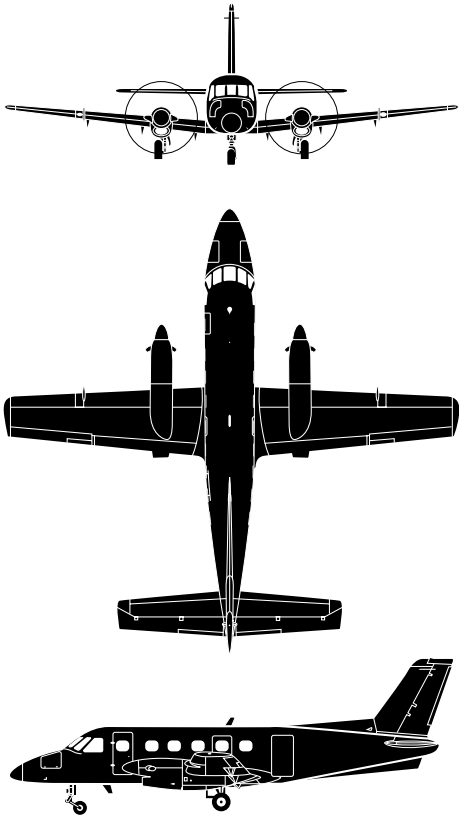
### Embraer Bandeirante 110

The Embraer Bandeirante 110 (EMB-110) is a twin-turboprop light transport airplane developed during the late 1960s as a general-purpose aircraft to be used in air transport, navigation training and aeromedical evacuation flights. The first prototype was flown in 1968, and the first production Bandeirante was flown in 1972. The Bandeirante was certified by the Aerospace Technical Centre of the Brazilian Ministry of Aeronautics, and the first three were delivered to the Brazilian Air Force in 1973. More than one dozen other models have been manufactured since then.
