Douglas DC-3 Strikes Hill During Night Cargo Flight

Investigators concluded that the controlled-flight-into-terrain (CFIT) accident occurred because the flight crew conducted a night visual flight rules (VFR) operation beneath a low ceiling and below Canadian obstacle-clearance-height requirements.

FSF Editorial Staff

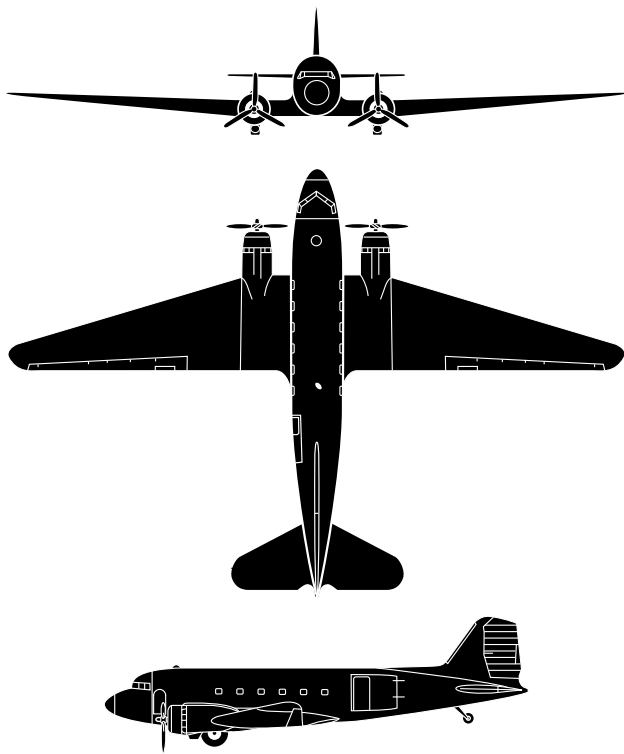
Douglas DC-3

The Douglas Aircraft DC-3 first flew Dec. 17, 1935. The airplane has accommodations for three crewmembers and 21 to 28 seated passengers, 14 passengers in sleeper berths or 3,725 pounds to 4,500 pounds (1,690 kilograms to 2,041 kilograms) of cargo.

Source: The Boeing Co.
