Rapid High-altitude Icing Linked to Series of Fatal Accidents

—
Editorial Staff Report

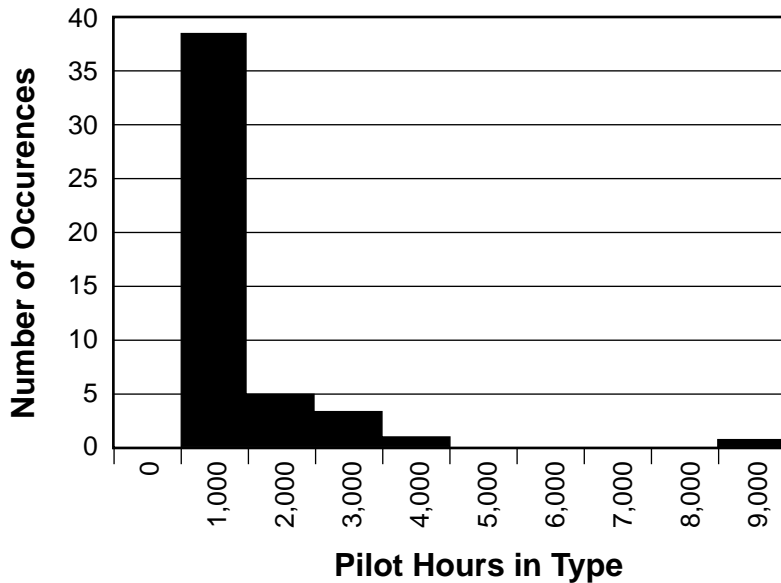
**Table 1
Total MU-2 Pilot Experience in
MU-2 Occurrences**

In general, pilots involved in these MU-2 occurrences (accidents/incidents) had recorded less than 1,000 hours on the MU-2.
Source: Australian Bureau of Air Safety Investigation
