Fatal Commuter Training Flight Crash Blamed On Spatial Disorientation, Poor Judgment

An instructor pilot with two captain trainees on board set up training scenarios at night that constituted multiple emergencies. When a pilot trainee began suffering from spatial disorientation, the instructor refused his request to take control of the aircraft and decided instead to talk him through the emergency, with tragic results.

The Beechcraft 1900C twin-turboprop commuter airliner, N811BE, was on a night training flight when it crashed into the Atlantic Ocean about 10 miles (16 kilometers) from Block Island, Rhode Island, U.S., killing the three pilots on board.

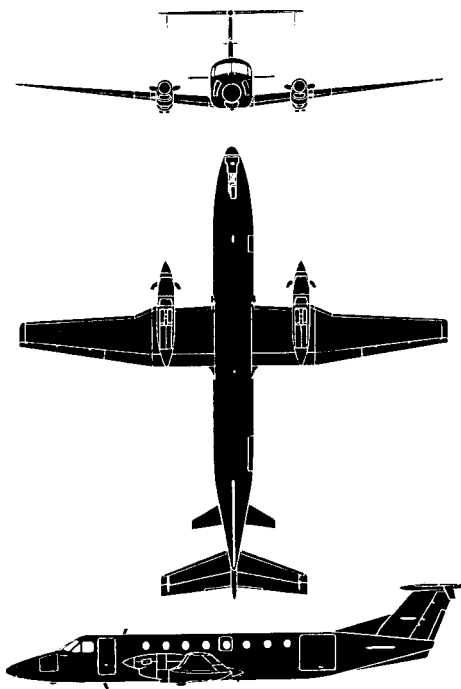
Beechcraft 1900C Twin-turboprop

The Beechcraft 1900C twin-turboprop was first flown in 1982. The basic 1900C airliner is equipped with a cargo door and carries a crew of two and up to 19 passengers. It has a maximum cruising speed of 267 knots (495 kilometers per hour) at an altitude of 8,000 feet (2,440 meters) and a range of 1,480 miles (2,383 kilometers) with 15 passengers on board. It has a service ceiling of 25,000 feet (7,625 meters).
