FLIGHT SAFETY FOUNDATION

Accident Prevention

Misloaded Douglas DC-8 Pitches Up Excessively On Takeoff, then Stalls and Strikes the Ground

The cargo was not loaded aboard the airplane according to the airline's instructions. As a result, the flight crew inadvertently used a horizontal-stabilizer-trim setting that was not correct for the airplane's aft center of gravity.

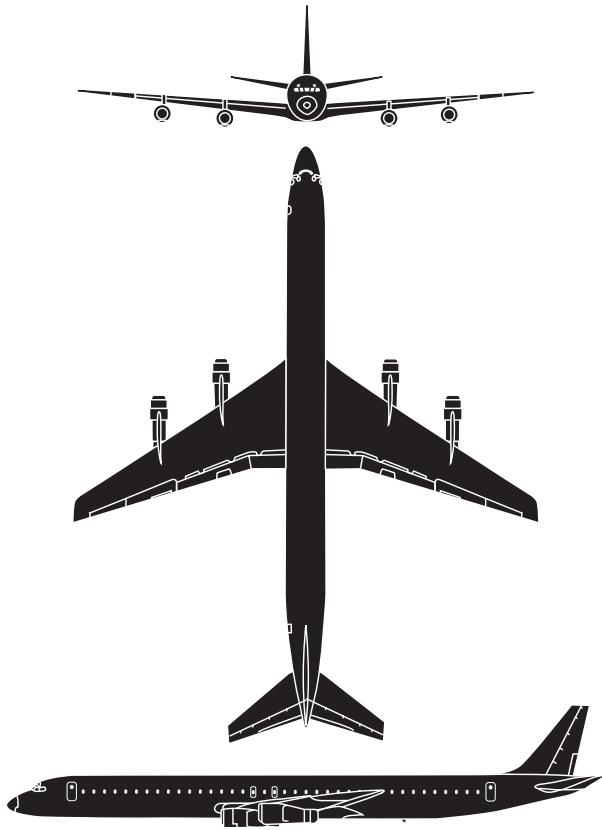
Douglas DC-8-61

The DC-8 was the first jet transport manufactured by Douglas Aircraft Co. Production began in 1959. The first five versions of the airplane — the series 10, 20, 30, 40 and 50 — had the same overall dimensions. The DC-8-61, introduced in 1965, is 36.7 feet (11.2 meters) longer than its predecessors and can carry up to 251 passengers and four crewmembers.
