The crew of a CHC Scotia Aérospatiale SA 365N Dauphin 2 lost control during a nighttime approach to a gas platform in the Irish Sea, overflying the landing site and striking the water.

‘Flying Into the Sea’

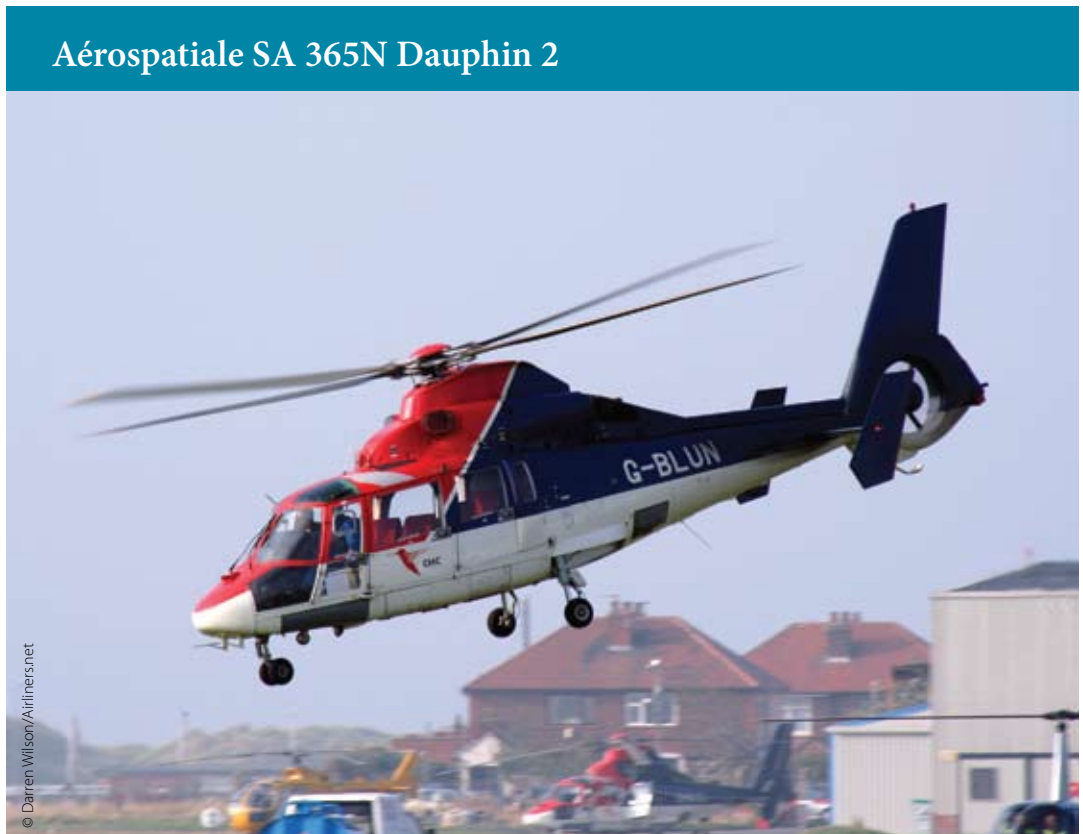
Aérospatiale SA 365N Dauphin 2

The Aérospatiale (now Eurocopter) SA 365N, first flown in 1979, is a twin-engine helicopter designed to carry two pilots and up to eight passengers. It is equipped with Turbomeca Arriel 1C gas turbine engines, each rated at 530 kW (710 shp).

Empty weight is 2,017 kg (4,447 lb) and maximum takeoff weight is 4,000 kg (8,818 lb). Maximum cruising speed at sea level is 140 kt, maximum rate of climb is 1,515 fpm, and service ceiling is 15,000 ft. Maximum range, with standard fuel at sea level, is 475 nm (880 km).
