Cargo Safety

The United States grapples with a relatively high accident rate in freight operations.

BY MARK LACAGNINA

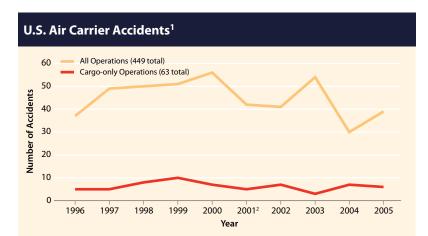
Figure 1

Fatal Accidents		Fatalities	
Year	All Operations	Cargo-only	All Operations	Cargo-only
1996	5	2	380	38
1997	4	1	8	5
1998	1	0	1	0
1999	2	0	12	0
2000	3	1	92	3
2001 ²	2	0	266	0
2002	0	0	0	0
2003	2	0	22	0
2004	2	1	14	1
2005	3	0	22	0
Total	24	5	817	47

1. Aircraft operated under U.S. Federal Aviation Regulations Part 121, Operating Requirements: Domestic, Flag and Supplemental Operations.

2. Does not include the hijackings of four air carrier aircraft that were flown into buildings and the ground, with 265 fatalities, on Sept. 11, 2001.

Source: U.S. National Transportation Safety Board

National Transportation Safety Board (NTSB) records show that in 1996 through 2005, 63 (14 percent) of the 449 accidents that occurred in U.S. Federal Aviation Regulations Part 121 air carrier operations involved cargo aircraft (Figure 1, page 30). Cargo aircraft were involved in five (21 percent) of the 24 fatal accidents during the period.

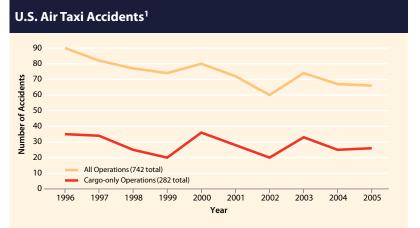
Figure 2

Fatal Accidents		Fatalities	
Year	All Operations	Cargo-only	All Operations	Cargo-only
1996	29	13	63	16
1997	15	7	39	9
1998	17	9	45	10
1999	12	5	38	6
2000	22	11	71	12
2001	18	10	60	14
2002	18	7	35	7
2003	18	8	42	9
2004	23	10	64	12
2005	11	5	18	5
Total	183	85	475	100

1. Aircraft operated under U.S. Federal Aviation Regulations Part 135, *Operating Requirements: Commuter and On-Demand Operations*.

Source: U.S. National Transportation Safety Board

Of the 742 accidents in Part 135 air taxi operations during the 10-year period, 282 (38 percent) involved cargo aircraft (Figure 2, page 31). The total included 183 fatal accidents, of which 85 (46 percent) occurred in cargo operations. Part 135 applies, in part, to cargo operations conducted in airplanes with payload capacities of 7,500 lb (3,402 kg) or less, or in helicopters.

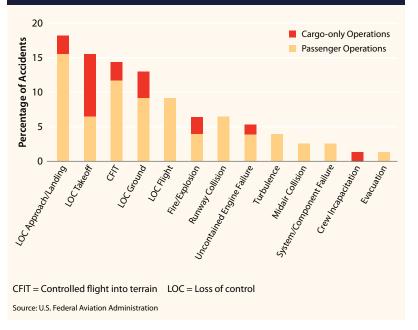
Figure 3

U.S. Air Carrier Hull Loss and Fatal Accidents, 1987–2000

FAA data show that a disproportionate percentage of Part 121 cargo aircraft hull loss and fatal accidents involve loss of control on takeoff (Figure 3, page 33). An example was the Aug. 7, 1997, crash of a Fine Air DC-8 at Miami International Airport. The airplane entered an extreme nose-up pitch attitude on takeoff, stalled and struck the ground, killing the three flight crewmembers, a security guard aboard the airplane and one person on the ground. The crew had trimmed the horizontal stabilizer according to the center of gravity (CG) shown on the load sheet. However, the cargo had not been loaded according to the airline's instructions; the CG was aft of the location indicated on the load sheet. The NTSB report said that the trim set by the crew likely caused a greater-than-expected pitching moment that was exacerbated by the lighter control-column forces resulting from the aft CG location. NTSB said that the accident might have been avoided if the crew had an independent method for verifying the aircraft's weight and balance.
