AeroSafety WORLD

THE JOURNAL OF FLIGHT SAFETY FOUNDATION

SEPTEMBER 2008

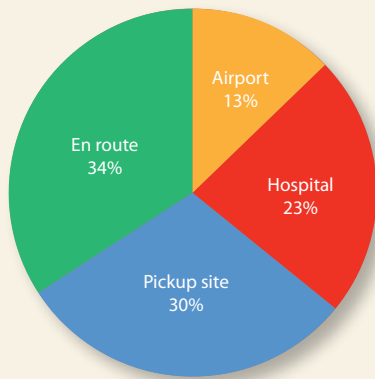
Figure 2

U.S. Helicopter EMS Accident Locations

Note: Based on 120 accidents involving U.S.-registered civil emergency medical services helicopters, Jan. 1, 1998–June 30, 2008.

More accidents occurred en route — 34 percent — than during any other phase of flight, including at the scene of a motor vehicle accident or another off-airport pickup site, 30 percent; at a hospital, 23 percent; or at an airport, 13 percent (Figure 2, p. 16). The pilot was most frequently cited as an accident causal factor — in 65 percent of all HEMS accidents (Figure 3, p. 16).

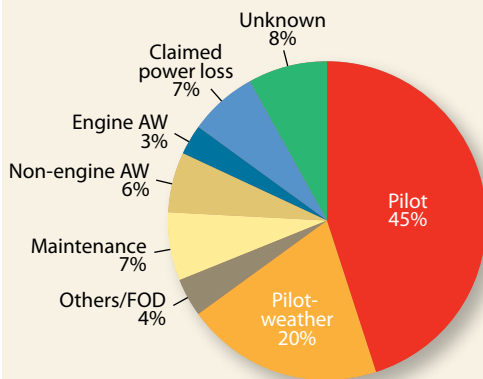
U.S. Helicopter EMS Causal Factors

AW = airworthiness issue
FOD = foreign object damage

Note: Based on 120 accidents involving U.S.-registered civil emergency medical services helicopters, Jan. 1, 1998–June 30, 2008.

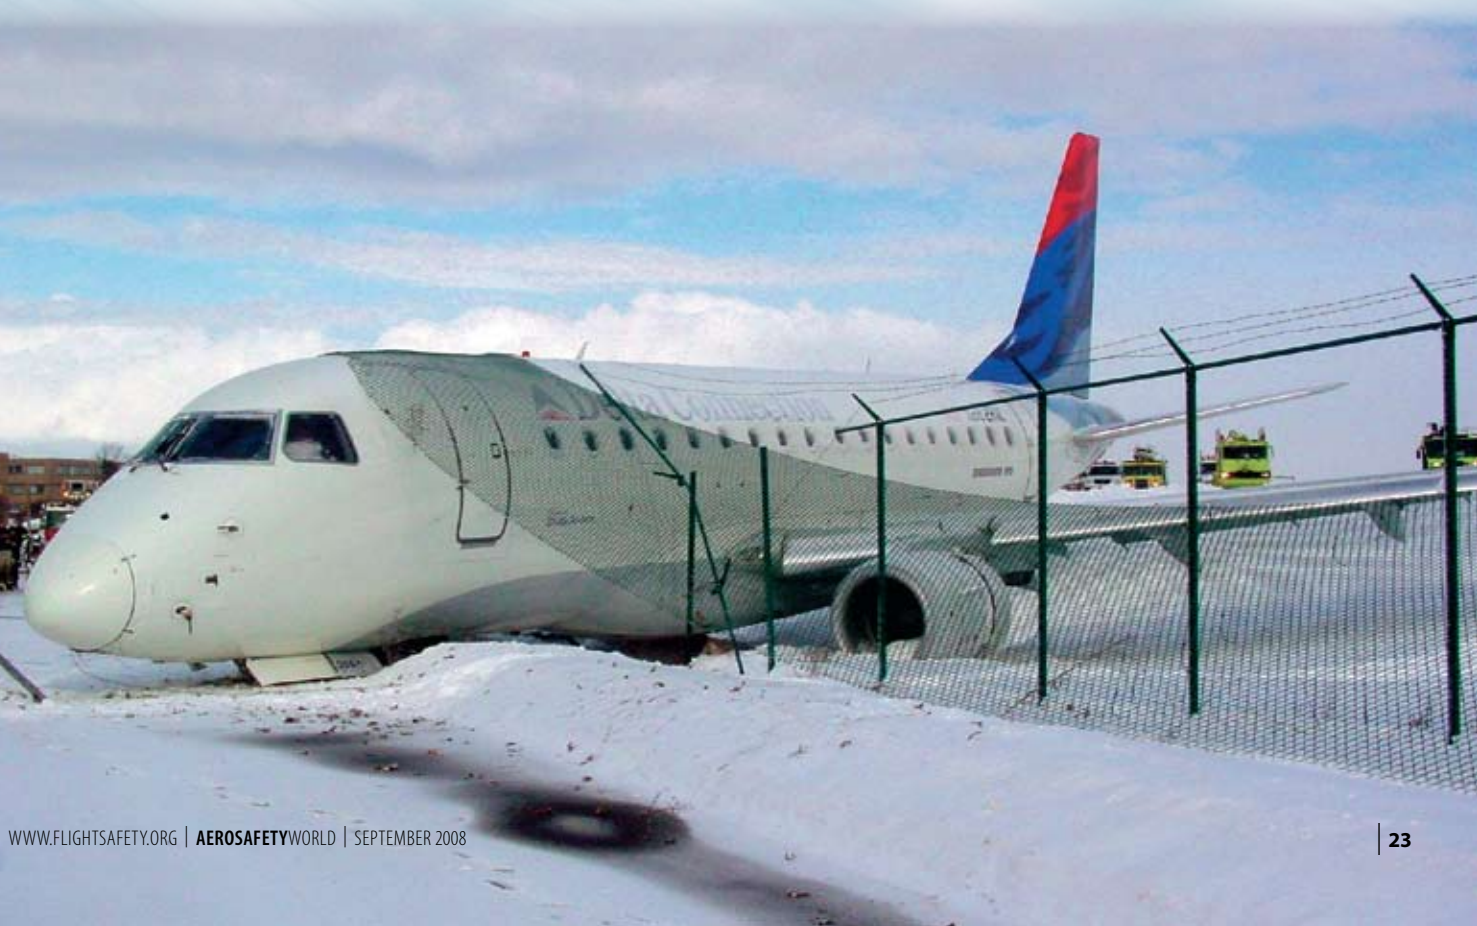
After landing long and overrunning the short, contaminated runway, the Shuttle America ERJ 170 became entangled in the airport perimeter fence, its nosegear broken.

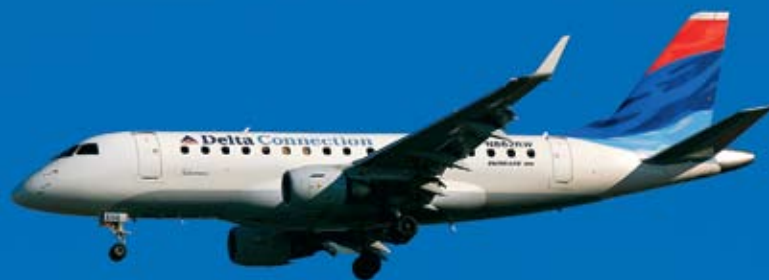
Embraer ERJ-170

The ERJ-170, which first flew in 2002, has 70 to 80 passenger seats and is powered by General Electric CF34-8E5 engines. Standard maximum weights are 79,344 lb (35,990 kg) for takeoff and 72,311 lb (32,800 kg) for landing. Maximum range is 2,000 nm (3,704 km).

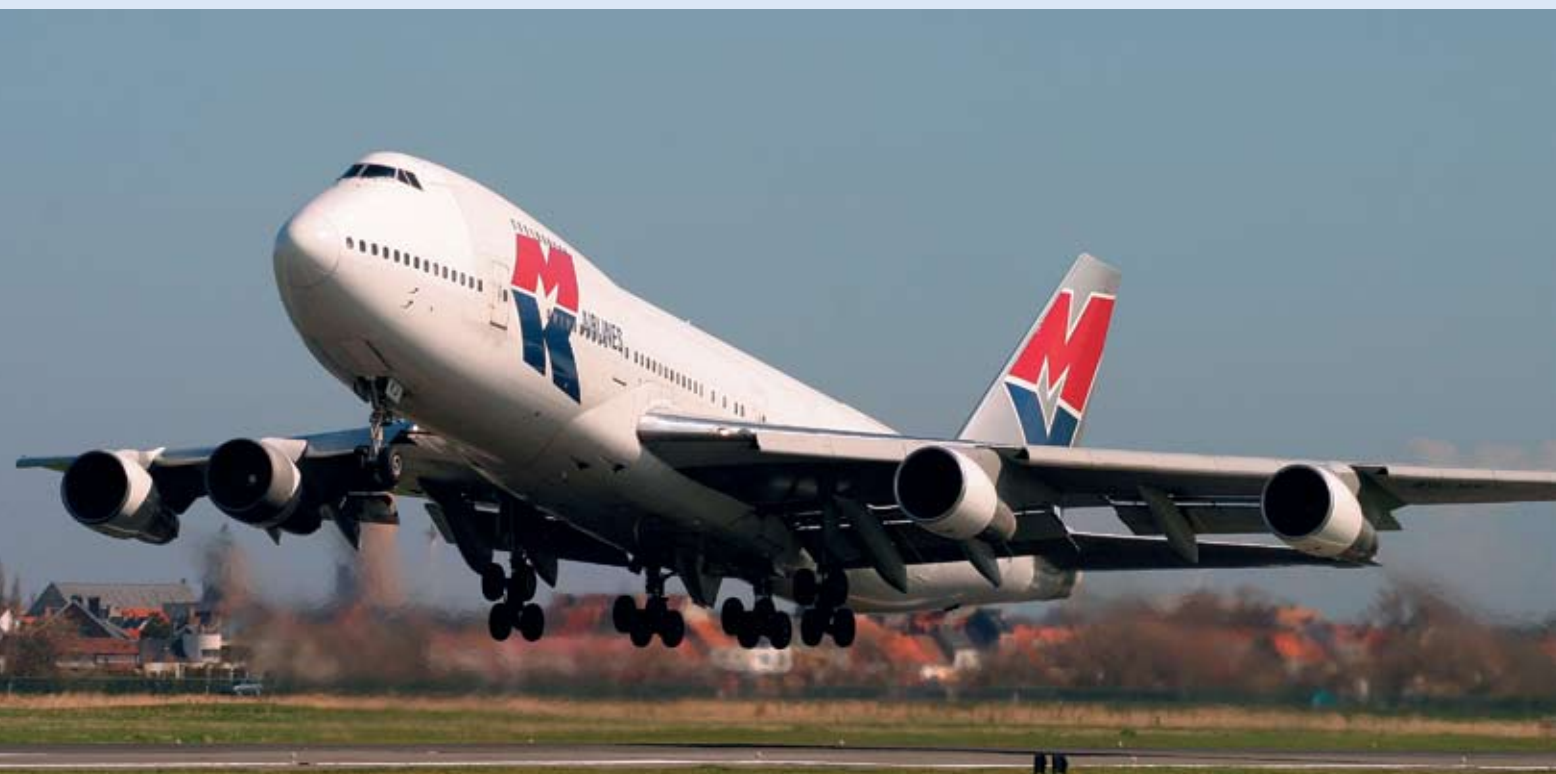
This MK Airlines Boeing 747 crashed on takeoff from Halifax, Nova Scotia, Canada, in 2004, after the crew unknowingly used an incorrect aircraft weight to calculate takeoff speeds and thrust settings, investigators said.

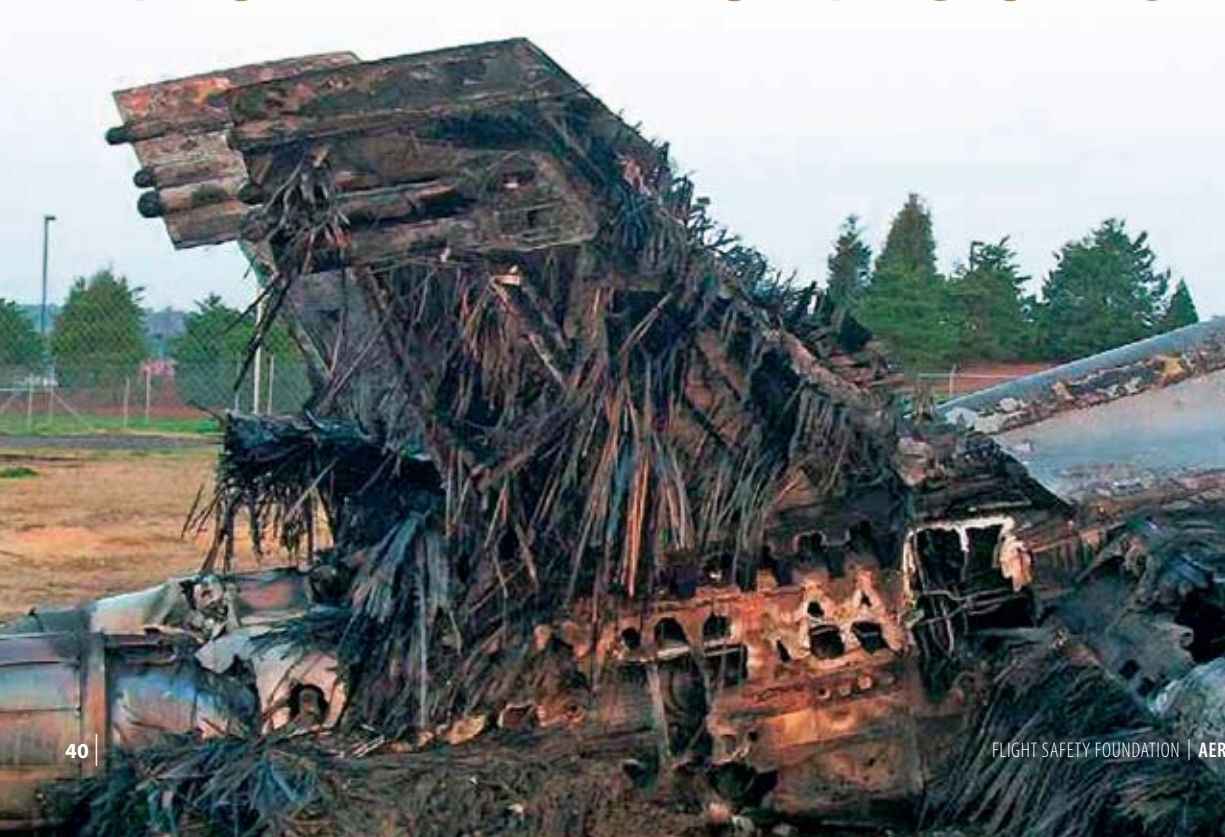
Fire damage to an F/A-18 Hornet fighter illustrates fiber composite debris.

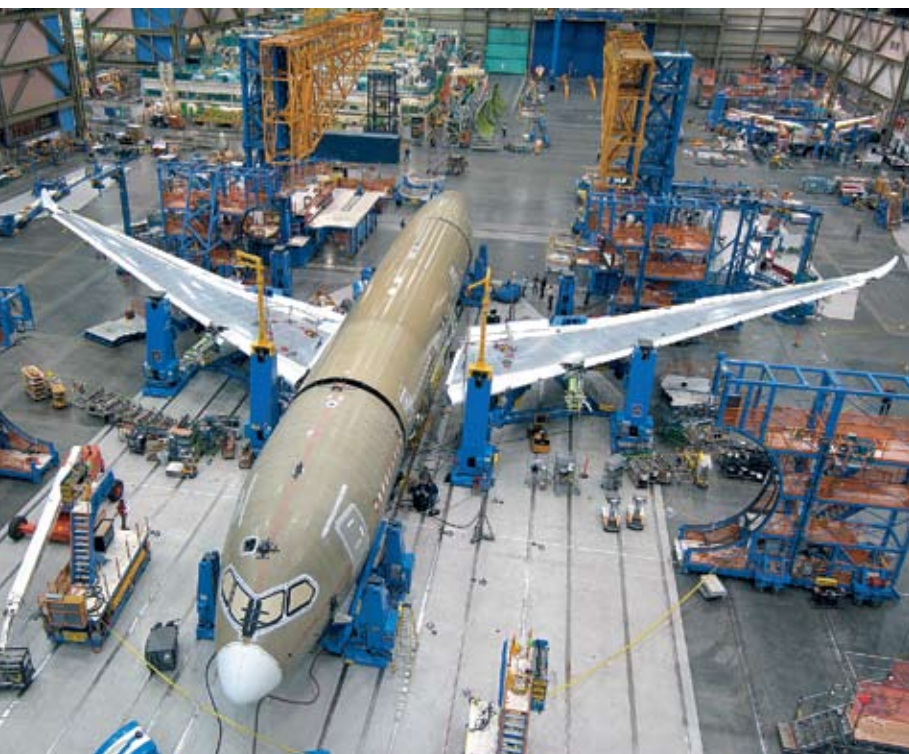
The fuselage and wing are fiber composite structures on the Boeing 787.

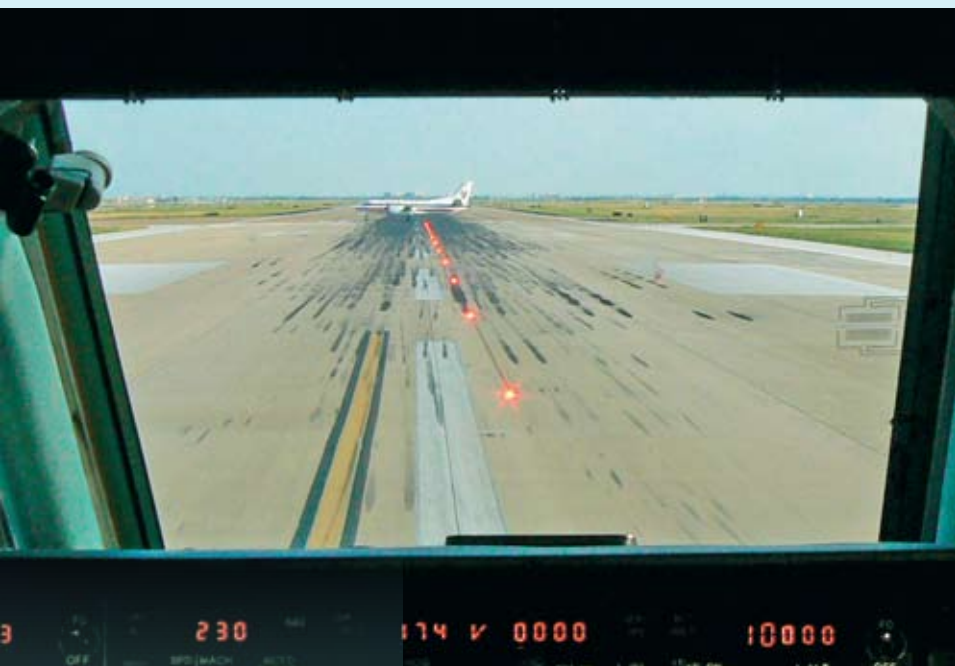
Takeoff hold lights at DFW warned two flight crews about aircraft crossing Runway 18L/36R after they received takeoff clearance.

controller — believing incorrectly that the 340 had been issued a position-and-hold clearance — cleared the flight crew of a McDonnell Douglas MD80 to cross Runway 36R at Taxiway Yankee. The 340 crew then radioed ATC that, although cleared for takeoff, they “saw the red lights” of RWSL and therefore did not begin the takeoff. The closest proximity of the two airplanes was 9,275 ft (2,827 m).

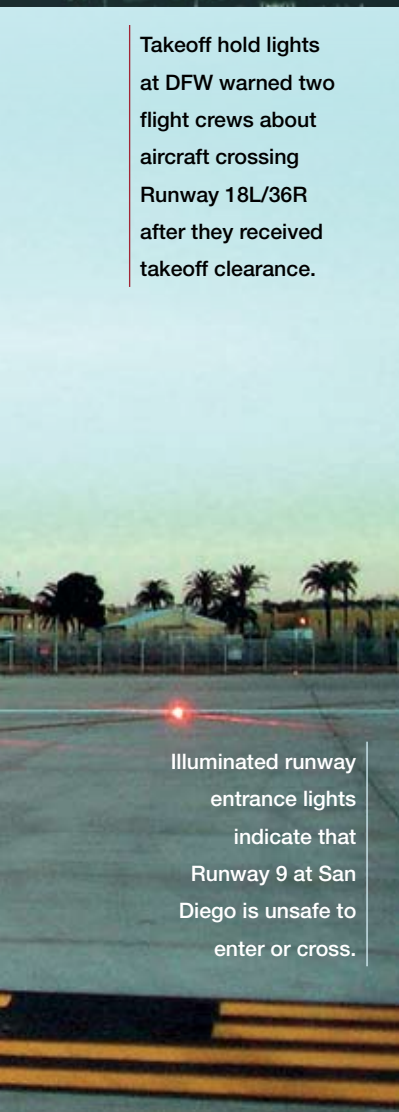
Illuminated runway entrance lights indicate that Runway 9 at San Diego is unsafe to enter or cross.

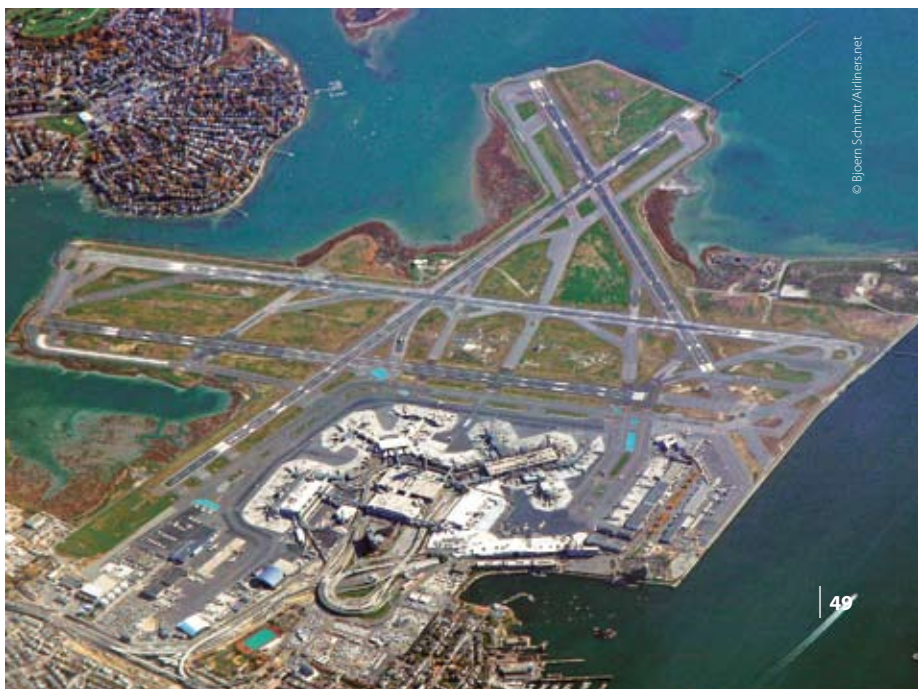
Complex intersecting runways at Boston Logan will get the nation's first runway intersection lights in late 2009.
