Photoluminescent Escape-path Marking Alters Few Duties of Flight Attendants

Some airlines require the cabin crew to ensure correct charging with ceiling lights, a process that prepares tracks or strips bordering the aisles to emit a green glow during an emergency evacuation.

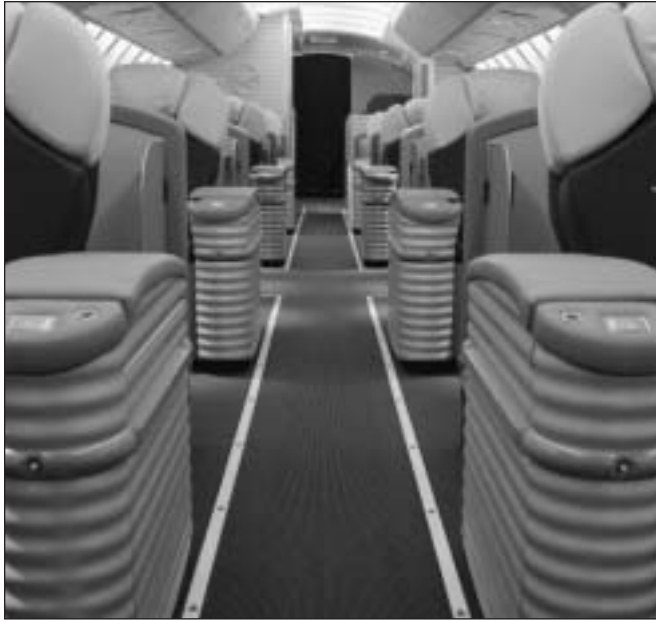
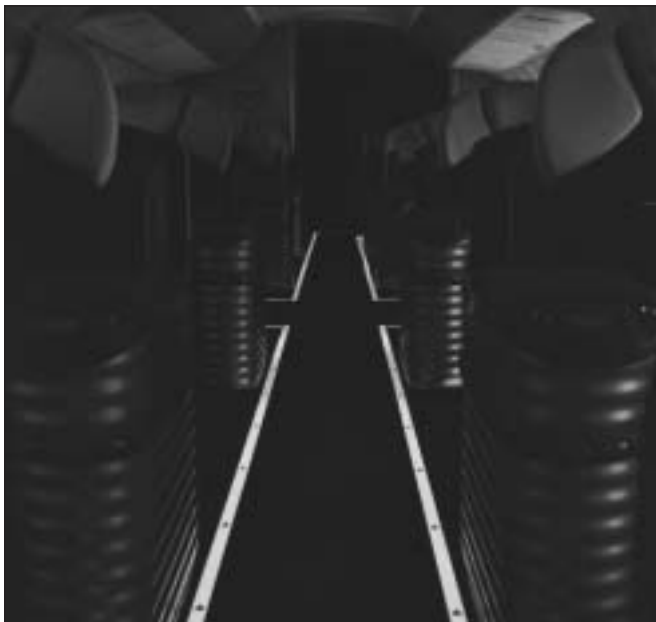
The green glow of photoluminescent strips or tracks along both sides of aisles becomes readily visible in darkness. (Lufthansa Technik photos)

The photoluminescent element in a track/sleeve is encapsulated in sealed polycarbonate for protection from spilled liquids and other contaminants. The exterior should be cleaned regularly using mild soap and water. Detergents and other products containing solvents should not be used because they can damage the polycarbonate cover/sleeve, said Muir.
