FLIGHT SAFETY FOUNDATION  
**CABIN CREW SAFETY**

## **FAA Proposes New Rules on Cargo Compartment Fire Detection and Suppression**

*The U.S. Federal Aviation Administration's (FAA's) aircraft systems fire safety program is also conducting research on the feasibility of cabin water-spray systems and on fire safety issues related to a new generation of large transport aircraft.*

—  
*Constantine P. Sarkos*  
*U.S. Federal Aviation Administration*

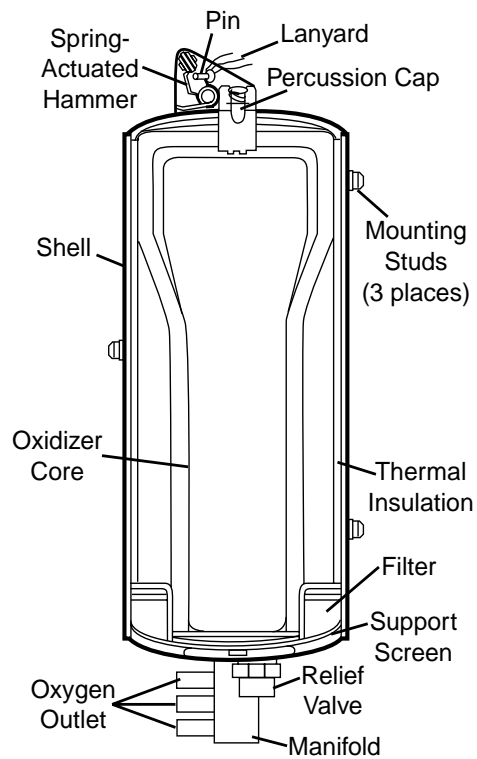
**Figure 1**

## Chemical Oxygen Generator, Cut-away View

A chemical oxygen generator (Figure 1, page 2) is a cylinder about the size of a can of spray paint, with a core containing primarily sodium chlorate. It produces oxygen when a pin is pulled, releasing a spring-loaded firing mechanism that strikes a percussion cap and starts a chemical reaction that produces oxygen — for emergency breathing apparatus used in a sudden, unexpected cabin decompression — and intense heat as a by-product when oxidation occurs in a confined space. The oxygen generator is designed to function safely when properly installed in an aircraft.
