**ROYAL
AERONAUTICAL
SOCIETY**

SMOKE, FIRE AND FUMES IN TRANSPORT AIRCRAFT

PAST HISTORY, CURRENT RISK AND RECOMMENDED MITIGATIONS

**Second Edition 2013
Part 1: Reference**

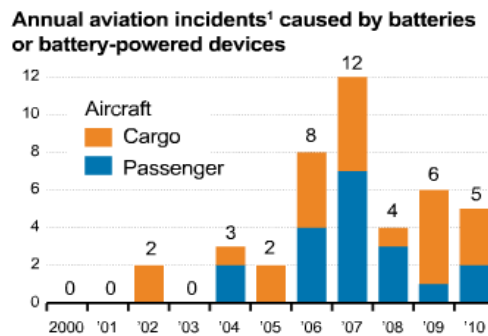
Battery Cargo in Planes

1 – Incidents involving smoke, fire, extreme heat or explosion

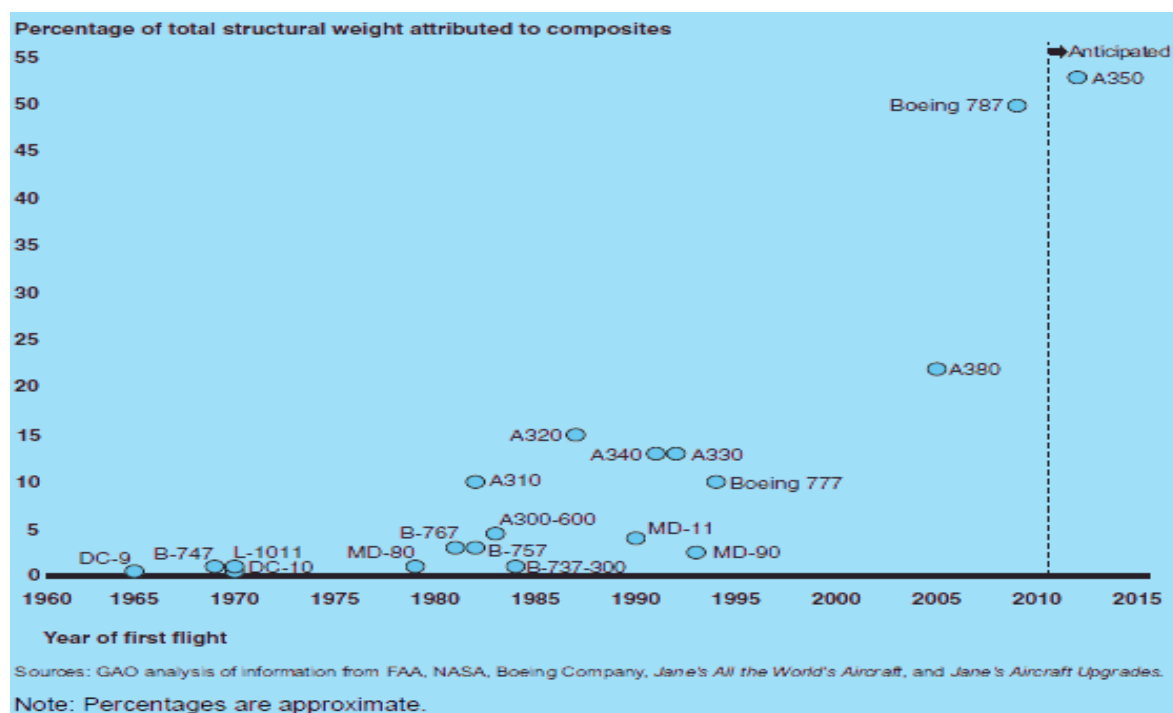
(United States Government General Accountability Office, 2011)

The following Figure shows the percentage of total structural weight attributed to composite materials used in aeroplane construction since the mid-1980s:
