**ATSB TRANSPORT SAFETY REPORT**  
Aviation Research and Analysis Report – AR-2008-018(1)  
Final

# Runway excursions

## Part 1: A worldwide review of commercial jet aircraft runway excursions

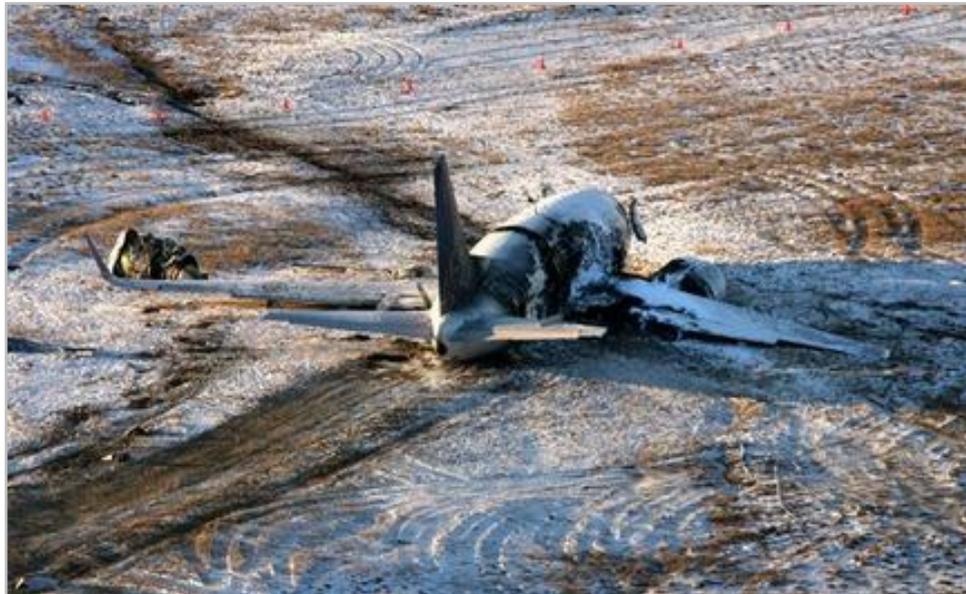
**Figure 5: Boeing 737-500 veer-off accident at Denver International Airport, Colorado, 20 December 2008**

damage to the fuselage, and a post-impact fire. The runway surface was dry and free from snow at the time of the accident. Of the 115 people on board, 38 sustained injuries with at least two people seriously injured (Figure 5).

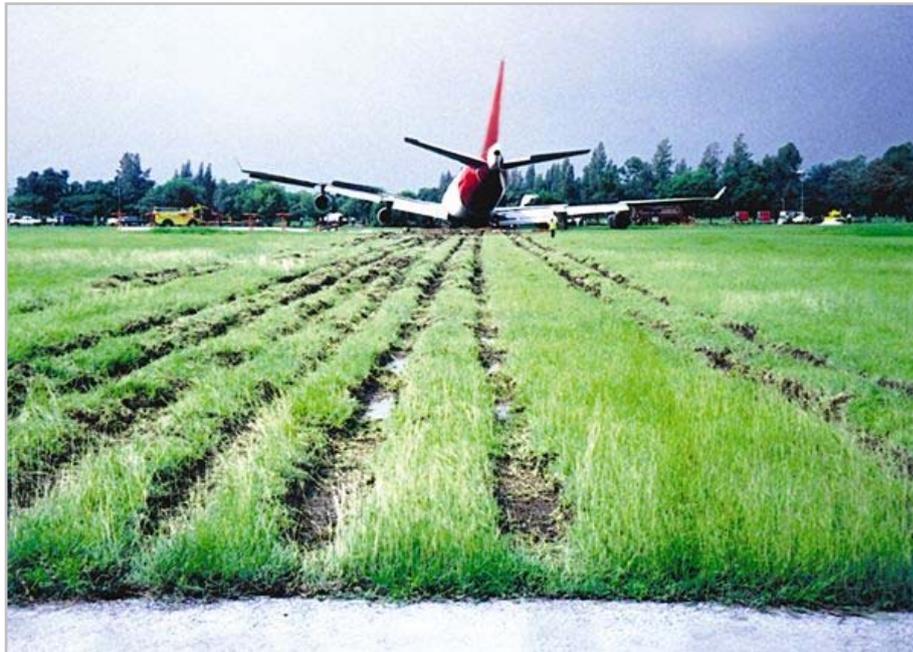
**Figure 6: Boeing 747-400 overrun accident at Bangkok International Airport, Thailand, 23 September 1999**

an instrument landing system (ILS) localiser antenna that initiated the collapse of the nose and right wing landing gear. This allowed the aircraft to adopt a slight right wing low attitude, resulting in the right inboard and outboard engine nacelles contacting the ground. The aircraft eventually came to rest on a road 220 m from the end of the stopway<sup>14</sup> (Figure 6). None of the three flight crew, 16 cabin crew or 391 passengers reported any serious injuries. The accident was investigated by the ATSB (ATSB, 2001).

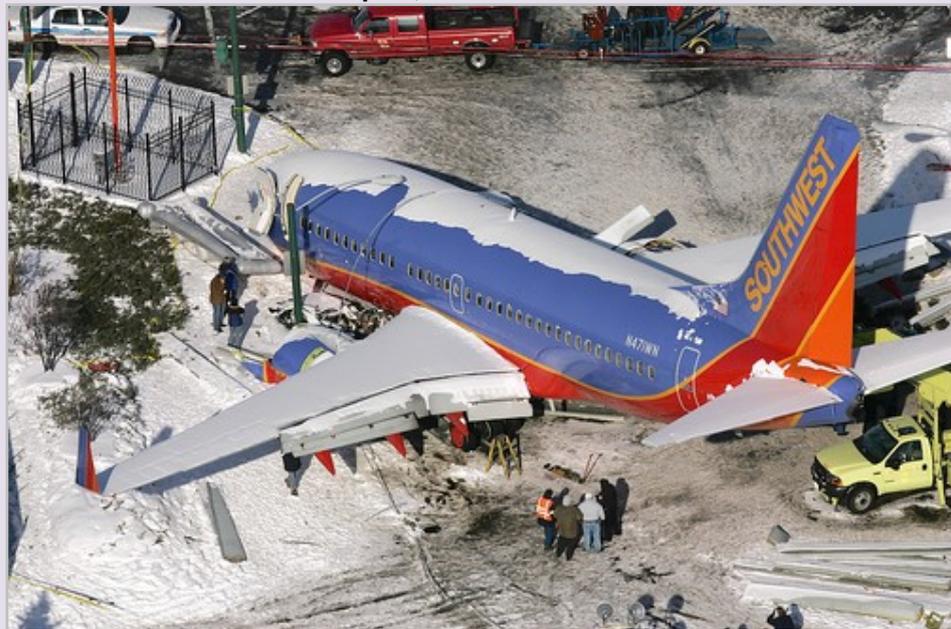
**Figure 15: Boeing 737-700 overrun accident, Chicago Midway International Airport, 8 December 2005**

The fatal runway overrun accident of a Boeing 737-700 at Chicago Midway International Airport, Illinois on 8 December 2005, highlighted how delayed flight crew actions can combine with poor environmental conditions and a narrow margin for landing errors at inner city airports to produce a tragic outcome.

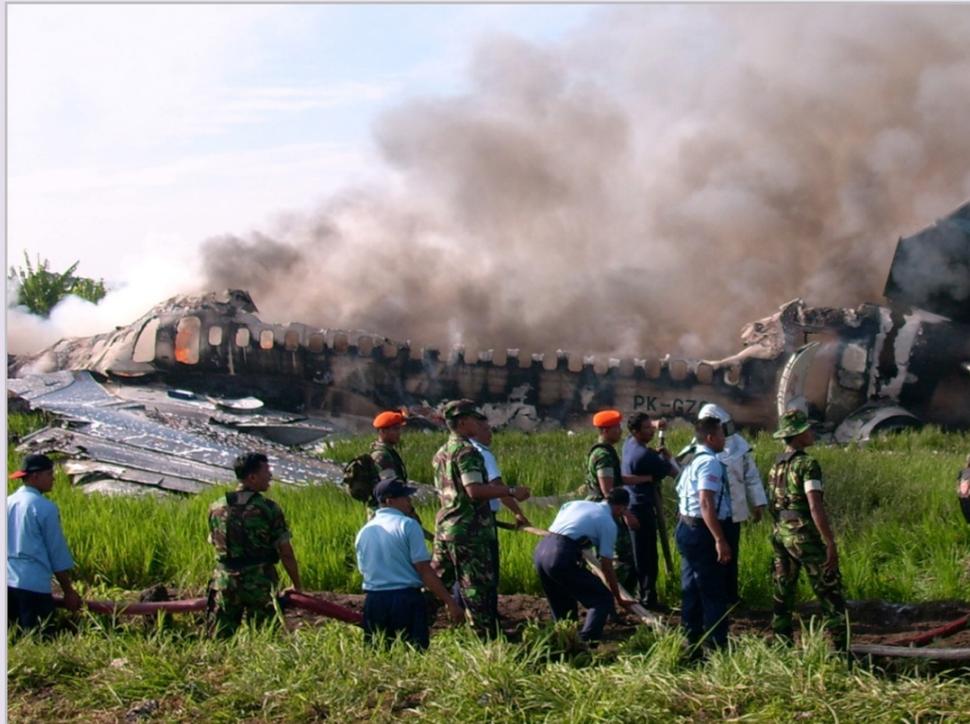
**Figure 16: Boeing 737-400 overrun accident, Adisucipto Airport, Yogyakarta, Indonesia, 7 March 2007**

The fatal runway overrun accident of a Boeing 737-400 at Yogyakarta, Indonesia on 7 March 2007 highlighted how a combination of flight crew techniques and decisions, such as CRM practices and a decision by the flight crew not to execute a go-around when the aircraft approach was unstabilised, can lead to a runway excursion accident.

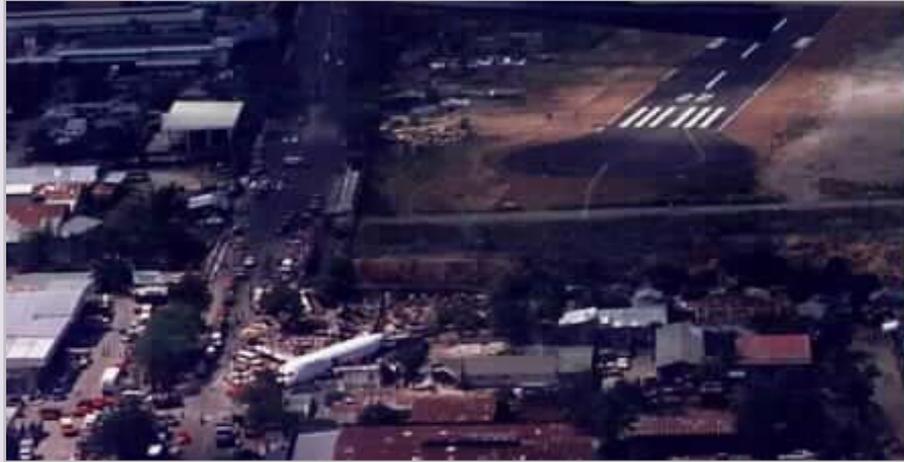
**Figure 18: Airbus A320-200 overrun accident, Bacolod Airport, Philippines, 22 March 1998**

While there were no on-board fatalities associated with this accident, there were three people on the ground who sustained fatal injuries. The aircraft was damaged beyond economical repair.

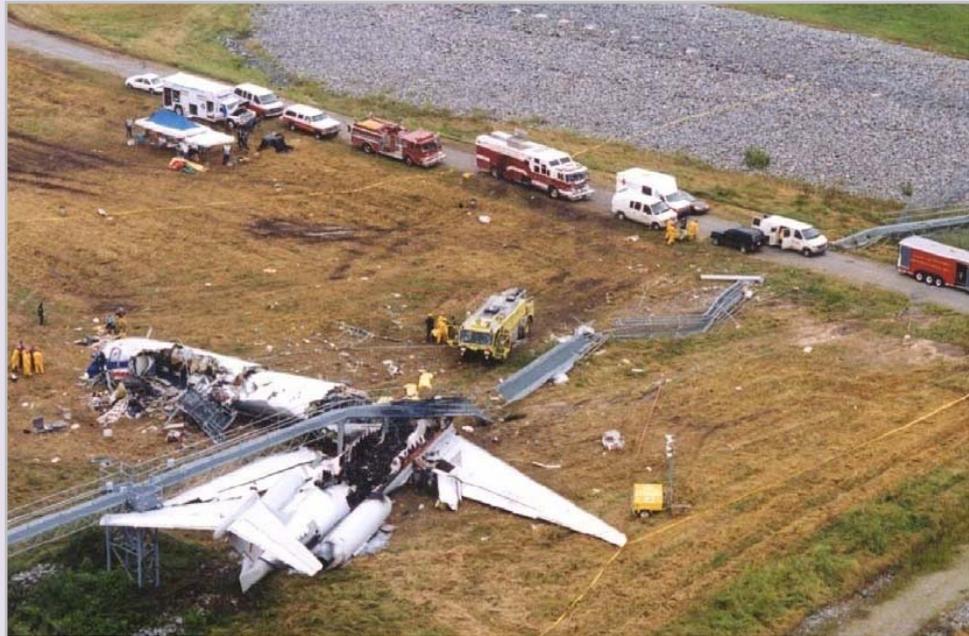
**Figure 19: McDonnell Douglas MD-82 overrun accident, Little Rock National Airport, Arkansas, 1 June 1999**

On 1 June 1999, a McDonnell Douglas MD-82 overran the runway after landing at Little Rock National Airport, Arkansas. In this accident, task saturation during a late evening approach in severe weather conditions led to a high flight crew workload. Situational stress contributed to the flight crew losing awareness of approach stability (not realising how much runway was being used up by the flare and initial float) and led to delayed crew action in braking after touchdown (e.g. late thrust reverser deployment, ground spoilers not armed). The effects of situational stress allowed the flight crew to place the aircraft in an undesired state in what were already critical weather conditions. The result was a runway overrun.

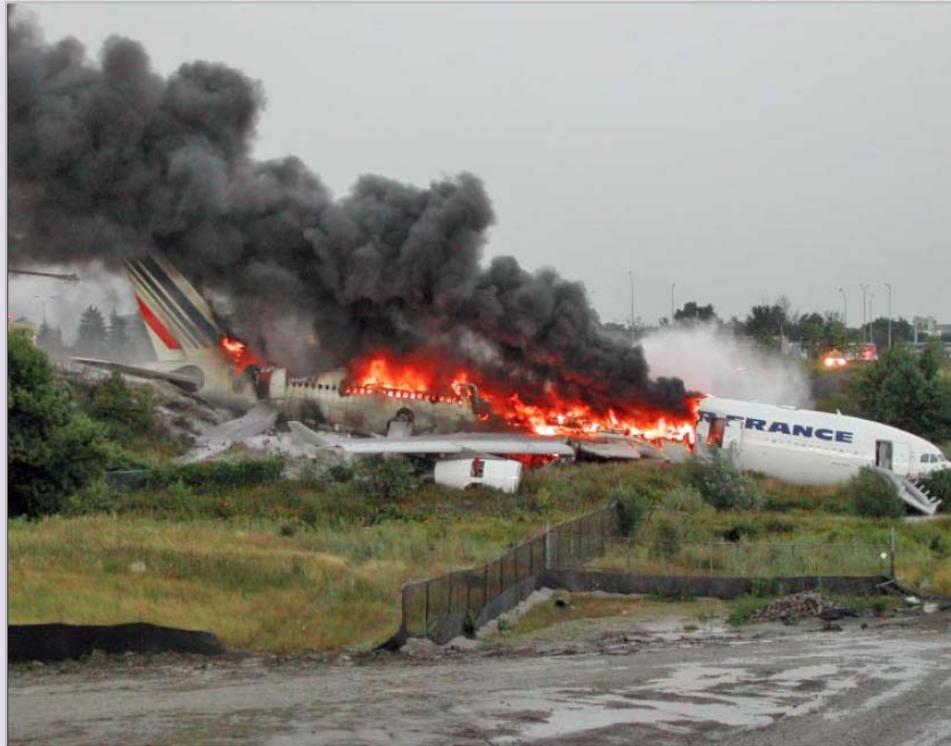
**Figure 22: Airbus A340-300 overrun accident, Lester B. Pearson International Airport, Toronto, Ontario, Canada, 2 August 2005**

On 2 August 2005, following an instrument landing system (ILS) approach to runway 24L at Lester B. Pearson International Airport, Toronto, Canada, an Airbus A340-300 aircraft landed long and then overran the runway, falling into Etobicoke Creek some 200 m beyond the end of the runway. A fire broke out and the aircraft was destroyed. The accident happened in daylight, but in severe weather conditions. All aircraft occupants were able to evacuate the aircraft before the post-impact fire reached the escape routes, with two flight crew and 10 passengers sustaining serious injuries. No aircraft occupants were fatally injured.

Runway 24L was 9,000 ft (2,744 m) in length. The aircraft touched down about 3,800 ft (1,160 m) beyond the runway threshold. As the aircraft crossed the runway threshold, with the heavy rain, low visibility, lightning and variable winds, the flight crew became overwhelmed by the severe weather conditions and became task saturated, making a normal landing difficult. Because the flight crew were focused on maintaining visual contact with the runway, they did not notice that the wind had shifted from a headwind to a 10 kt tailwind during the flare, significantly increasing the landing distance in the prevailing weather conditions.

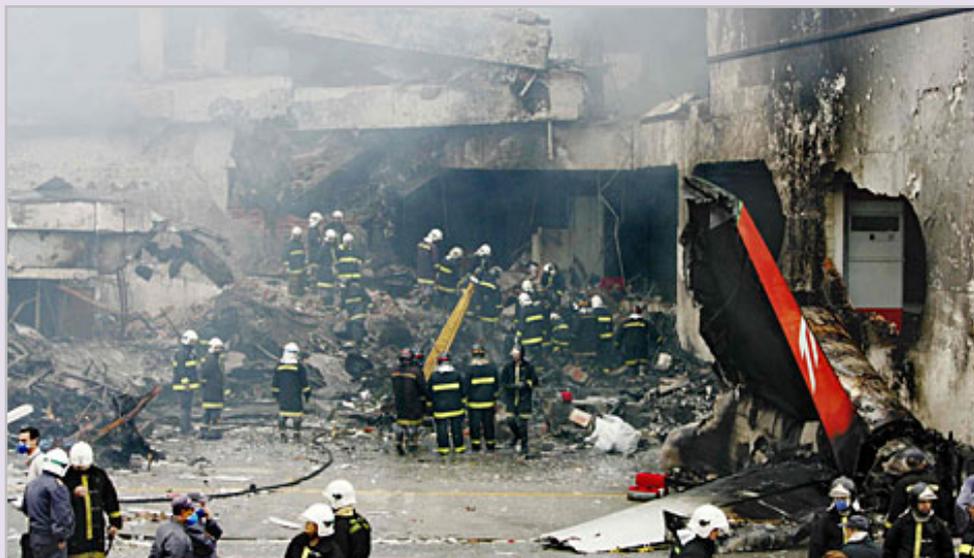
**Figure 24: Airbus A320 overrun accident, Congonhas Airport, Sao Paulo, Brazil, 17 July 2007**

The tower controller cleared the Airbus A320 to land on runway 35L at Congonhas Airport, Sao Paulo after operating a flight from Porto Alegre, Brazil. The aircraft was destroyed when it overran on landing. After departing the end of the runway, the aircraft veered slightly to the left before going over a steep embankment. It became airborne as the ground fell away beneath it, flew over a major road, and impacted a TAM Express cargo building on the far side of the road at a speed of 94 kts. A fire broke out that destroyed both the aircraft and the building. All 187 crew and passengers on board and 12 people on the ground were fatally injured.
