APRIL–MAY 2001

# FLIGHT SAFETY

**Human Error Cited as Major Cause of U.S.  
Commercial EMS Helicopter Accidents**

**Data Show That More Than Half of EMS  
Airplane Accidents Occur During  
Approach and Landing**

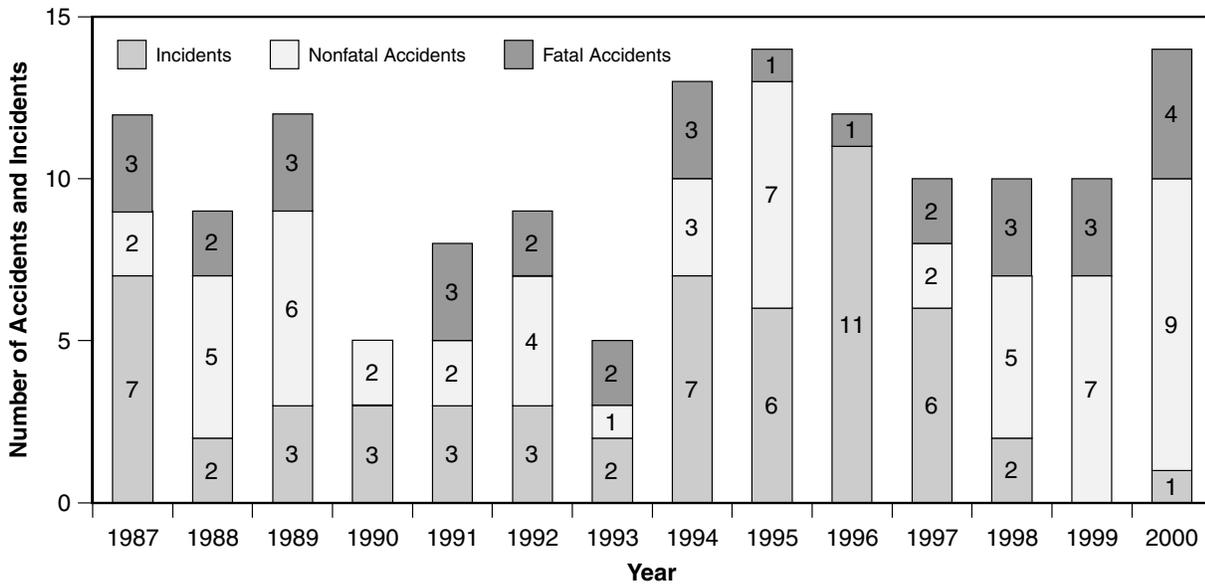
**Figure 1**

## U.S. Commercial EMS Helicopter Accidents and Incidents, 1987–2000

From January 1987 through December 2000, there were 87 accidents and 56 incidents involving commercial emergency medical services (EMS) helicopters in the United States (Figure 1, page 2). The accidents included 32 fatal accidents (37 percent of the total) and 17 serious-injury accidents (20 percent). Human error was associated with 66 accidents (76 percent) and 27 fatal accidents (84 percent); in some phases of flight, the percentage of accidents associated with human error was more than 90 percent. Of the 275 people aboard the helicopters, 96 people were killed, 33 people were seriously injured and 31 people received minor injuries. Thirty-six of the 87 aircraft were destroyed, and 51 were damaged substantially.<sup>1,2</sup>

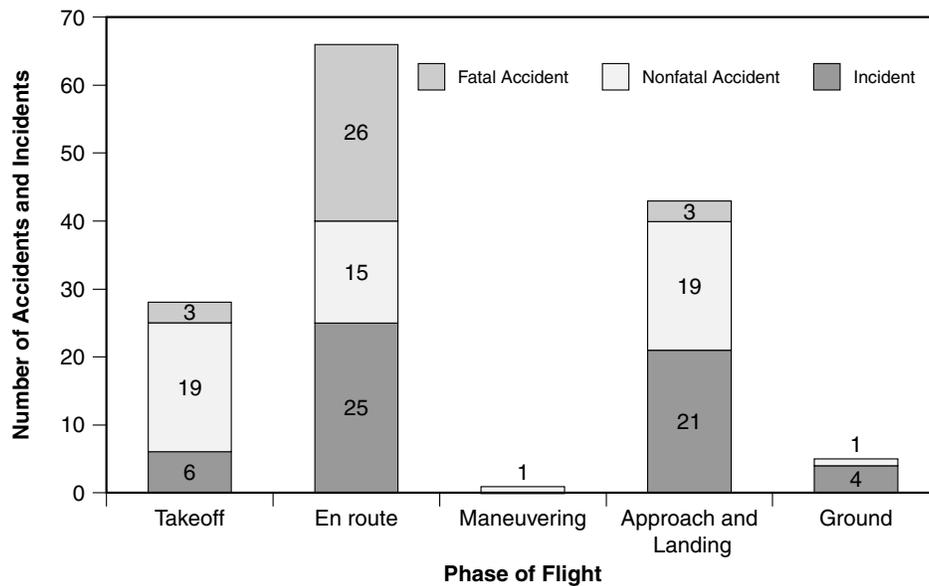
Figure 2

### Phase of Flight for 143 U.S. Commercial EMS Helicopter Accidents and Incidents, 1987–2000

- Forty-one of the 87 accidents (47 percent), including 26 of the 32 fatal accidents (81 percent), and 25 of the 56 incidents (45 percent) occurred during the en route phase of flight (Figure 2, page 3). Of the en route accidents, 68 percent resulted from human error (Figure 3, page 3);

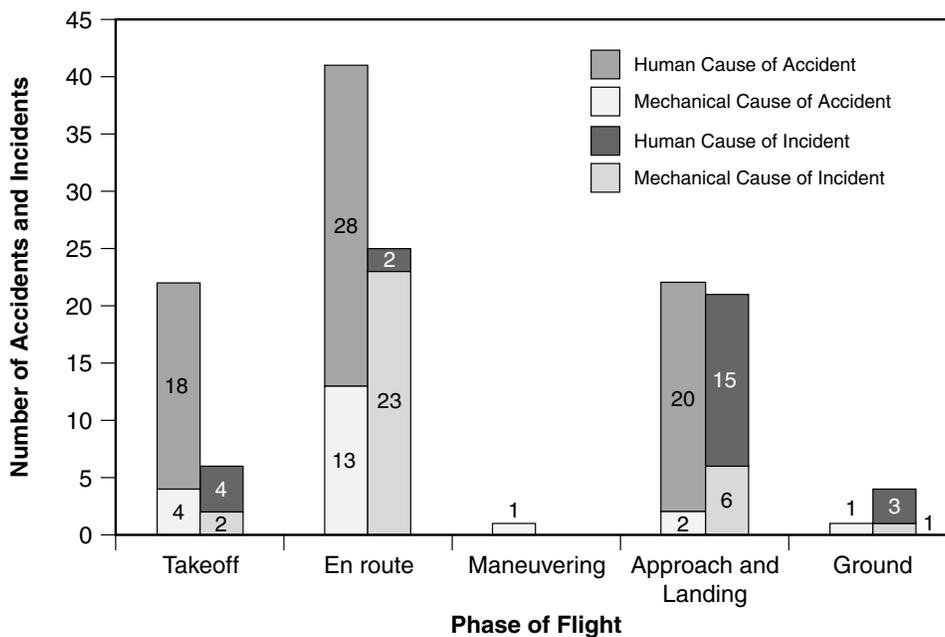
Figure 3

### Involvement of Human Error and Mechanical Failure by Phase of Flight In 143 U.S. Commercial EMS Helicopter Accidents and Incidents, 1987–2000

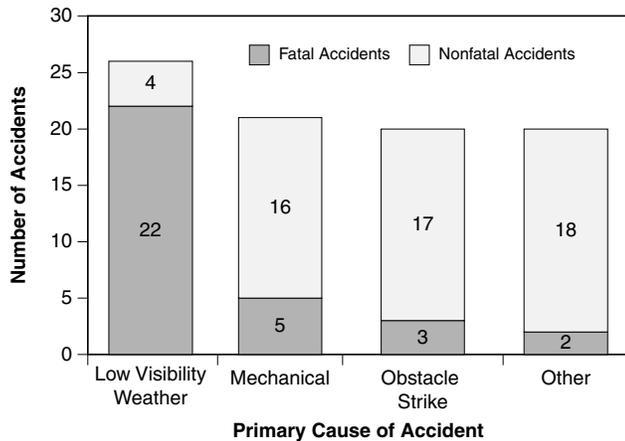
## General Causes of U.S. Commercial EMS Helicopter Accidents, 1987–2000

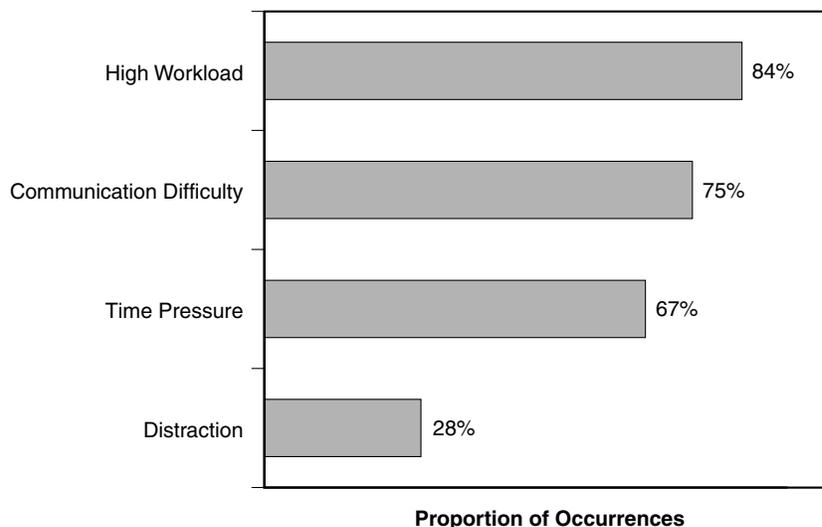
**Figure 6**

## Contributing Factors to Human Error in U.S. Commercial EMS Helicopter Events Reported to NASA ASRS, 1988–1999

Note: Some reports involved more than one contributing factor.

Pilot workloads are substantial during EMS operations, and task saturation commonly is cited as a contributing factor in NTSB accident reports and ASRS reports (Figure 6, page 7).<sup>16</sup>

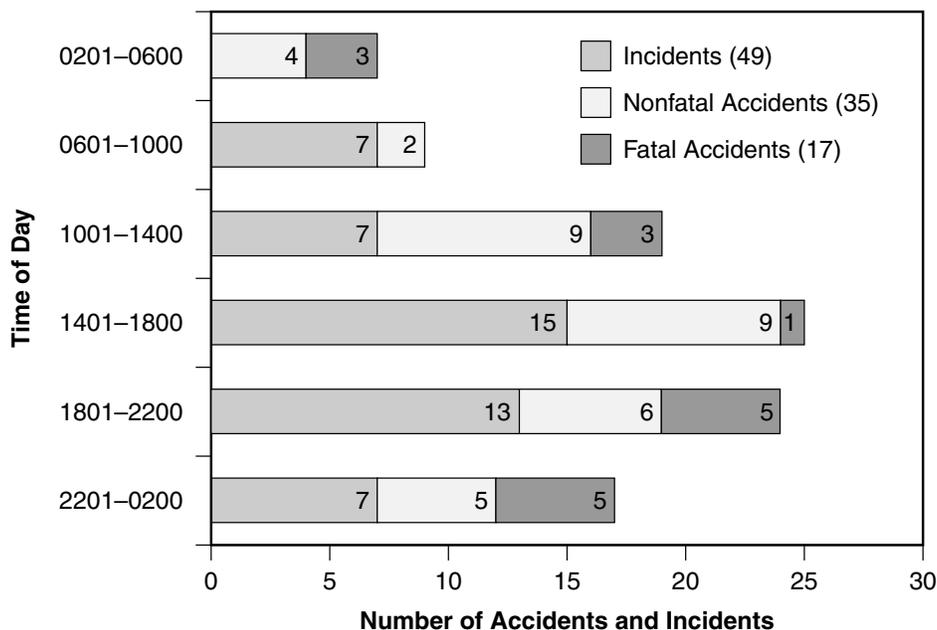
### Reported Times of U.S. Commercial EMS Helicopter Accidents and Incidents, July 1993–December 2000

Note: Some reports did not include the time of the accident or incident

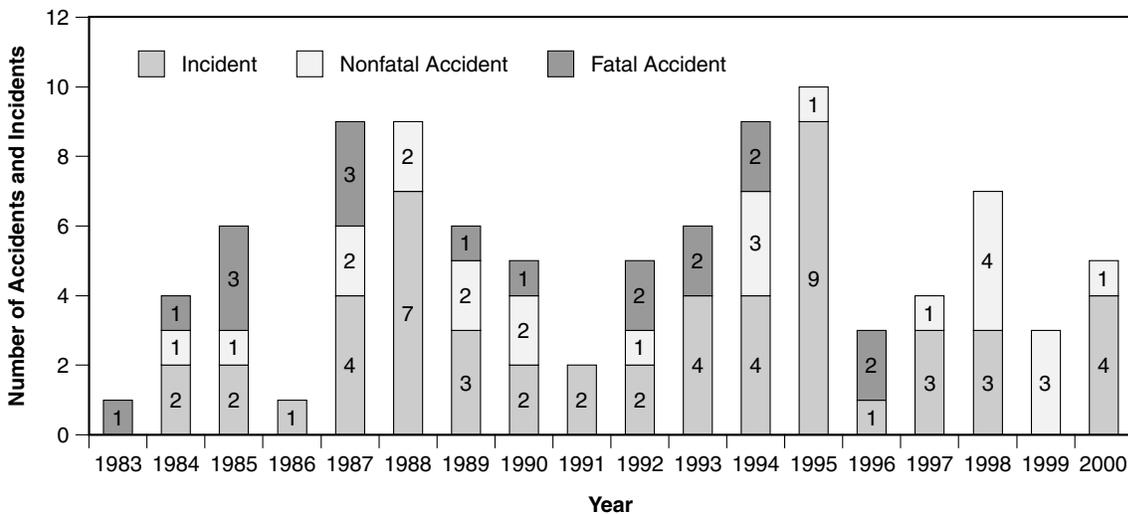
**Figure 1**

## U.S. Commercial EMS Airplane Accidents and Incidents, 1983–2000

From 1983 to 2000, there were 42 accidents and 53 incidents involving U.S.-registered airplanes on EMS flights within the United States. The 42 accidents included 18 fatal accidents and six serious-injury accidents. Of 153 occupants of the aircraft, 54 people were killed, 11 people were seriously injured, and 12 people received minor injuries. Nineteen aircraft were destroyed, and 20 aircraft received substantial damage (Figure 1, page 40).

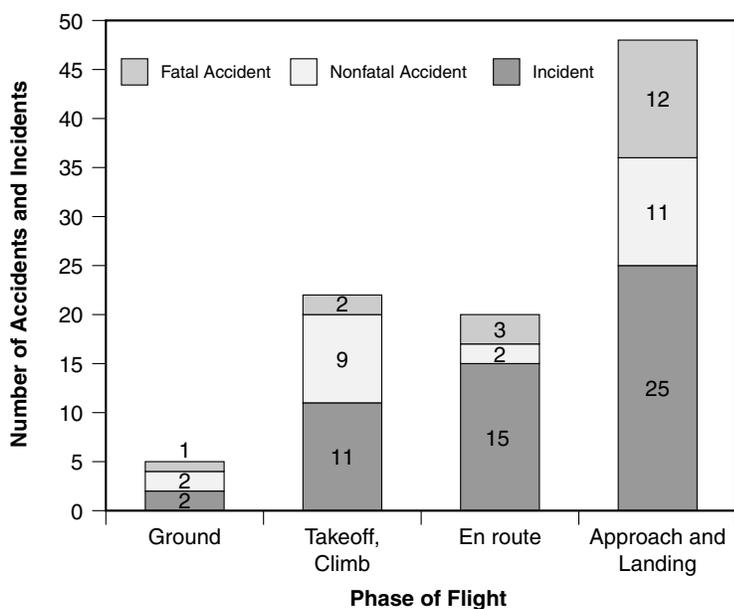
**Figure 2**

## Phase of Flight for 95 U.S. Commercial EMS Airplane Accidents and Incidents, 1983–2000

- Twenty-three of the 42 accidents (55 percent) occurred during approach and landing (Figure 2, page 40);
- Eleven accidents (26 percent) occurred during takeoff;
- Mountainous terrain was a contributing factor in 25 accidents (60 percent), including 11 fatal accidents. Sixty-one percent of all fatal accidents involved mountainous terrain;

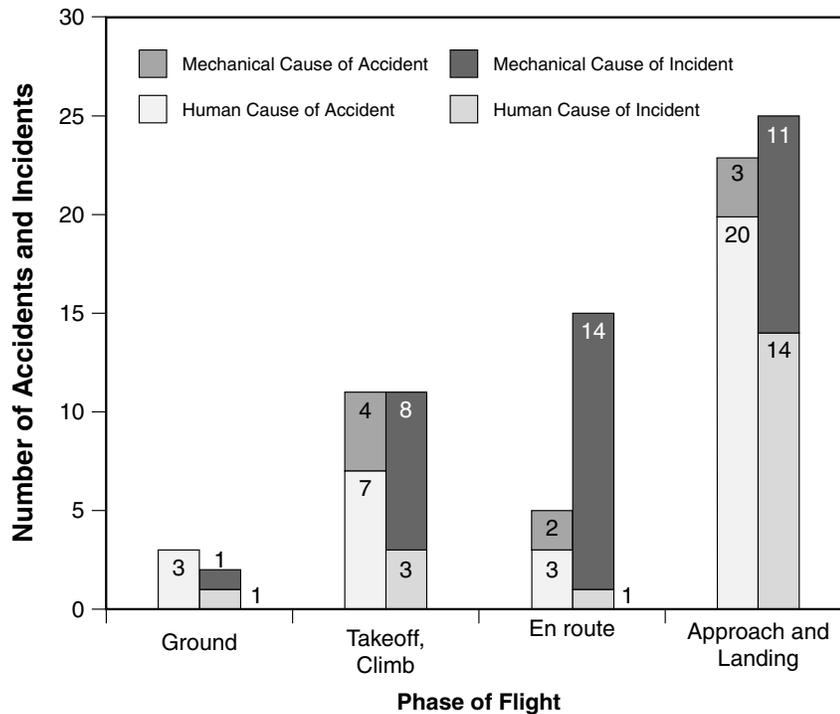
**Figure 3**

## Involvement of Human Error and Mechanical Failure by Phase of Flight In 95 U.S. Commercial EMS Airplane Accidents and Incidents, 1983–2000

Twenty-three of the 42 accidents (55 percent), including 12 of the 18 fatal accidents (67 percent), and 25 incidents occurred during approach and landing. The 12 fatal accidents resulted in 37 fatalities (69 percent of all fatalities in EMS airplane accidents). Human error was involved in 20 of the 23 approach-and-landing accidents (ALAs [87 percent]) and in 14 of the 25 approach-and-landing incidents (56 percent) (Figure 3, page 42).

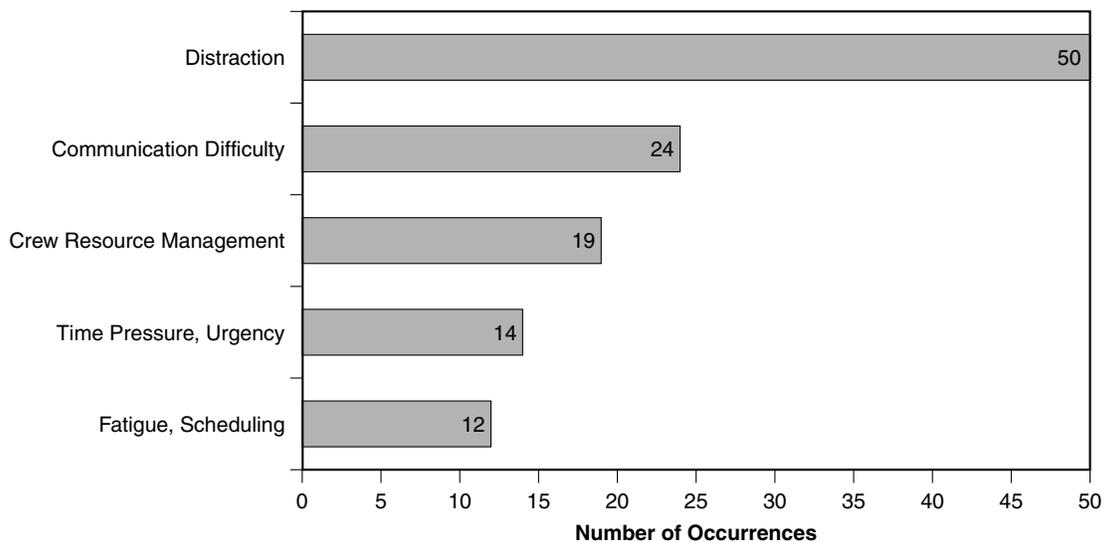
**Human Error Factors Cited In U.S. Commercial EMS Airplane Events  
Reported to NASA ASRS 1988–1999**

Note: Some reports involved more than one contributing factor.

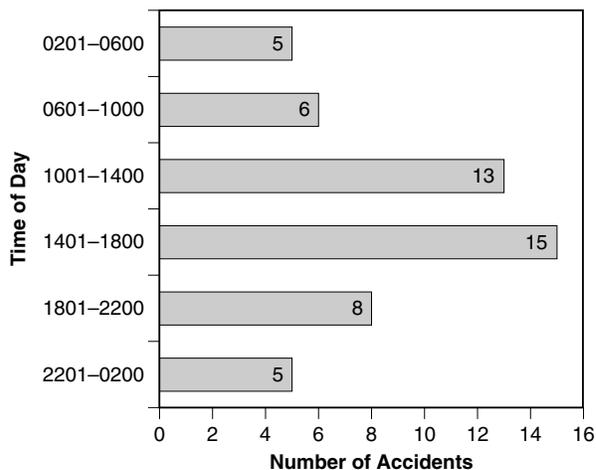
**Figure 5**

**Reported Times of U.S. Commercial EMS Airplane Accidents, April 1993–December 2000**

Figure 5 and Figure 6 show the time of day at which some accidents and incidents occurred. The greatest concentrations of incidents (28 incidents, or 54 percent) occurred during the two consecutive four-hour periods (1001 to 1800 hours) that comprise the typical workday. The greatest concentration of accidents (five accidents, or 28 percent) however, occurred during the single four-hour period from 0201 local time to 0600 local time.

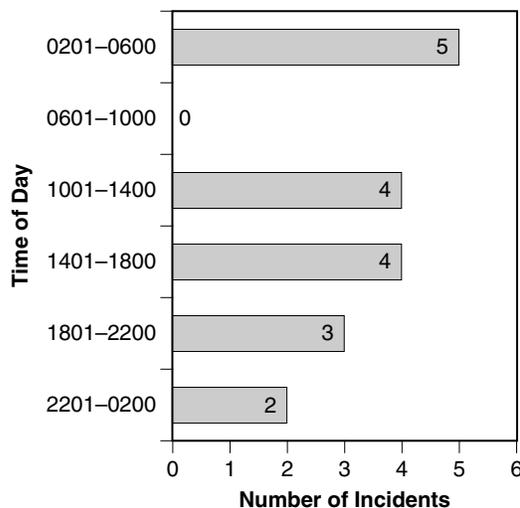
**Figure 6**

**Reported Times of U.S. Commercial EMS Airplane Incidents, January 1994–April 2000**
