# Use of Flight Data Recorders To Prevent Accidents in the U.S.S.R.

*Analysis of flight recorder information has proven a valuable tool both for investigating accidents and improving the level of flight safety since 1965.*

Dr. V. D. Kofman, Deputy Director  
Scientific Research Laboratory  
State Supervisory Commission for Flight Safety of  
the Council of Ministers of the U.S.S.R. (Gosavianadzor)

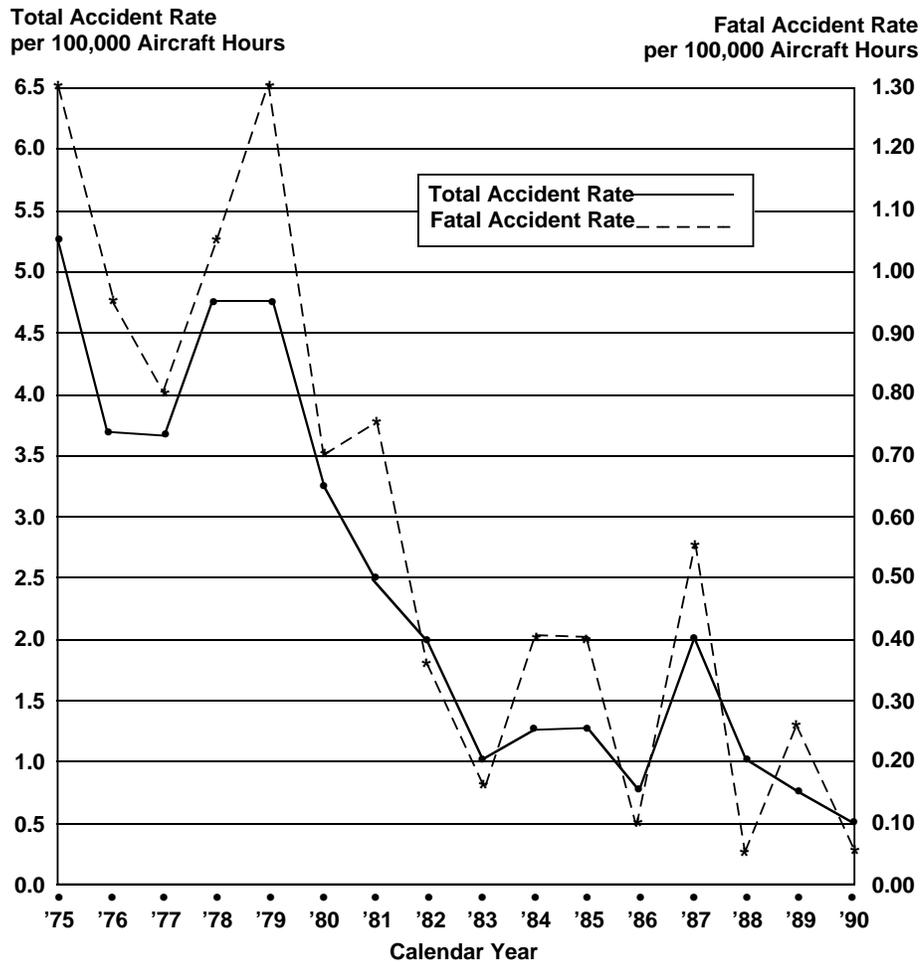
**Figure 1 — Total Accidents and Fatal Accident Trends  
U.S. Commuter Air Carriers 1975-1990**

from 5.13 accidents per 100,000 aircraft flight hours in 1975 to a rate of 0.63 in 1990, a decrease of 88 percent. Figure 2 shows a scatter diagram of annual total accidents and fatal accidents involving commuter air carriers against annual flight hours for the past decade. The graphic depiction clearly delineates that in commuter air carrier operation, aircraft accidents and aircraft hours flown were well correlated: the accident frequency distribution appears to be an inverse function of aircraft hours flown. In other words, the aircraft accident frequency decreased proportionately as the aircraft hours flown increased.

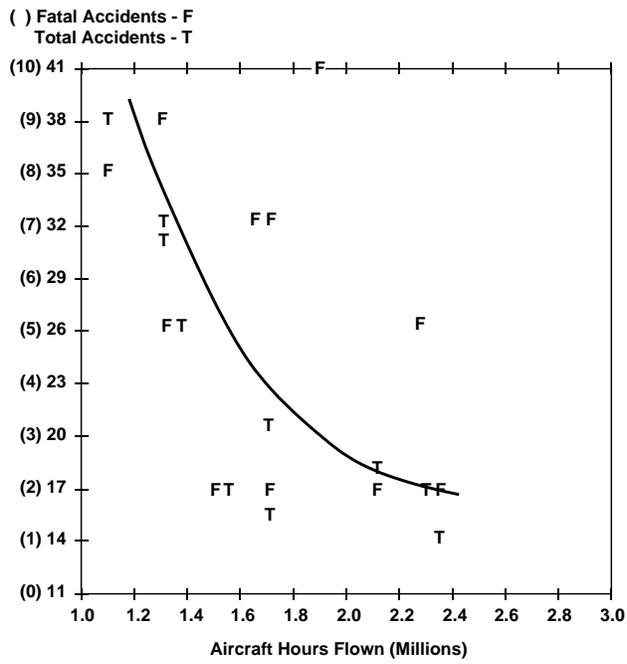
**Figure 2 — Scatter Diagram of Total Accidents, Fatal Accidents and Hours Flow  
U.S. Commuter Air Carriers 1980-1990**

Because aircraft hours flown has been used for years by governments as well as by private industry to measure aviation safety, the opposite findings of the correlation analysis over aircraft accidents and exposure involving commuter air carriers and air taxis as shown in Figures 2 and 4 could renew a debate of an old question: Are aircraft hours flown a valid measurement of flight safety? ♦

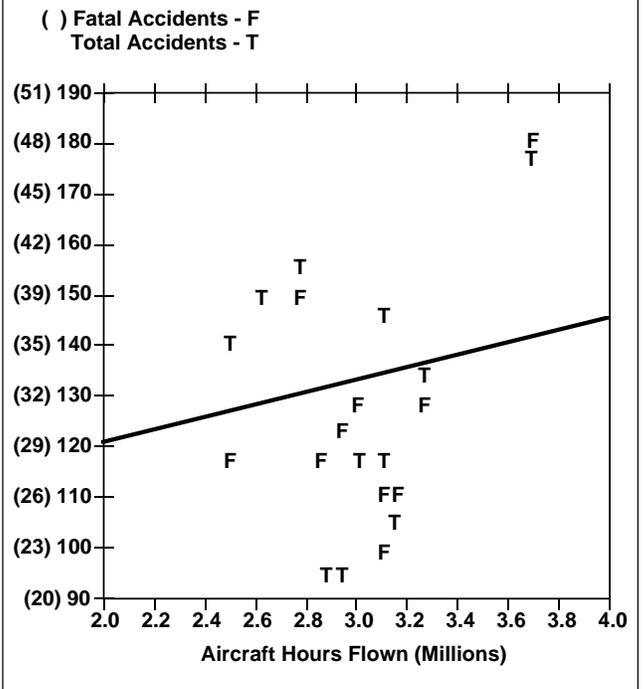
**Figure 4 — Scatter Diagram of Total Accidents, Fatal Accidents and Hours Flow**

The frequency of total and fatal accidents appeared to follow a similar up-and-down pattern of aircraft hours flown. During the period between 1975-1985, the safety performance of air taxi operations in terms of accidents per 100,000 aircraft flown showed few changes. Again, unlike the commuter air carriers which recorded a significant improvement in safety over the period, the safety performance of air taxis was very unstable. The changes are shown in Figure 3. Although the accident and fatal accident rates decreased somewhat in the past three years, the scatter diagram of air taxi accidents and hours flown as shown in Figure 4

did not reflect that the aircraft accidents and aircraft hours flown were correlated at all.

The correlation coefficient is too small to be considered significant.

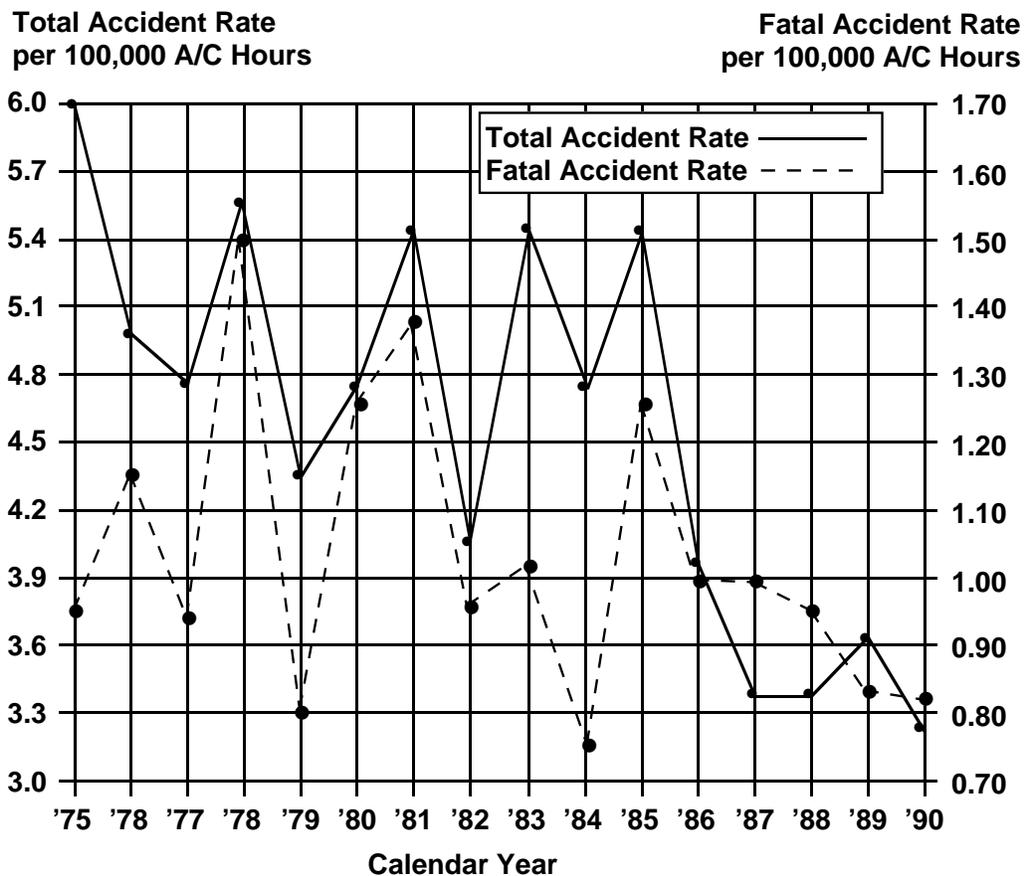
**Figure 3 — Total Accidents and Fatal Accident Trends  
U.S. On-demand Air Taxi**

Over the period from 1975 to 1990, the operational and safety performance indicators for U.S. air taxis, unlike the commuter air carriers, varied up and down without a discernable
