Stabilized Approach And Flare Are Keys to Avoiding Hard Landings

Flight Safety Digest

Vol. 23 No. 8

August 2004

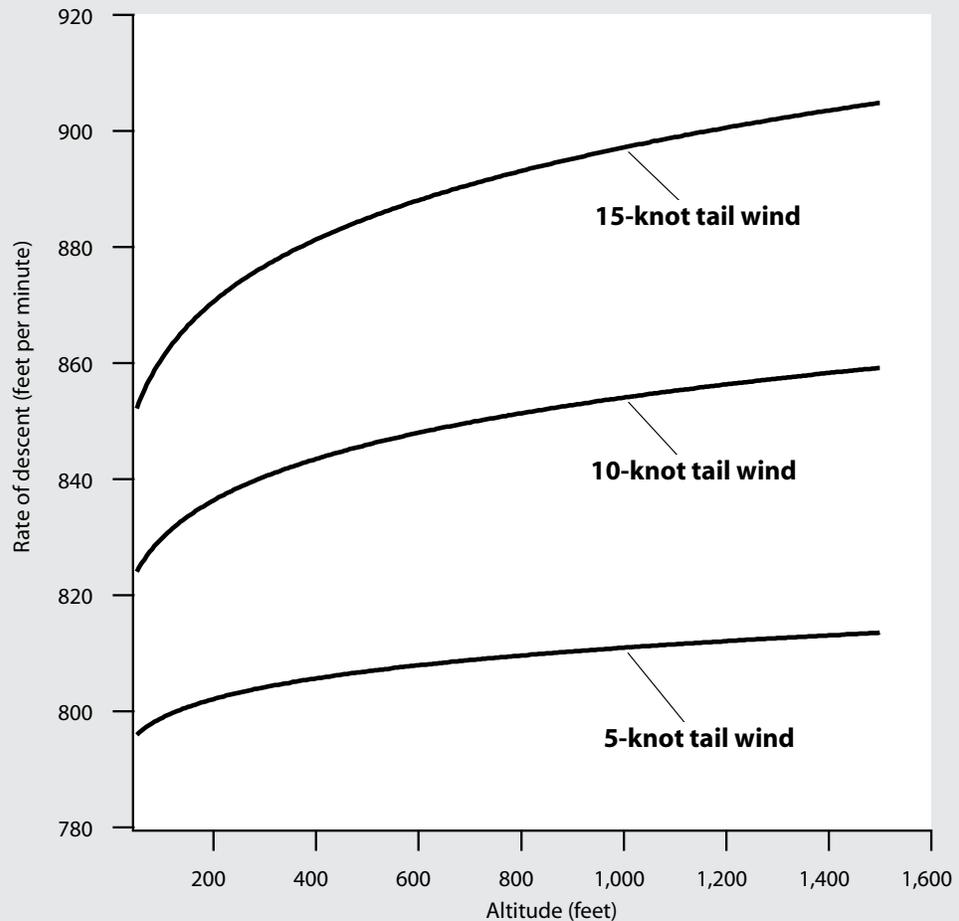
Figure 2
Examples of Descent Rates Required to Maintain Glideslope With a Tail Wind*

* Examples assume a constant approach speed of 145 knots, a three-degree glideslope and tail wind velocities measured at 33 feet (10 meters) above ground level.

Figure 2 (page 12) shows the rates of descent required to maintain a three-degree glideslope at a constant approach speed of 145 knots with tail winds of five knots, 10 knots and 15 knots at various altitudes. (Wind speed normally decreases with altitude and typically is measured at 33 feet AGL.)

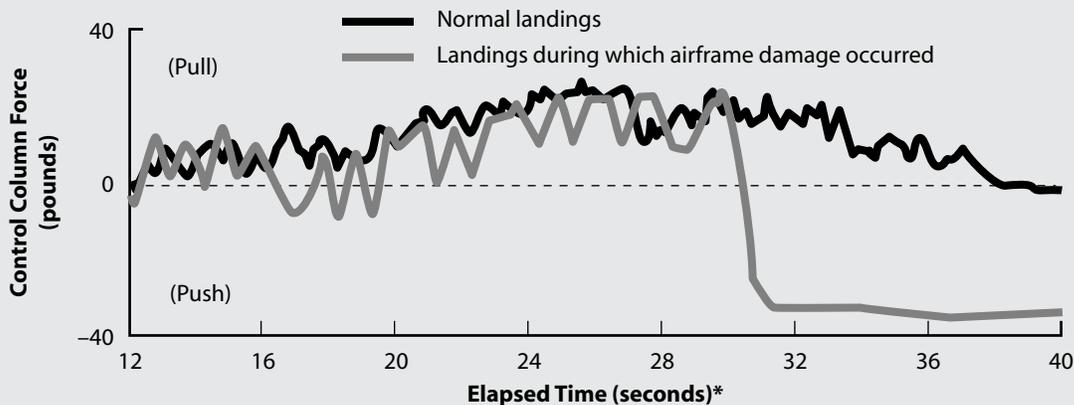
Figure 3
Control-column Movements Recorded During Normal Landings and Landings Involving Airframe Damage

* Landings are positioned so that all reach zero feet radio altitude at the same elapsed time (28.5 seconds).

Data recorded by Boeing during normal landings and during landings in which structural damage was caused by hard nose-landing-gear touchdowns show that the latter involved application of nose-down pitch control (Figure 3).
