# Cooperation in the Analysis of Data and the Improvement of Aircraft Engine Safety

*Although engine failure rates are low, uncontained failures remain a serious concern.*

Jean-Paul Herteman, Quality, and Pierre Mouton, Flight Safety  
Societe Nationale d'Etude et de Construction de Moteurs d'Aviation (SNECMA)

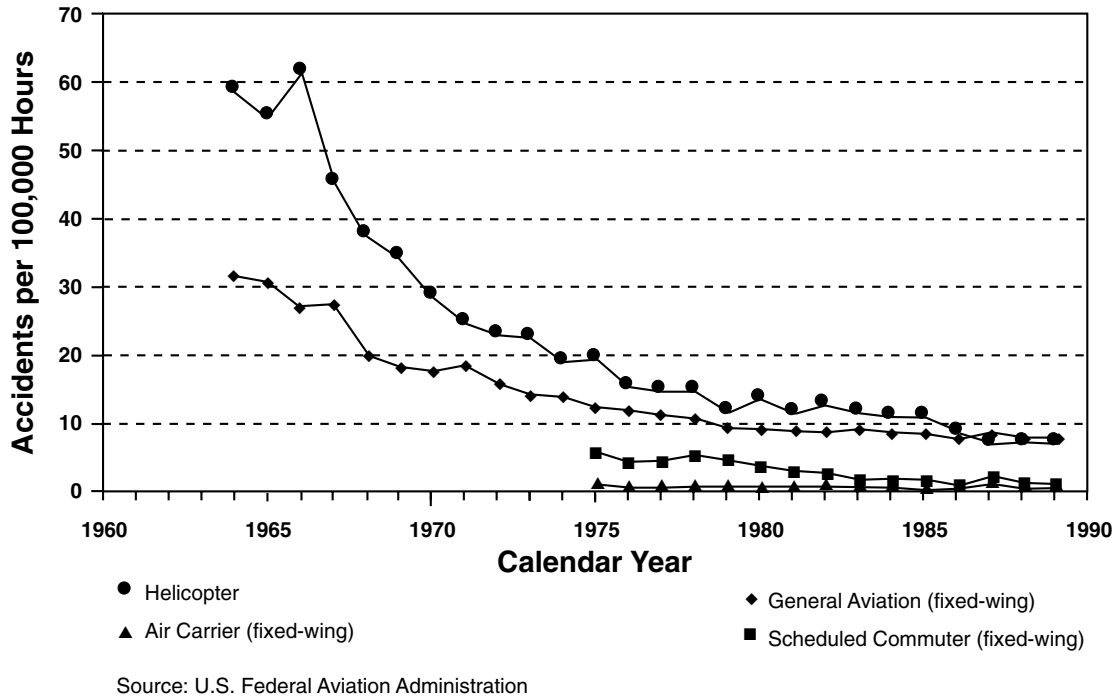
Figure 1

## Annual Aircraft Accident Rate (1964-1989)

Figures 1 and 2 show total accident rates and fatal accident rates, respectively, of helicop-

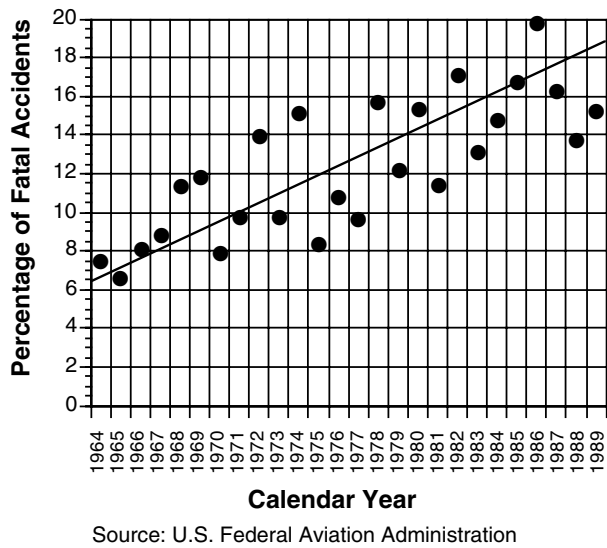
Figure 3

### Fatal Civil Rotorcraft Accidents (1964-1989)

decreased during the 26-year period, the ratio of fatal accidents as a percentage of total helicopter accidents, as shown in Figure 3, reveals an upward trend.
