DECEMBER 1992

FLIGHT SAFETY

Small Airline Continues to Win Big Battle Against Aircraft Ground Icing

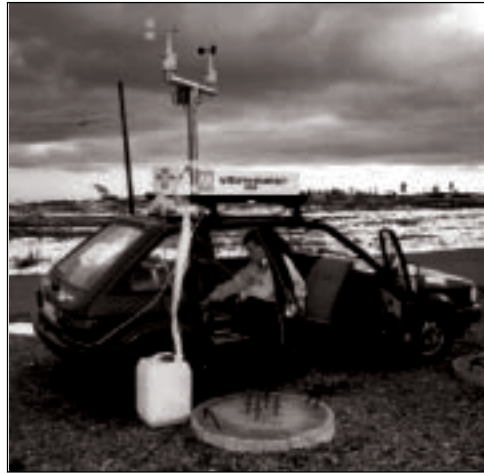
A car is equipped with a simulated aircraft aluminum fuel tank on its roof that has a Vibro-Meter electrical ice sensor built into the tank's upper surface. Various data, including wind speed, ambient temperature, fuel temperature and other information are recorded on a computer in the car. Several Finnair first officers conduct tests to determine optimum operating characteristics and standards for the sensor.

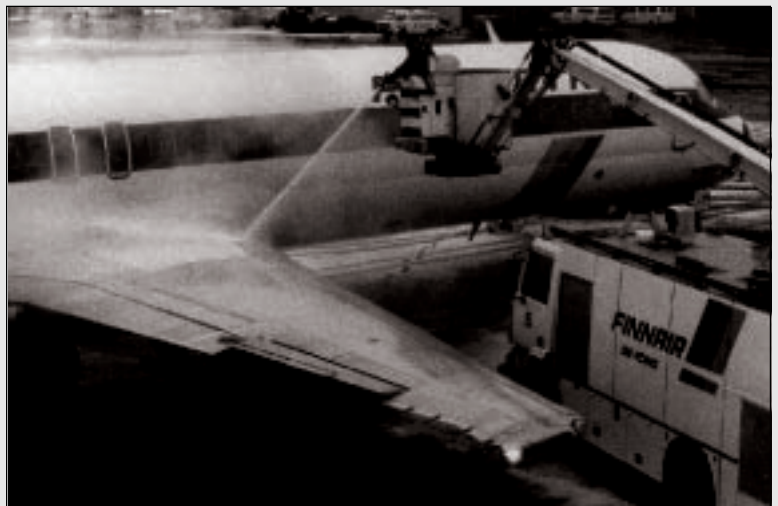
Ice forms more readily over the wing root, where the cold fuel settles and there is more metal structure, including the landing gear components, which can contribute to colder temperatures.

It was determined, finally, that the fuel carried in the wing tanks was supercooled during the long high-altitude flight to Zürich. After landing, if there was moisture in the air or precipitation, clear ice formed on the wing. The ice was nearly invisible. During takeoff, the wings flexed at rotation and broke the ice free, and it flowed aft into the engines.

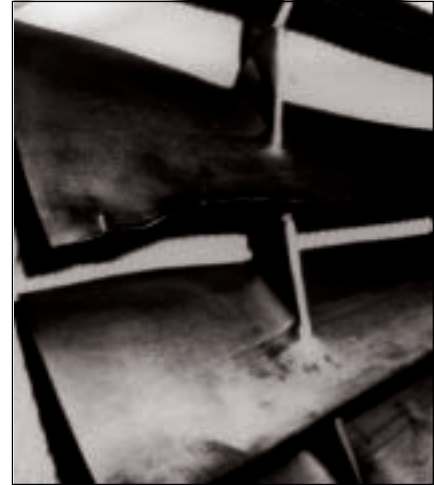
The gentle bend in the blades is characteristic of soft foreign object damage.

Several incidents in the early 1980s — most at Zürich during cold weather — involved damage to engine fan blades that was not indicative of traditional foreign object damage (FOD). Damage suggested soft FOD — several blades in a section were bent, but not sharply.

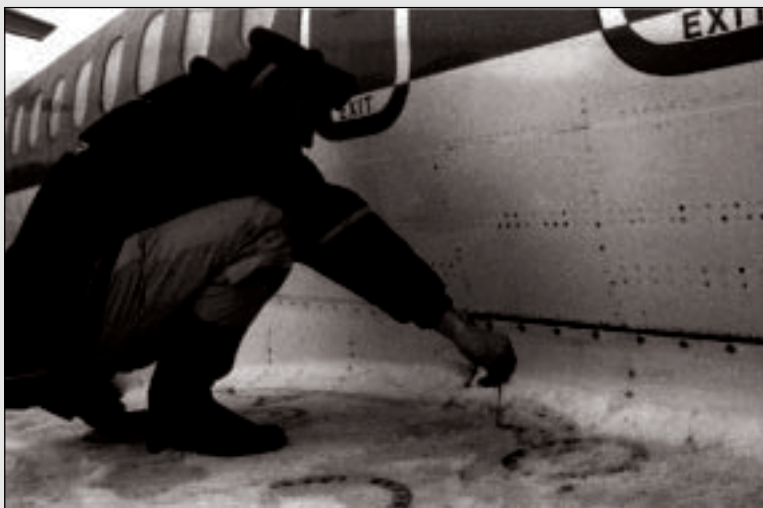
The tuft of parachute cord moved freely, but underneath the snow, clear ice had formed, and the cord's base was frozen solid.

freezes only the base of a tuft and the remainder of the tuft is free. So this is not a foolproof device."

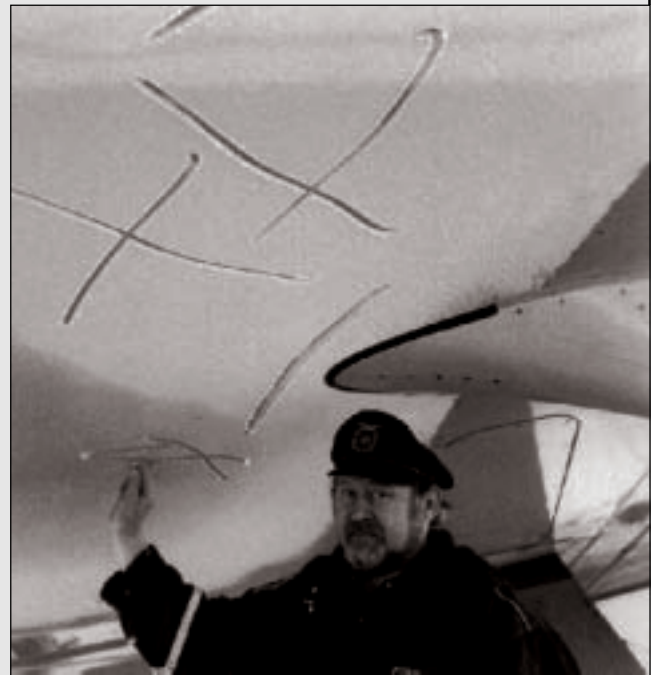
Frost formed readily under the wings in the fuel tank area.

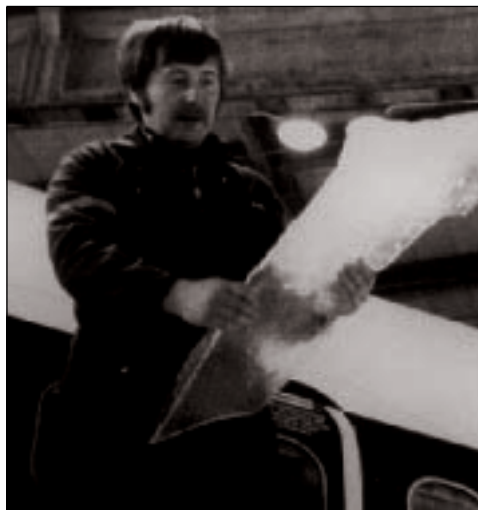
A mechanic holds a sheet of ice taken from the wing of the Finnair DC-9 that aborted a takeoff at Helsinki-Vantaa Airport in 1985 after flexing wings on the uneven runway broke the ice free, and it was ingested into the engines.

Then, in 1985, a Finnair DC-9 aborted a takeoff at Helsinki. When the aircraft was taken back to the hangar, large sheets of clear ice were found on the wings. During the ground roll on uneven pavement, the wings flexed and the ice broke free and damaged both engines.

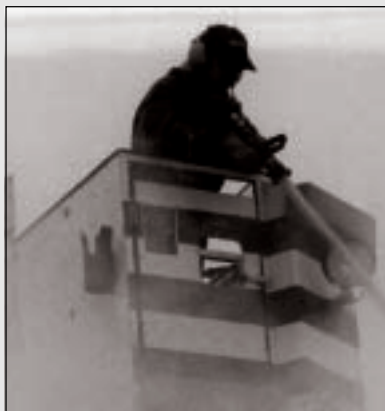
Hot water under high pressure in a tight stream was required to break ice free from an aircraft wing.

"It is the heated water that melts the ice," he explained. "The glycol is only there to prevent the water from refreezing. One of the most important things in deicing is the capability of the equipment to produce enough pressure to break into the ice and force the hot water under the ice to lift it from the wing."

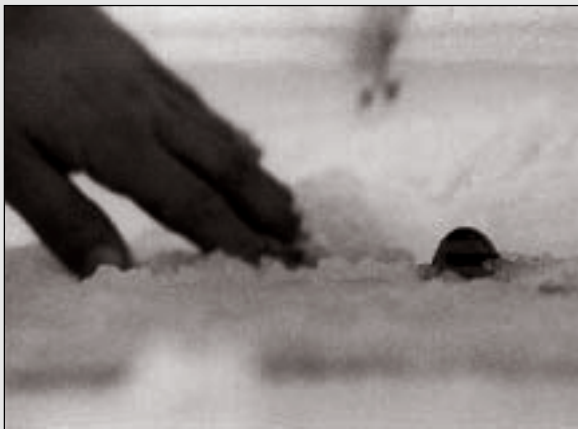
The small brightly colored horizontal tab was buried in snow and clear ice, and provided a visual indication of contamination. It has no influence on the flight characteristics of the wing.

ice on the wing "and again everybody just called me 'crazy Eloranta.'" He developed a small tab with alternating horizontal color bands that could be used to judge the depth of accumulated snow and ice on the wing. When clear ice was present, refracted light would distort the color bands. Triangles painted on the wings served a similar purpose.

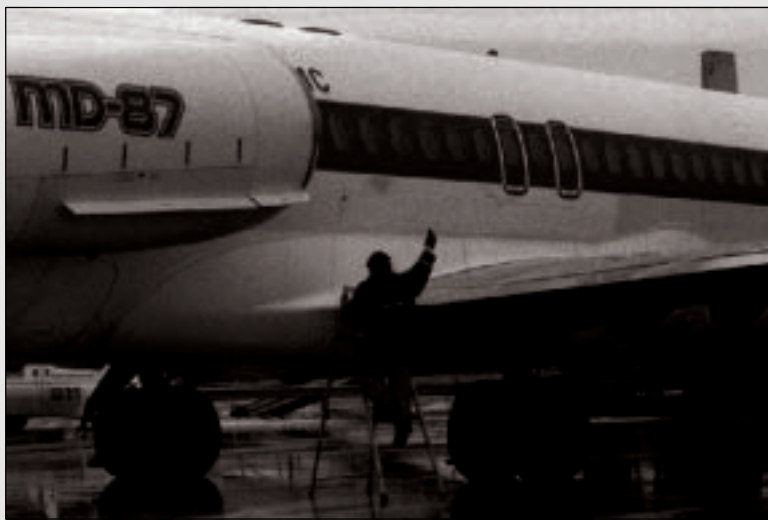
The mechanic gave a "thumbs-up" acknowledgment to the deicing truck crew that the wing surface was clean and there was no ice on it.

truck and could be located over a wing. Once on the wing, the mechanic removed a glove and put his bare hand onto the wing surface, usually near the wing root, to confirm that there was no ice on the wing. He also notified the aircraft's pilot that deicing had been performed and a hand check had confirmed that the wing was clear of ice.

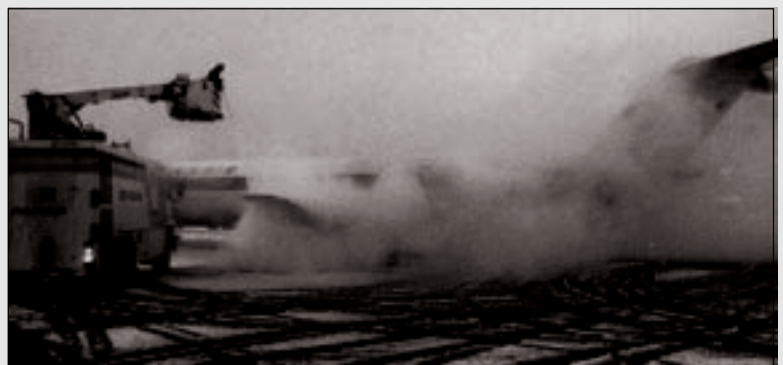
Fog formed from the hot water used in deicing, but the Type I fluid did not seem to add any slipperiness to the snow-covered ramp.

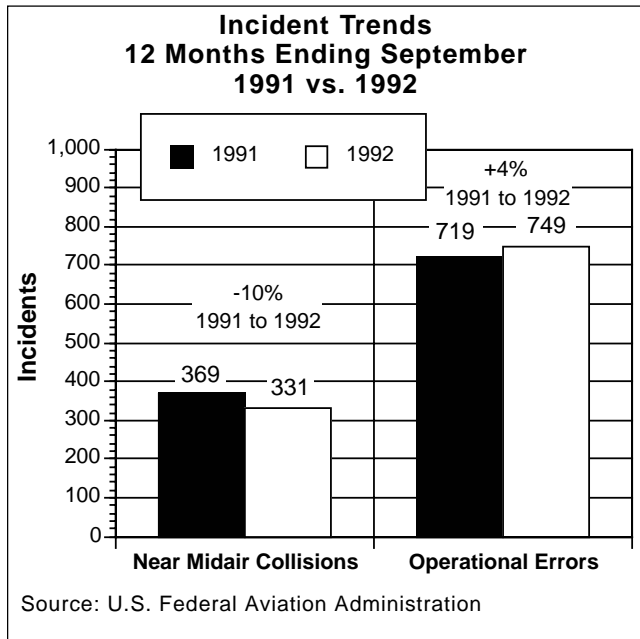
1992 Incident Trend: Operational Errors Increase

Figure 1 shows incident trends for near mid-air collisions and operational errors compiled from data through September 30, 1992.

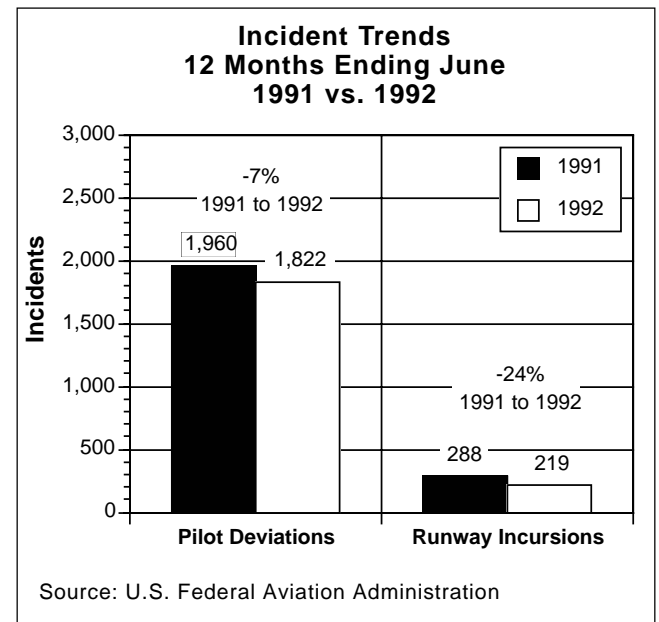
Figure 2 shows pilot deviations and runway incursions compiled from data through June 30, 1992.

Pilot deviations and runway incursions decreased during the 12-month period ending June 1992 when compared to the same period in 1991. Pilot deviation and runway incursion monthly totals usually require 90 days to stabilize. Therefore, comparisons do not include the most recent 90-day period. ♦
