FLIGHT SAFETY FOUNDATION

FEBRUARY 2000

A Review of Transport Airplane Performance Requirements Might Benefit Safety

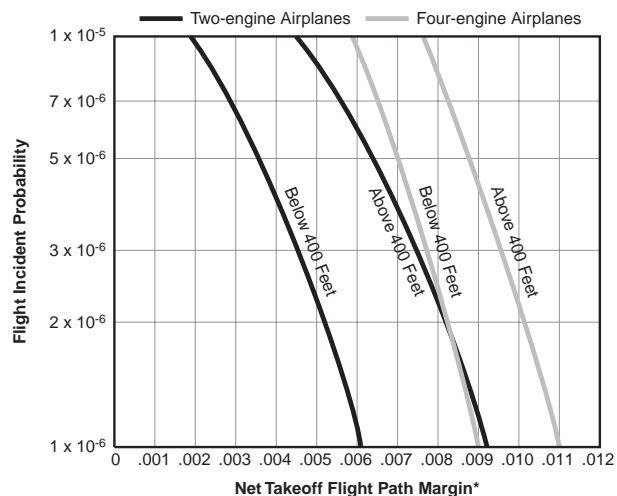
Figure 1

International Civil Aviation Organization Standing Committee on Performance In-flight Incident Probabilities

* The net takeoff flight path is derived by subtracting performance margins from the one-engine-inoperative flight path demonstrated during certification of takeoff obstacle-clearance performance. The margins correct for factors such as average pilot skill and average airplane performance.

Figure 1, page 4, is an adaptation of SCP study results about incident probabilities of twin-engine airplanes and four-engine airplanes. The SCP did not select a target incident probability; the committee presented proposals for two incident probabilities — 2×10^{-6} and 7×10^{-6} — with the understanding that ICAO subsequently would select a target incident probability.¹¹

- The SCP proposed two incident probability targets, with the understanding that ICAO would adopt one of the targets. The targets proposed by SCP were 200x10⁻⁸ incidents per flight and 700x10⁻⁸ incidents per flight. The SCP did not establish an accident probability objective, but an accident probability target one order of magnitude (i.e., a factor of 10) lower than the incident probability target would correspond with approximately 50x10⁻⁸ accidents per flight;
- AC 25.1309-1A and AMJ 25.1309 said that the probability of a catastrophic accident caused by a system failure or a performance problem should be less than 0.1x10⁻⁸ per flight hour; and,
- ETOPS established an all-causes accident probability target of 30x10⁻⁸ accidents per flight hour. The associated probability target for a total loss of thrust from independent causes is 0.3x10⁻⁸ per flight hour.

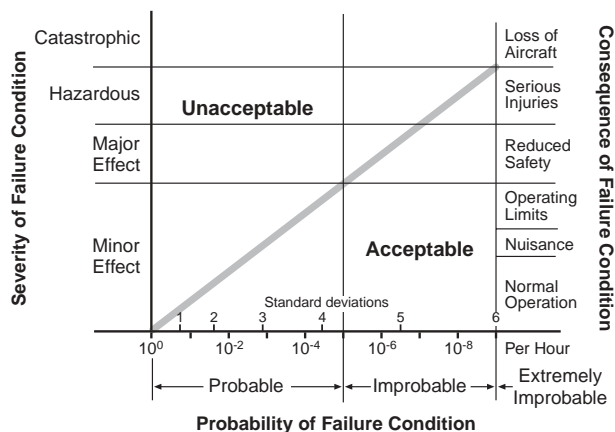
U.S., European Certification Guidance For System Design and Analysis*

* Terminology and numerical information are adapted from U.S. Federal Aviation Administration Advisory Circular (AC) 25.1309-1A, *System Design and Analysis*, and Joint Aviation Authorities Advisory Material—Joint (AMJ) 25.1309, *System Design and Analysis*.

Figure 2 shows a summary of the terminology and the numerical information that are applied in AC 25.1309-1A and AMJ 25.1309. For reference purposes, a standard deviation scale — based on a normal (Gaussian¹⁴) single-sided frequency distribution — has been added to the probability scale. Figure 2 shows that the probability of a catastrophic accident¹⁵ caused by a system failure or by a performance problem should be less than 1x10⁻⁹, with the unit of risk expressed as a rate of occurrence per flight hour.

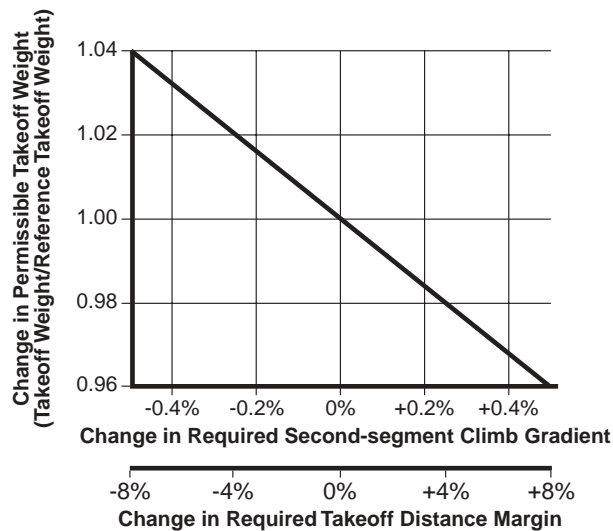
Figure 3

Effect of Change in Required Second-segment Climb Gradient and Required Takeoff Distance Margin on Permissible Takeoff Weight

- Available runway length. A variation in runway-length margin of 1 percent results in approximately a 0.5 percent variation in permissible takeoff weight;
- Obstacles in the takeoff flight path area; and,
- Requirements for first-segment climb, second-segment climb and final-segment climb. The second-segment climb requirement usually has the greatest effect on an airplane's permissible takeoff weight. A variation of 0.1 percent in the second-segment climb requirement results in approximately a 0.8 percent variation in permissible takeoff weight (Figure 3, page 7).

By combining these standard deviations with the data in Figure 3, Figure 4 and Figure 5, and assuming that normal frequency distributions are applicable, mutual relationships are established between variations in safety level in terms of orders of magnitude and various aircraft performance parameters. For the two selected performance criteria — all-engine takeoff distance and second-segment climb gradient — the following are equivalent to a change of one order of magnitude (approximately 0.4 standard deviation):

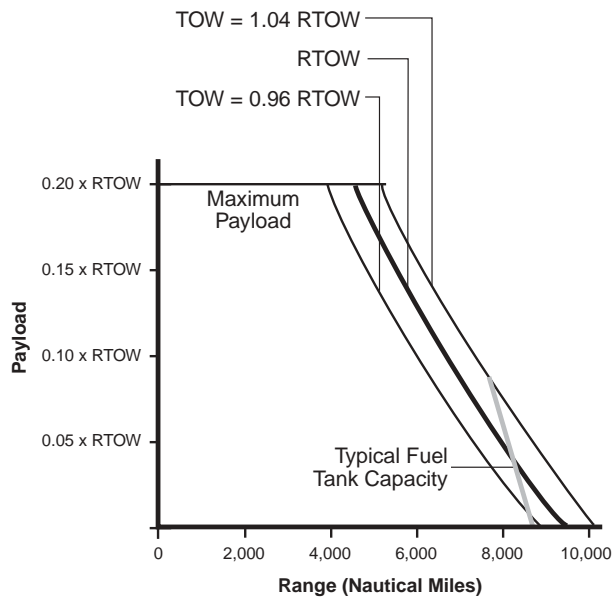
Figure 4

Effects of Change in Permissible Takeoff Weight on Payload Capability and Range

TOW = Takeoff weight RTOW = Reference takeoff weight
Source: Joop H. Wagenmakers

Figure 4, page 7 shows the approximate effects of a 4 percent change in the permissible takeoff weight on a typical long-range airplane's payload capability and range capability. The example shows that an airplane with full fuel tanks (i.e., at the typical fuel-tank-capacity limit) and with a reference takeoff weight (RTOW) of 500,000 pounds has a payload capacity of approximately 25,000 pounds (0.05 x RTOW) and a maximum range of approximately 8,100 nautical miles. A 4 percent increase in RTOW (to 520,000 pounds) would result in a payload capacity of approximately 46,800 pounds (0.09 x RTOW) and a maximum range of approximately 7,750 nautical miles. A 4 percent decrease in RTOW (to 480,000 pounds) would result in a payload capacity of approximately 9,600 pounds (0.02 x RTOW) and a maximum range of approximately 8,450 nautical miles. (With the same fuel load, the lighter airplane would have a greater range than the heavier airplane.)

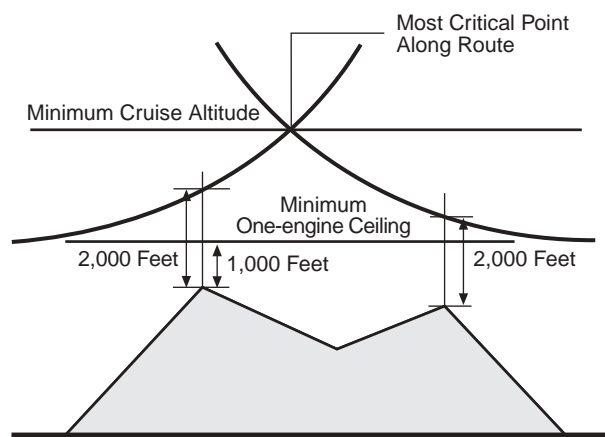
Transport Category Turbine Airplane Performance Requirements for Compliance with En Route Obstacle-clearance Criteria

The operating regulations require sufficient airplane engine-out performance to safely operate above any terrain along the route. Figure 3a shows that, to meet this requirement, the
