JANUARY 2001

FLIGHT SAFETY

Q-Star Verification Process Provides Safety Assessment Of Aircraft Charter Providers

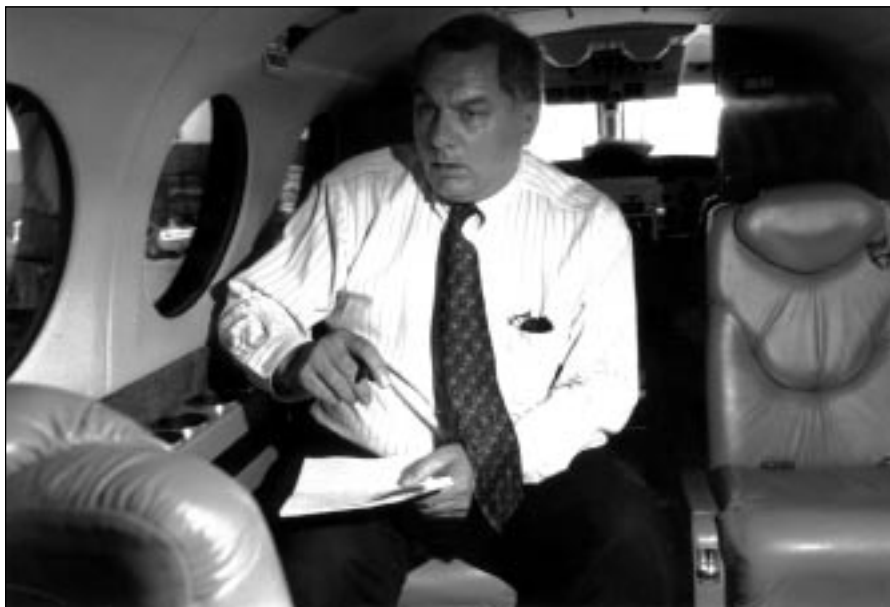
Q-Star verification specialist Robert McCutchan checks emergency equipment aboard a TAG Aviation USA aircraft.
